**Subject: Phase 2, Modules 10 and 11 Liner Construction Documentation Report
Addendum #1
Dry Ash Disposal Facility (WDNR License #3025)
Wisconsin Power and Light Company – Columbia Energy Center
Portage, Wisconsin**

Construction Documentation Report Addendum No.1

Phase 2, Modules 10 and 11 Liner Construction
Columbia Dry Ash Disposal Facility
Pardeeville, Wisconsin

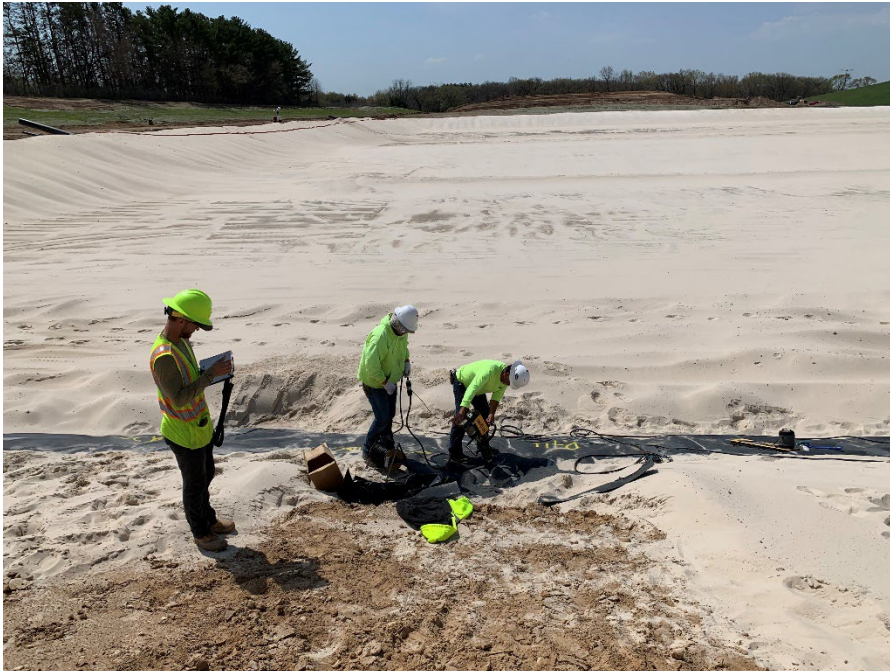
Photo 22: Repairing existing damage of the existing geomembrane.
(Looking south)
(5/4/2023)

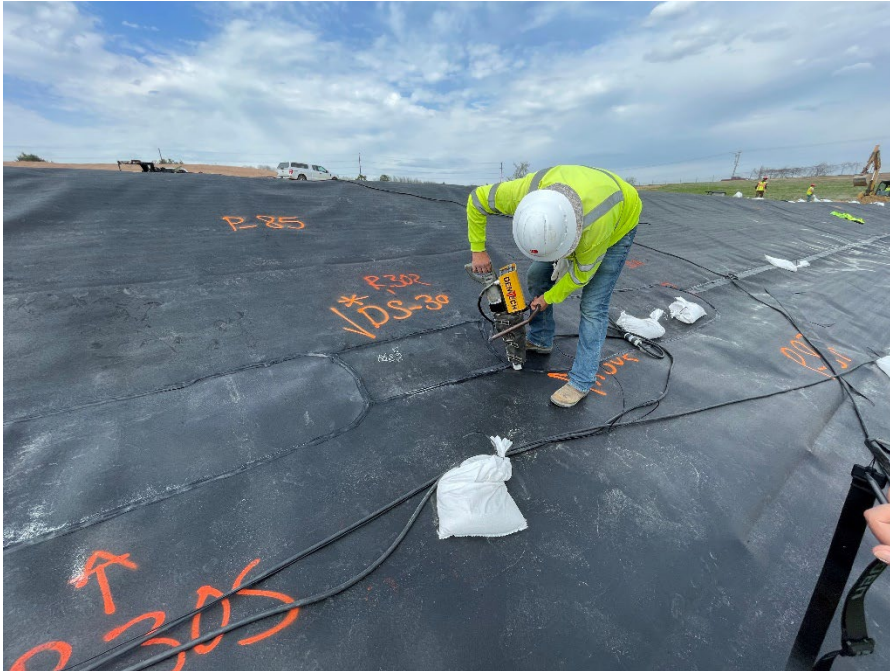
Photo 29: Extrusion welding of the geomembrane repairs on Module 11 north berm. (Looking northeast) (5/5/2023)

Repair of the geomembrane was completed by tack welding a piece of geomembrane to the repair area with a leister. The geomembrane patch was ground using a grinder and then welded with an extrusion welder. Trial welds were tested before extrusion welding was performed. The repairs were non-destructively tested by vacuum box testing.

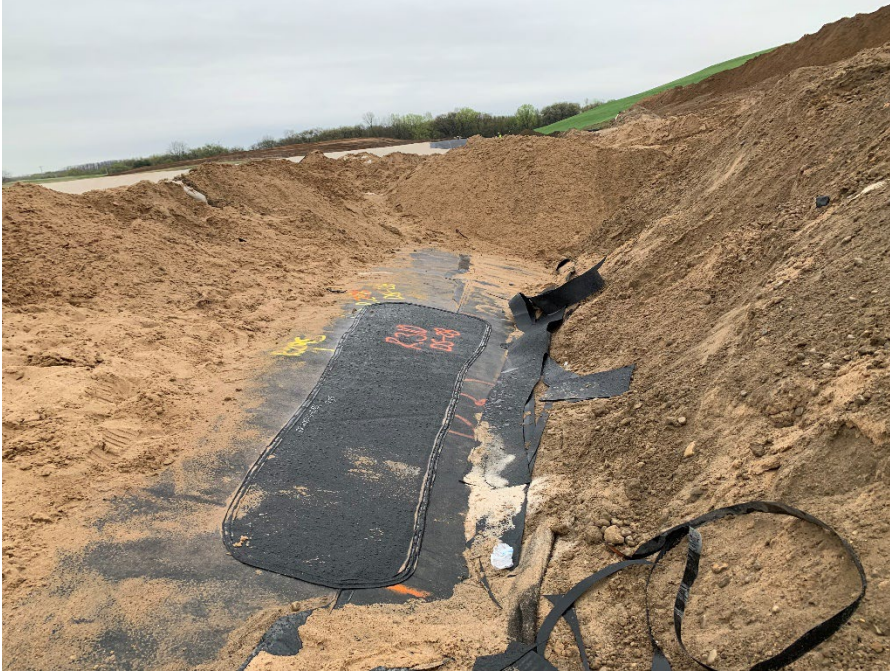
Photo 31: Repaired damaged section on the existing geomembrane of Module 4.
(Looking south)
(5/6/2023).

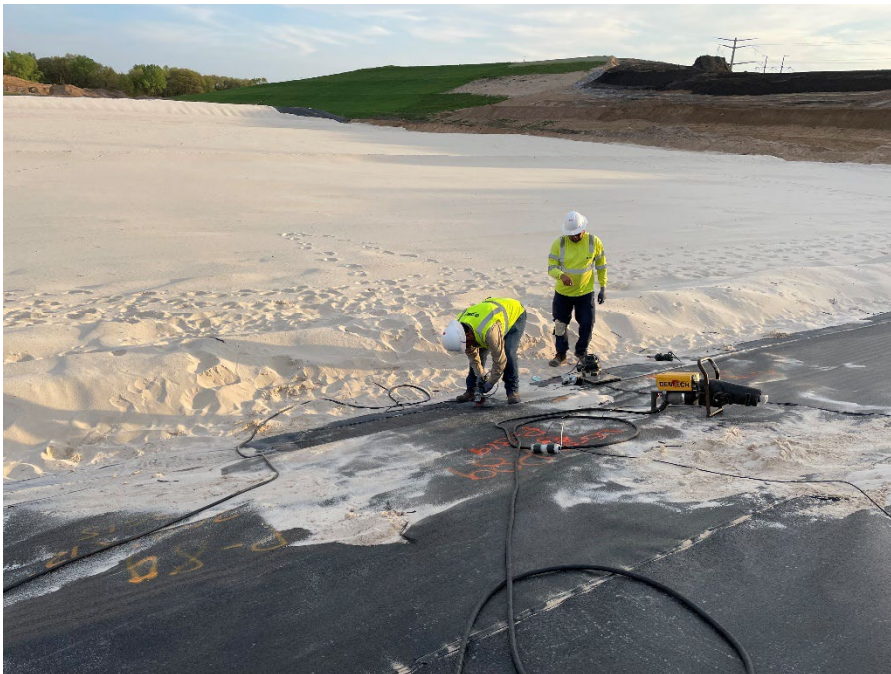
Photo 34: Collecting an additional destruct and performing repairs.
(Looking southwest)
(5/11/2023)

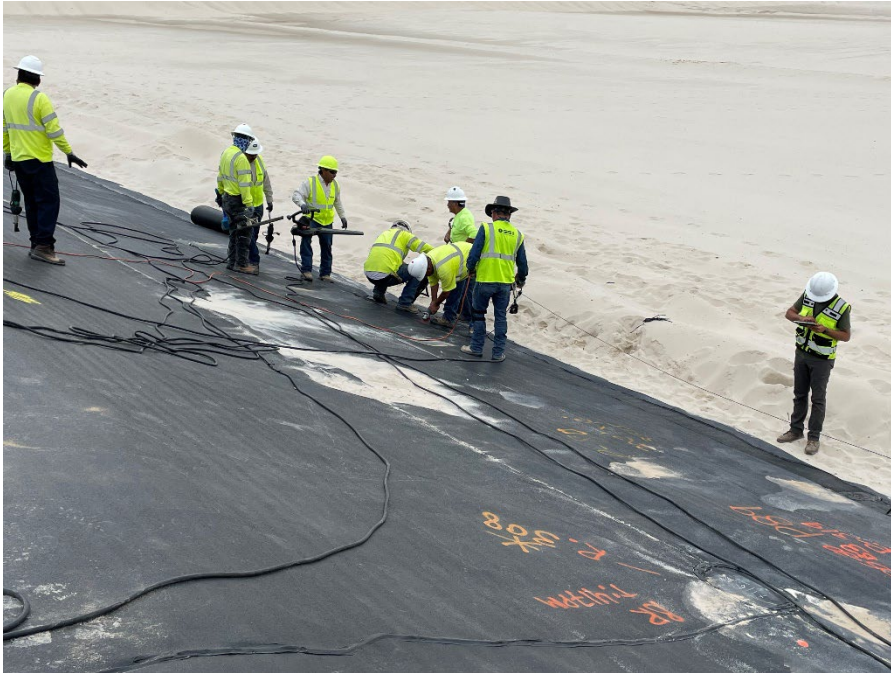
Photo 35: Collecting an additional destruct and performing repairs and vacuum box testing. (Looking southeast) (5/12/2023)

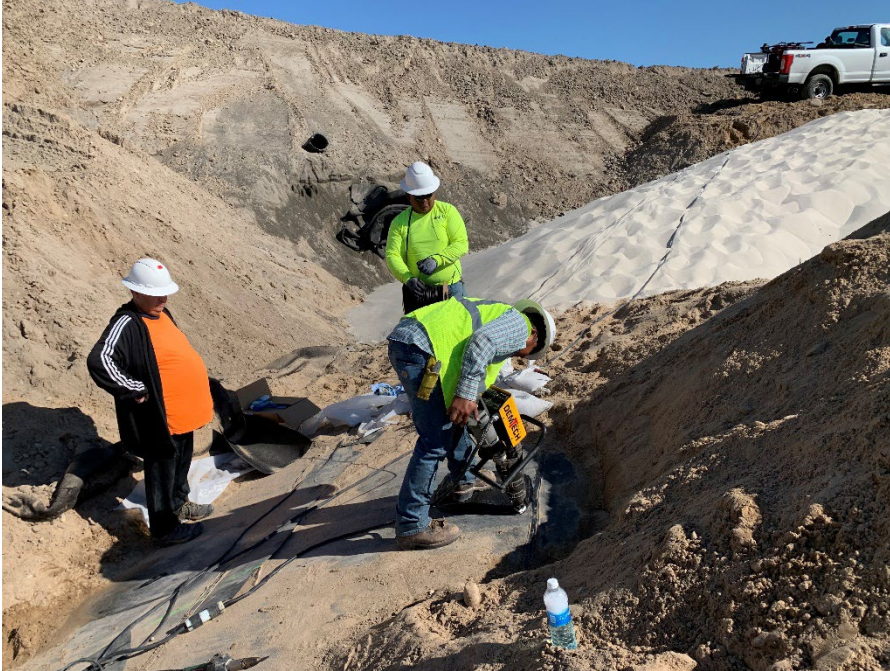
Photo 41: Geomembrane repairs between Modules 4 and 11. (Looking north) (5/20/2023)

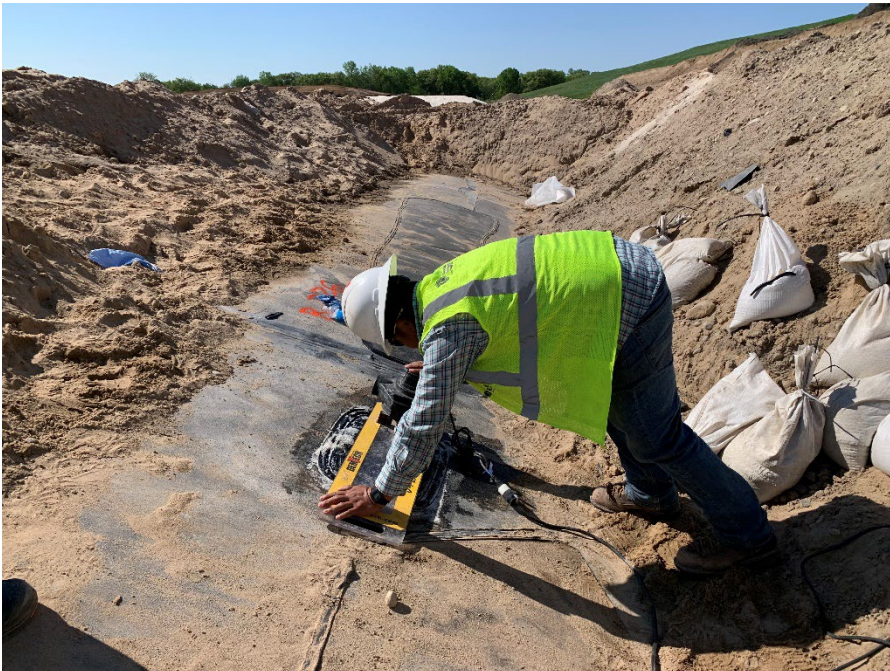
Photo 42: Vacuum box testing of the geomembrane repairs. (Looking south) (5/20/2023)

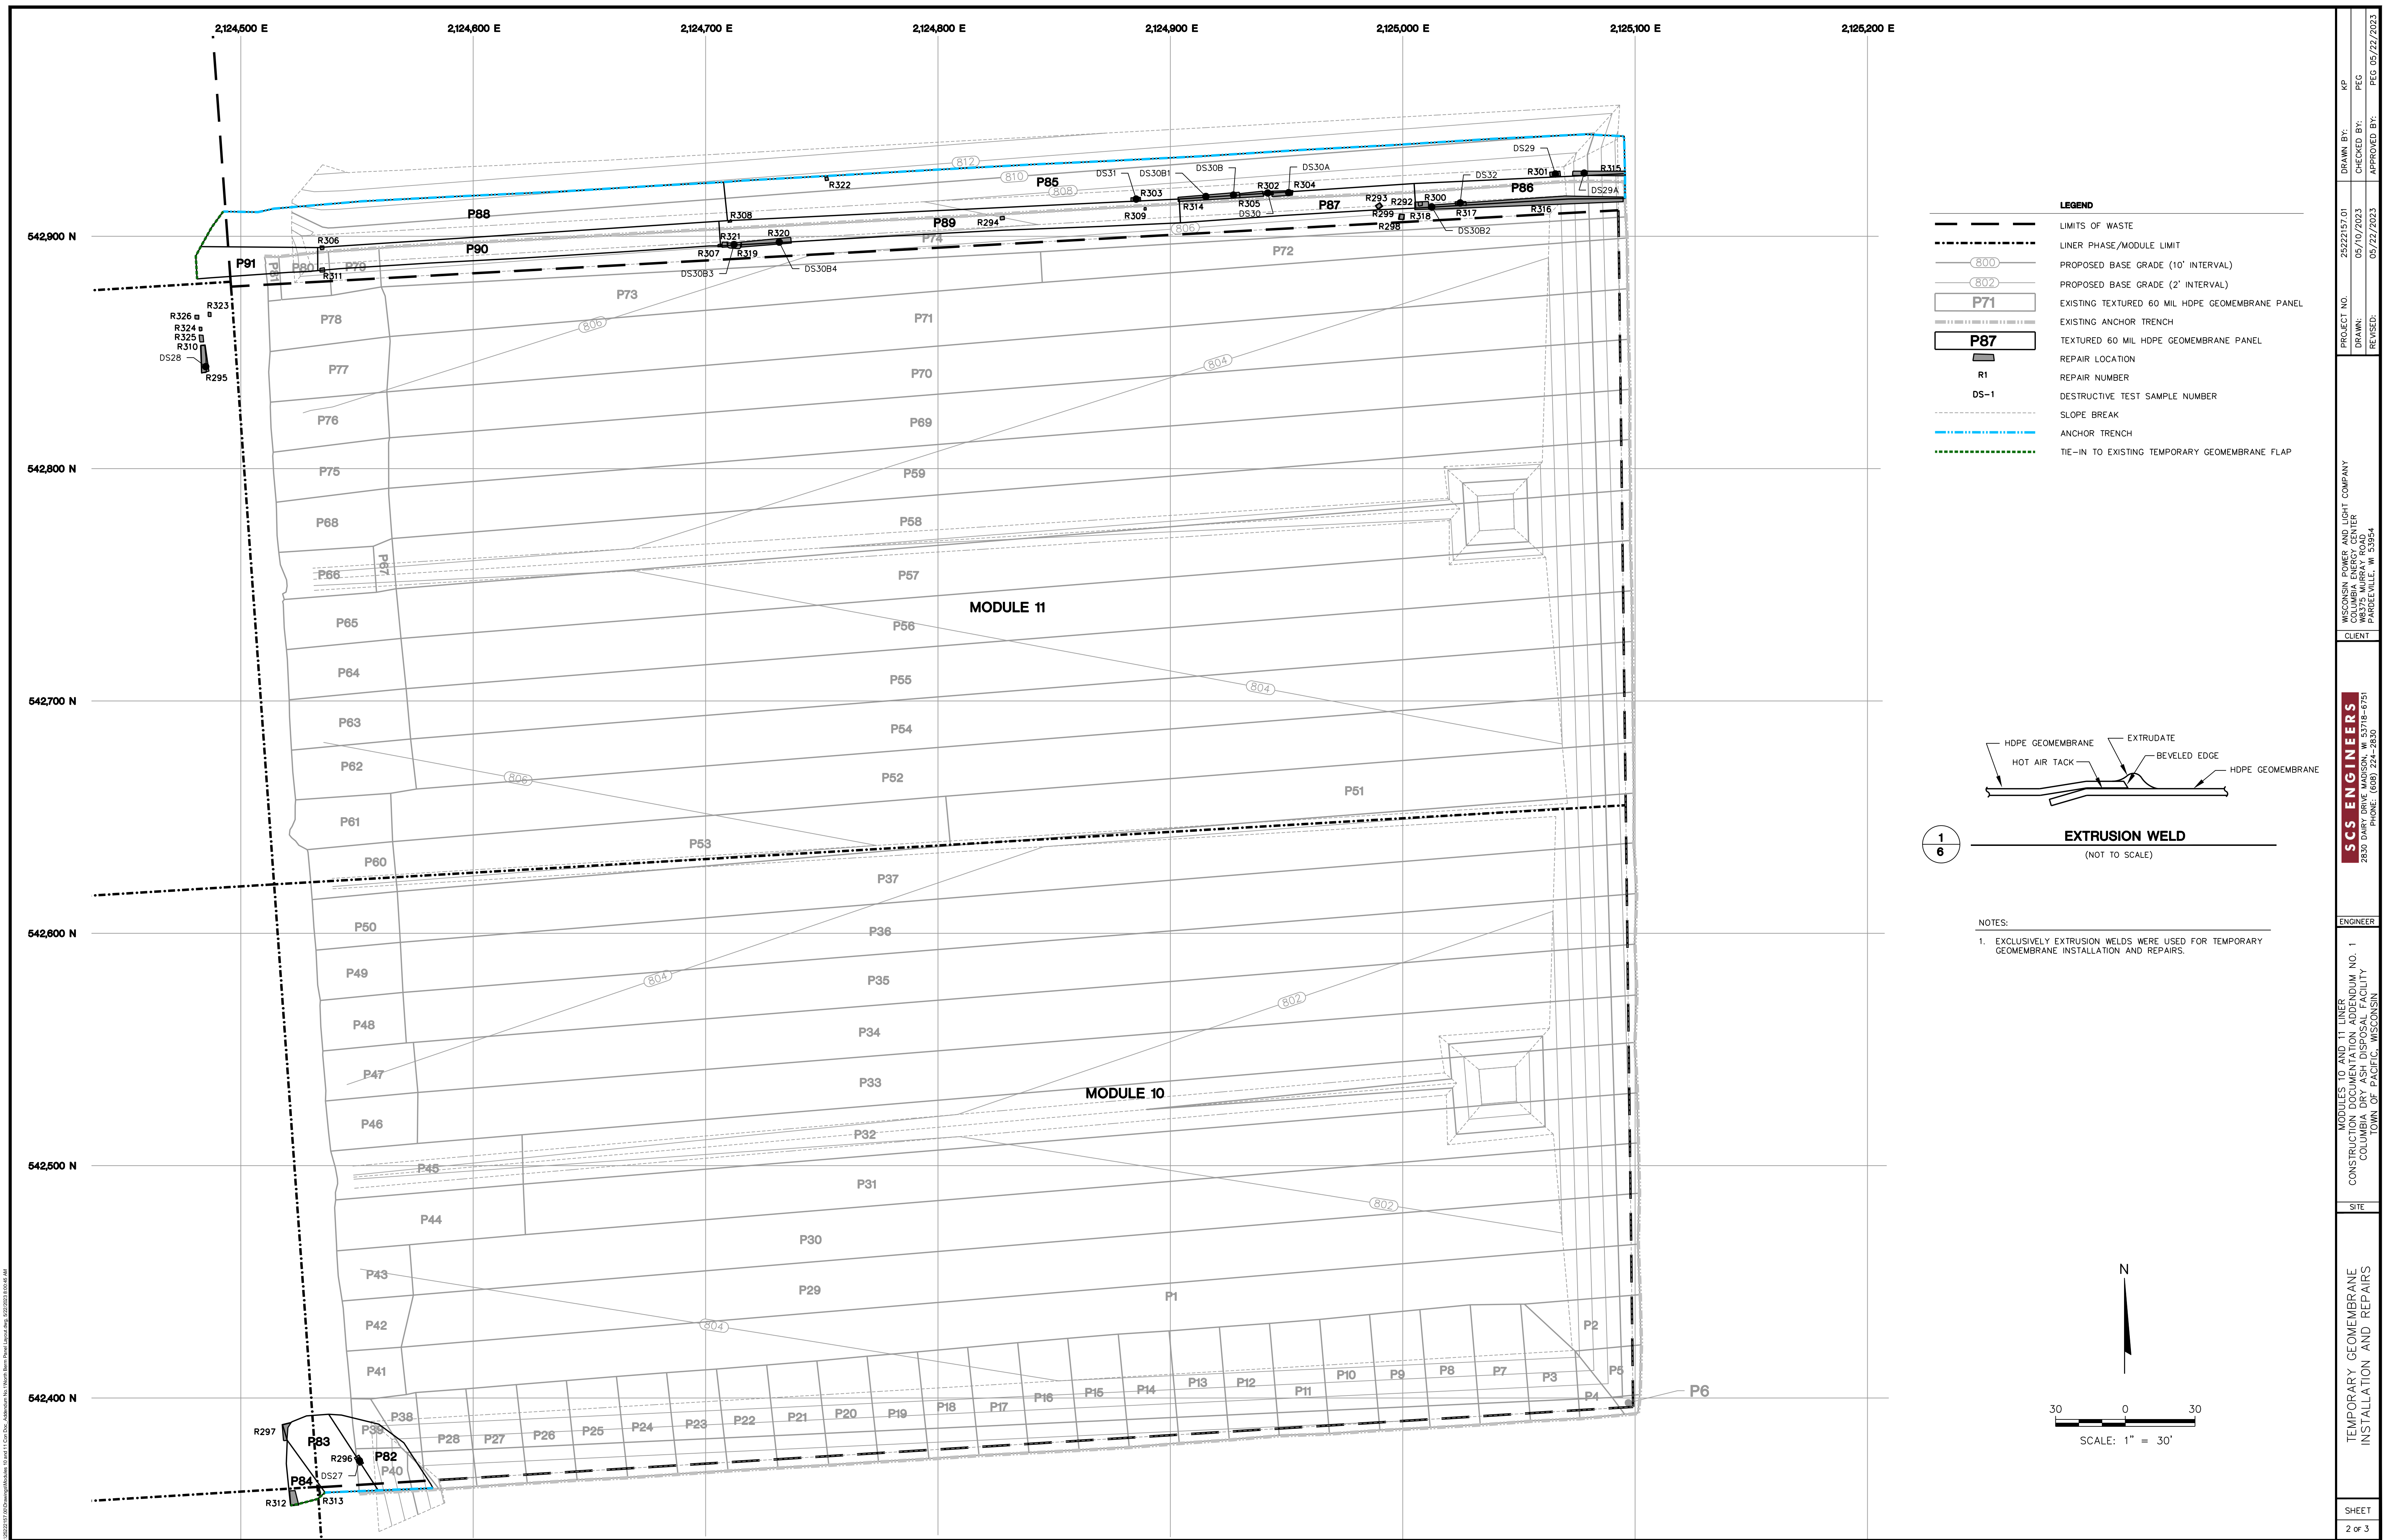
geomembrane that was damaged and needed repair. The repair is shown as R295 and R310 on the temporary geomembrane installation and repairs drawing (**Plan Sheet 2**). **Detail 1, Plan Sheet 3** also shows the tie-in detail location where the temporary geomembrane was removed.
