**ALLIANT ENERGY
Wisconsin Power and Light Company
Edgewater Generating Station**

CCR SURFACE IMPOUNDMENT

STRUCTURAL STABILITY ASSESSMENT

Report Issued: September 21, 2016
Revision 0

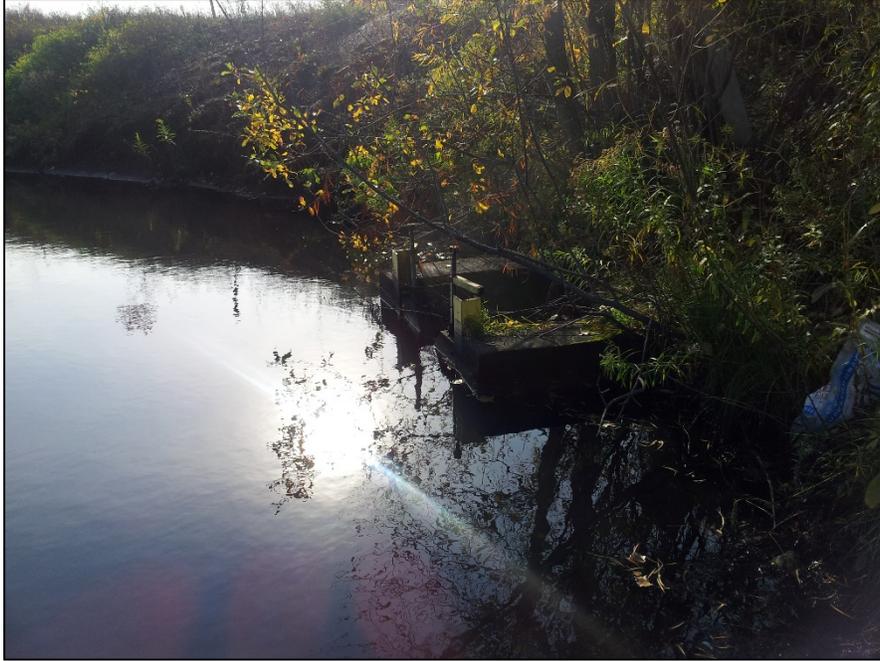
Photo 1: EDG Slag Pond inlet of hydraulic structure. Hydraulic structure consist of v-notch overflow weir that discharges into a 48-inch diameter corrugated metal pipe.

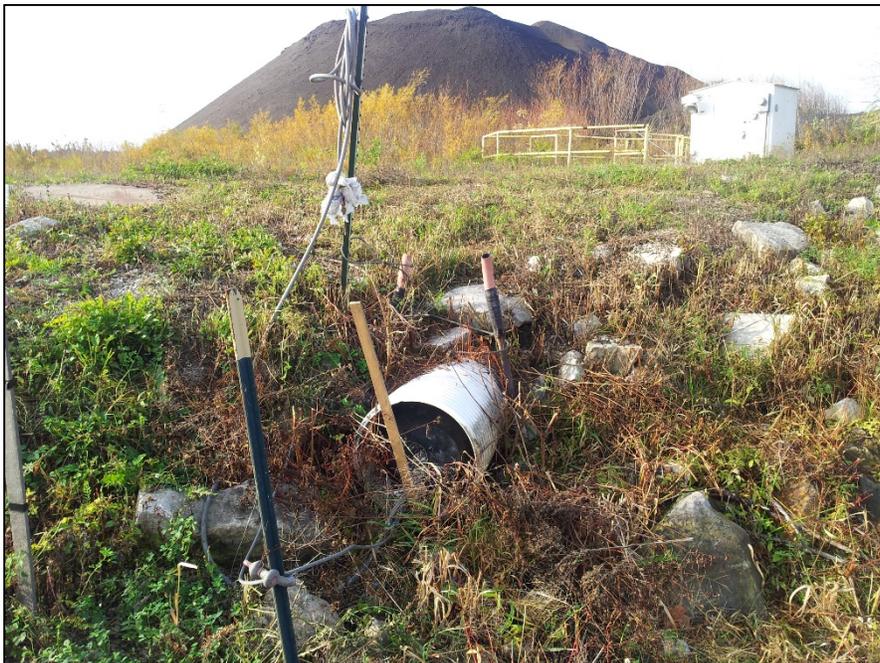
Photo 2: EDG North A-Pond inlet of hydraulic structure. Hydraulic structure consist of 18-inch diameter corrugated plastic pipe. The hydraulic structure is currently plugged.

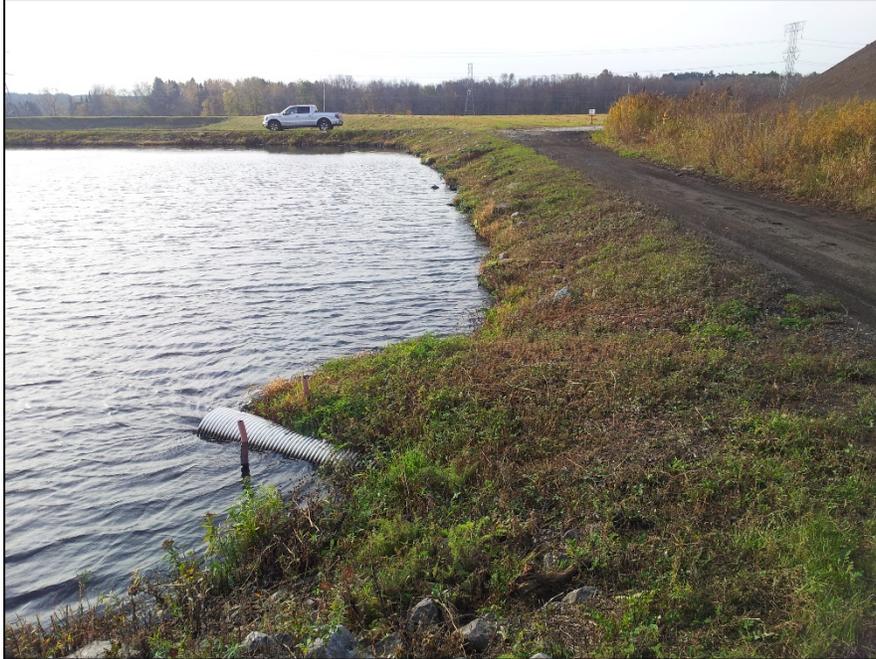
Photo 3: EDG South A-Pond inlet of hydraulic structure. Hydraulic structure consist of 18-inch diameter corrugated plastic pipe. Water flows through the hydraulic structure and discharges into a concrete sluice box prior to flowing through a Parshall flume structure.

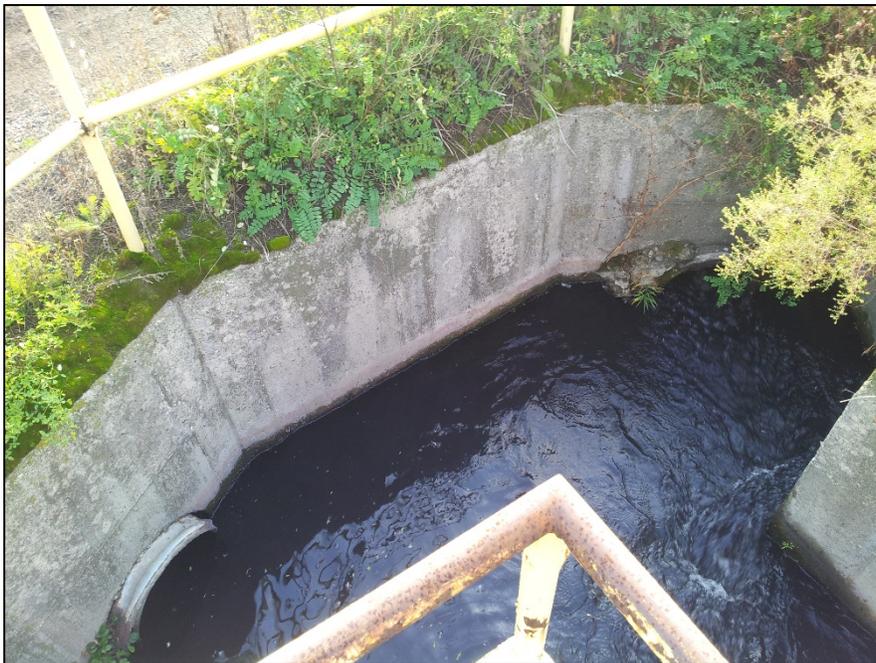
Photo 4: Outlets of EDG North A-Pond and EDG South A-Pond hydraulic structures. Currently, water only flows through the hydraulic structure of the EDG South A-Pond. Water flows through a Parshall flume structure and into a 48-inch diameter corrugated metal pipe.

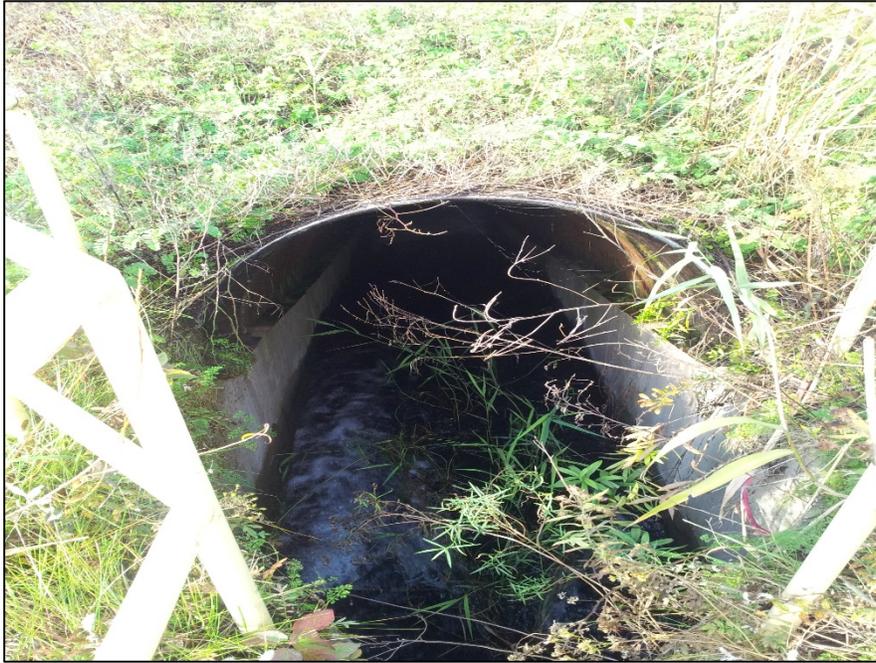
Photo 5: Water from the EDG South A-Pond flows into a 48-inch diameter corrugated metal pipe and combines with the flow from the EDG Slag Pond. The combined flows discharge into the EDG B-Pond.

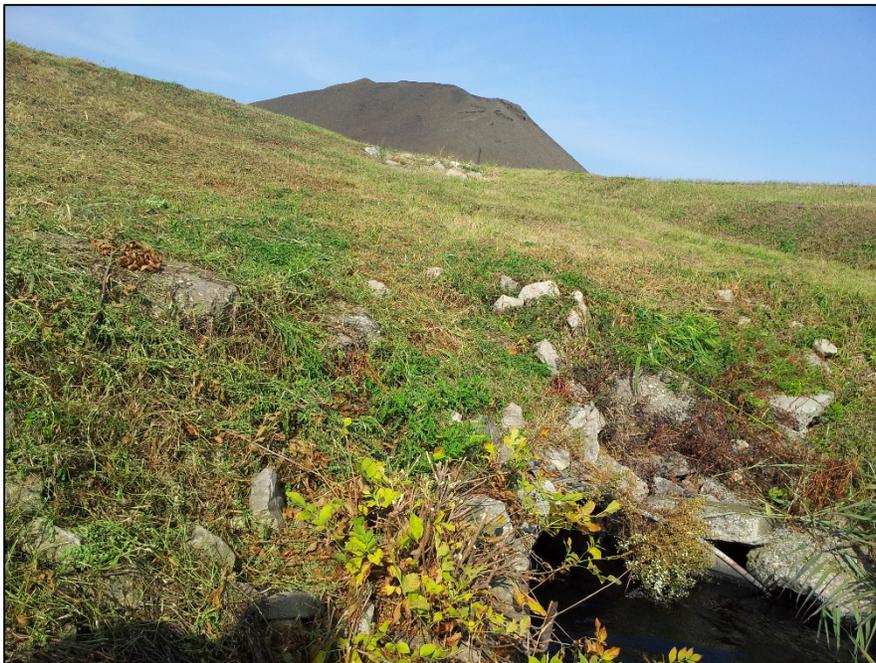
Photo 6: Outlet of 48-inch diameter corrugated metal pipe which contains flows of the EDG Slag Pond and EDG South A-Pond. The water discharges into the EDG B-Pond.

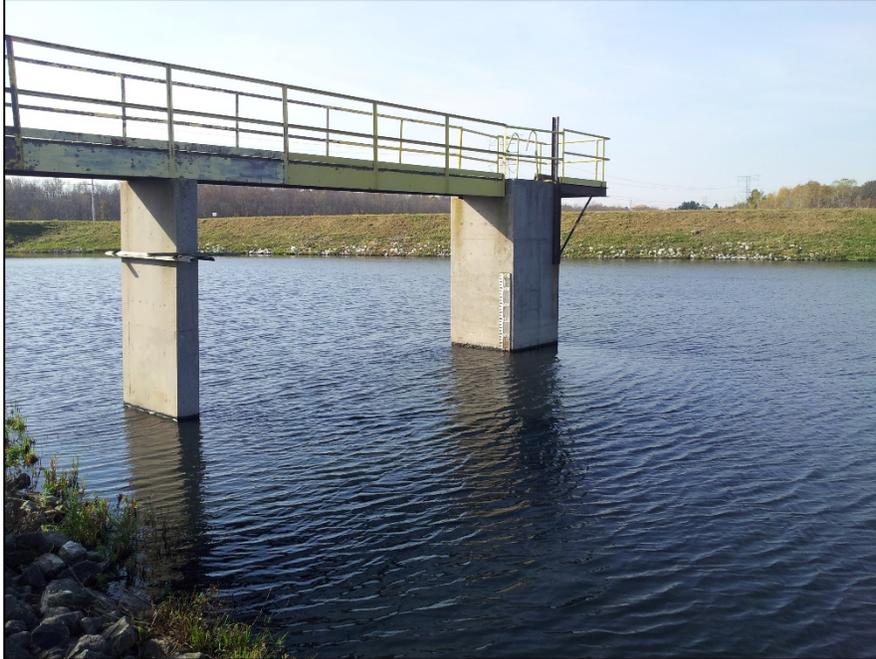
Photo 7: Water within the EDG B-Pond flows through an overflow weir structure. The water gravity flows through a 24-inch diameter corrugated metal pipe which discharges into the EDG C-Pond.

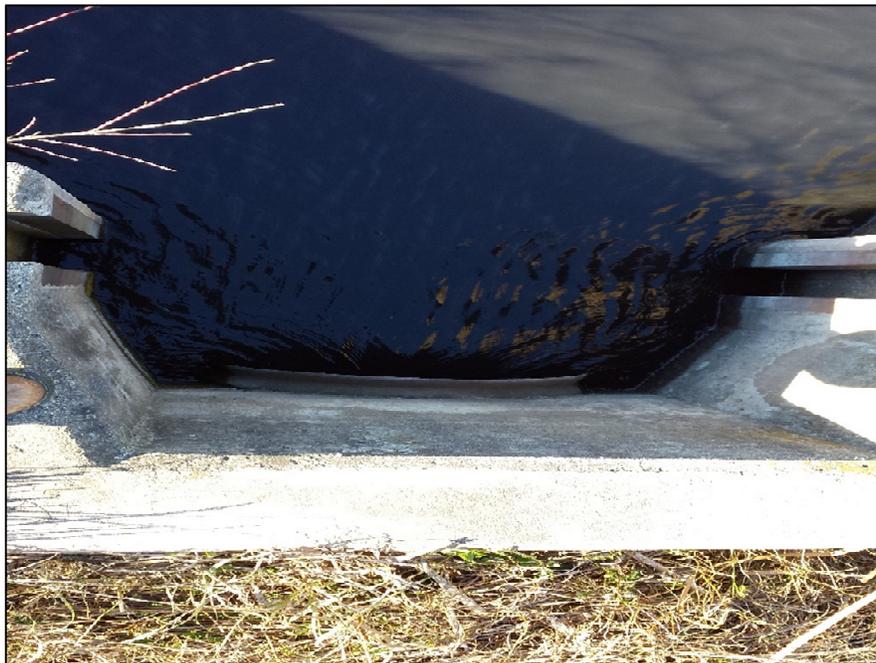
Photo 8: Outlet of EDG B-Pond hydraulic structure. Water from EDG B-Pond discharges into the EDG C-Pond. Water within EDG C-Pond flows to the east to the EDG F-Pond. Water in the EDG F-Pond discharges through the facility's WPDES Outfall 004 into Lake Michigan.
