**Interstate Power and Light Company**

Burlington Generation Station

CCR Surface Impoundment Structural Stability Assessment

Report issued: June 15, 2026 – Revision 2

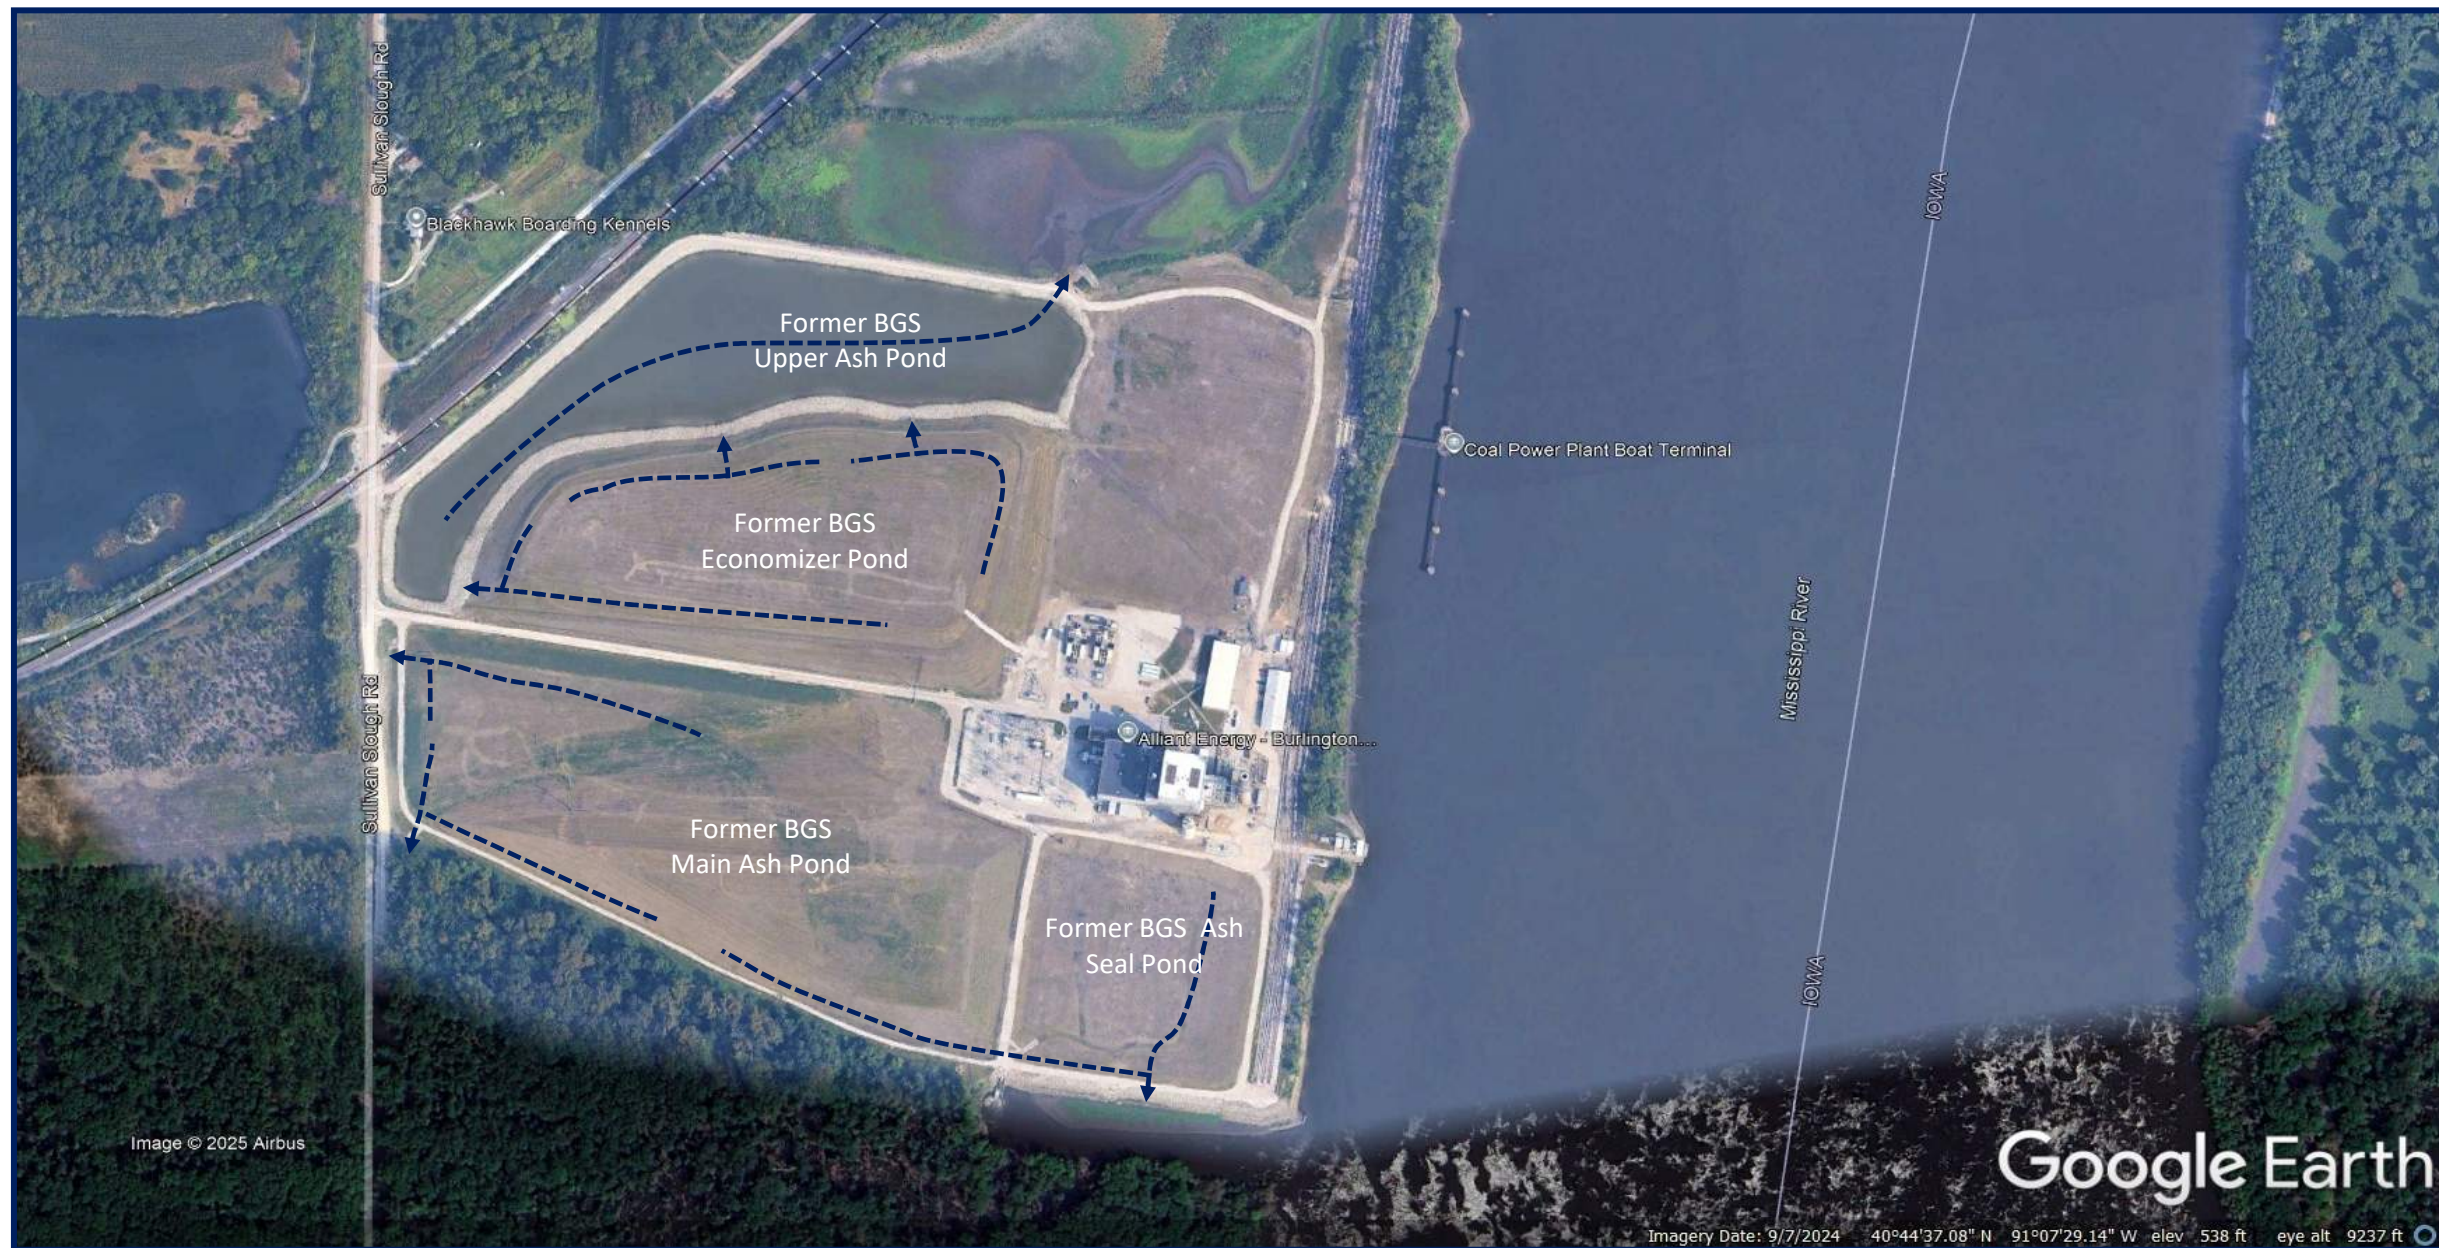
Drawing  
Figure 1  
Date  
5/13/2026

Interstate Power and Light Company  
Facility Location Map  
Burlington Generating Station; Burlington, Iowa  
no scale

BGS is located southeast of the City of Burlington, Iowa, on the western shore of the Mississippi River in Des Moines County, at 4282 Sullivan Slough Road, Burlington, Iowa (Figure 1). BGS is a fossil-fueled electric generating station consisting of one steam electric generating unit and four combustion turbine units. Sub-bituminous coal was the primary fuel for producing steam, with the ability to use natural gas for the combustion turbines. The burning of coal produces CCR. The CCR at BGS was categorized into three types: bottom ash, economizer ash, and precipitator fly ash. As of December 30, 2021, the BGS steam electric generating unit no longer used coal as a fuel source and was converted to natural gas.
