Location Restriction Compliance Demonstration

Burlington Generating Station Surface Impoundments
4282 Sullivan Slough Road
Burlington, Iowa 52601

Interstate Power and Light Company
Burlington Generating Station
4282 Sullivan Slough Road
Burlington, Iowa 52601

25219168.00 | October 29, 2020

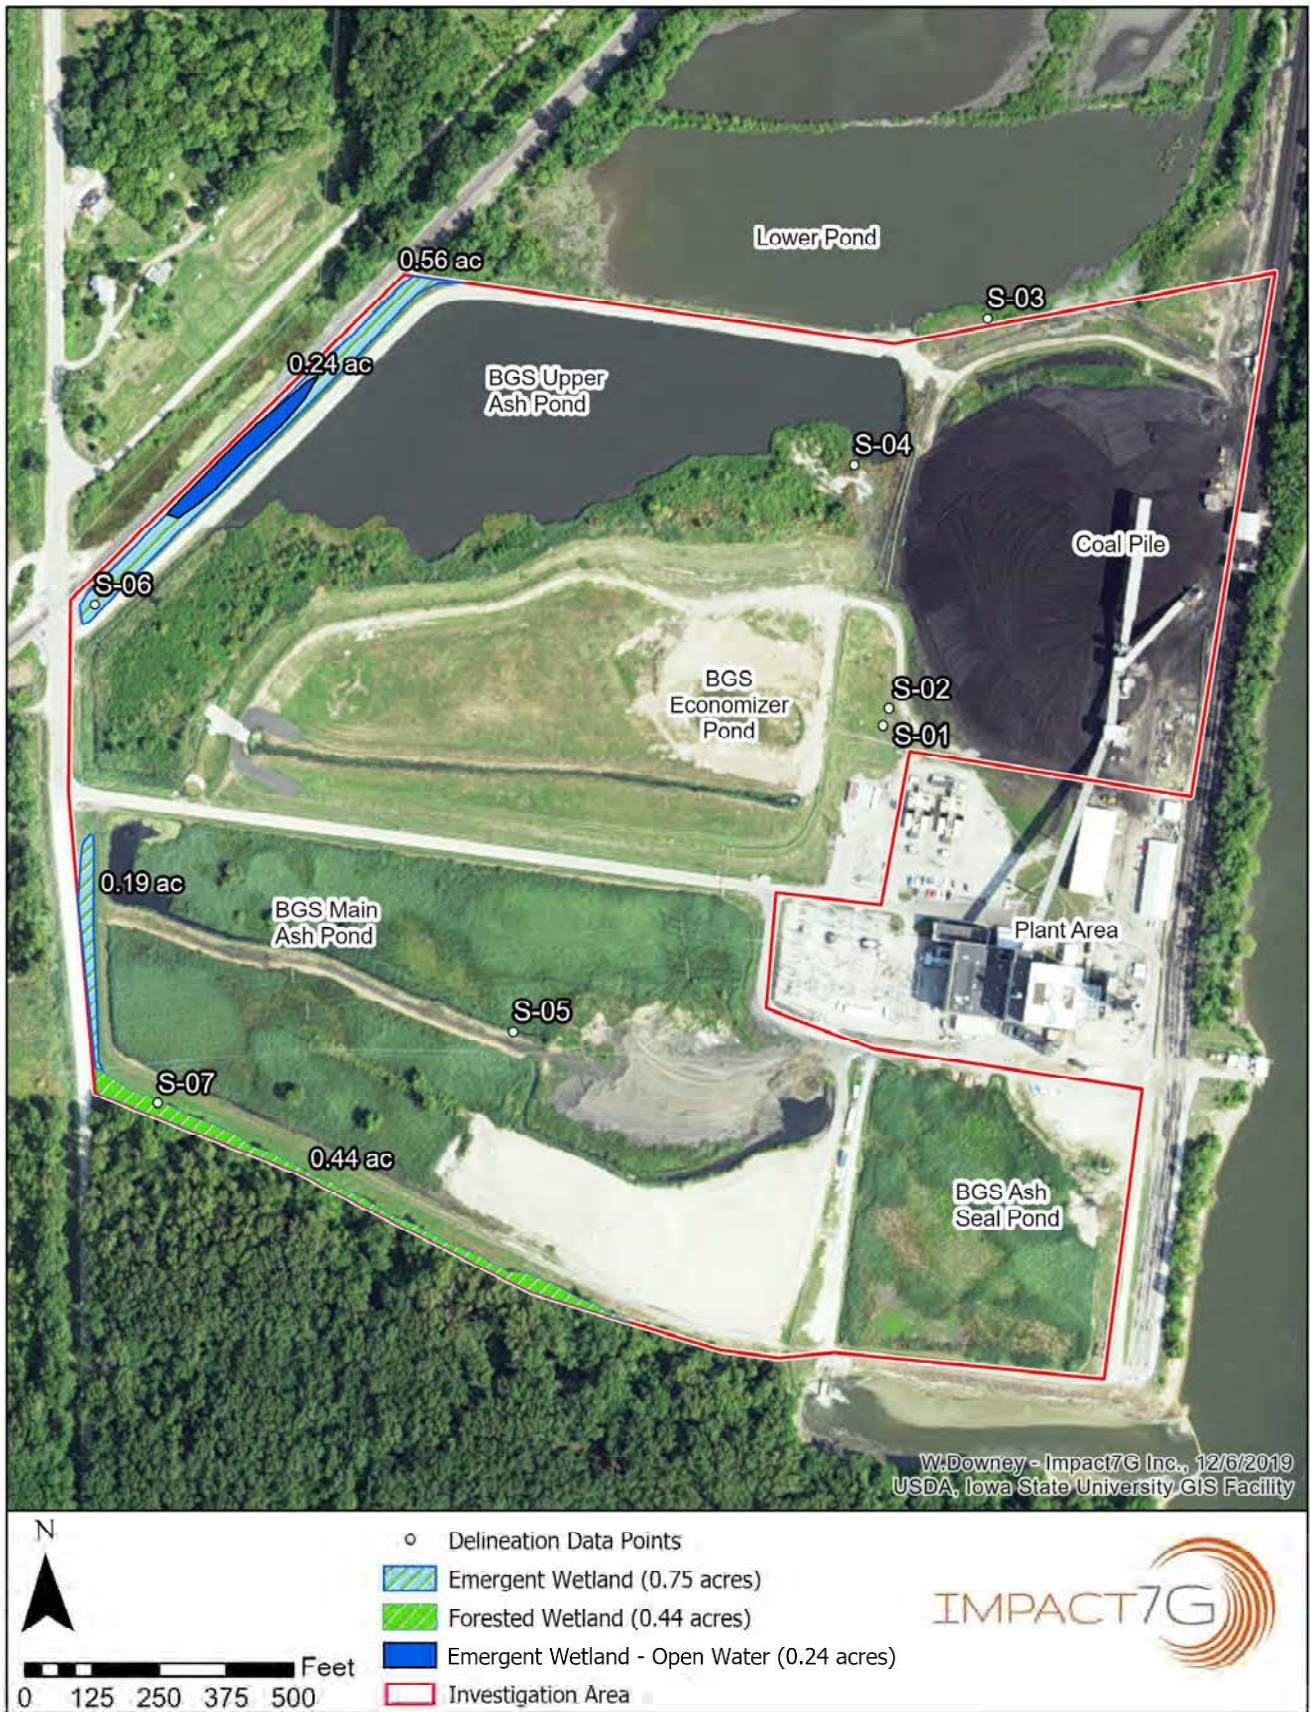
Figure A: Wetland Delineation Map

Impact7G delineated 1.43 total acres of wetland within the Investigation Area, composed of 0.99 acres of emergent wetland and 0.44 acres of forested wetland. Figure A shows delineated wetlands within the Investigation Area.

Non-wetland areas including industrial ponds and waterways (labeled on Figure A) were dominated by common reed and other hydrophytic species (data points S-04 & S-05). Wetland hydrology was present in most areas. Soils within these areas were not hydric, composed of a shallow mixture of CCR and fill soils above a barrier of unknown material at approximately 10 inches of depth, where sampled. Furthermore, these areas are considered previously disturbed due to a well-documented history of disturbance and industrial nature of the site. Disturbance history is evident on historic aerial imagery and is described in detail on *Alliant Energy's CCR Rule Compliance Data and Information*² website.

Impact7G delineated 1.43 total acres of wetland within the Investigation Area, composed of 0.99 acres of emergent wetland and 0.44 acres of forested wetland.

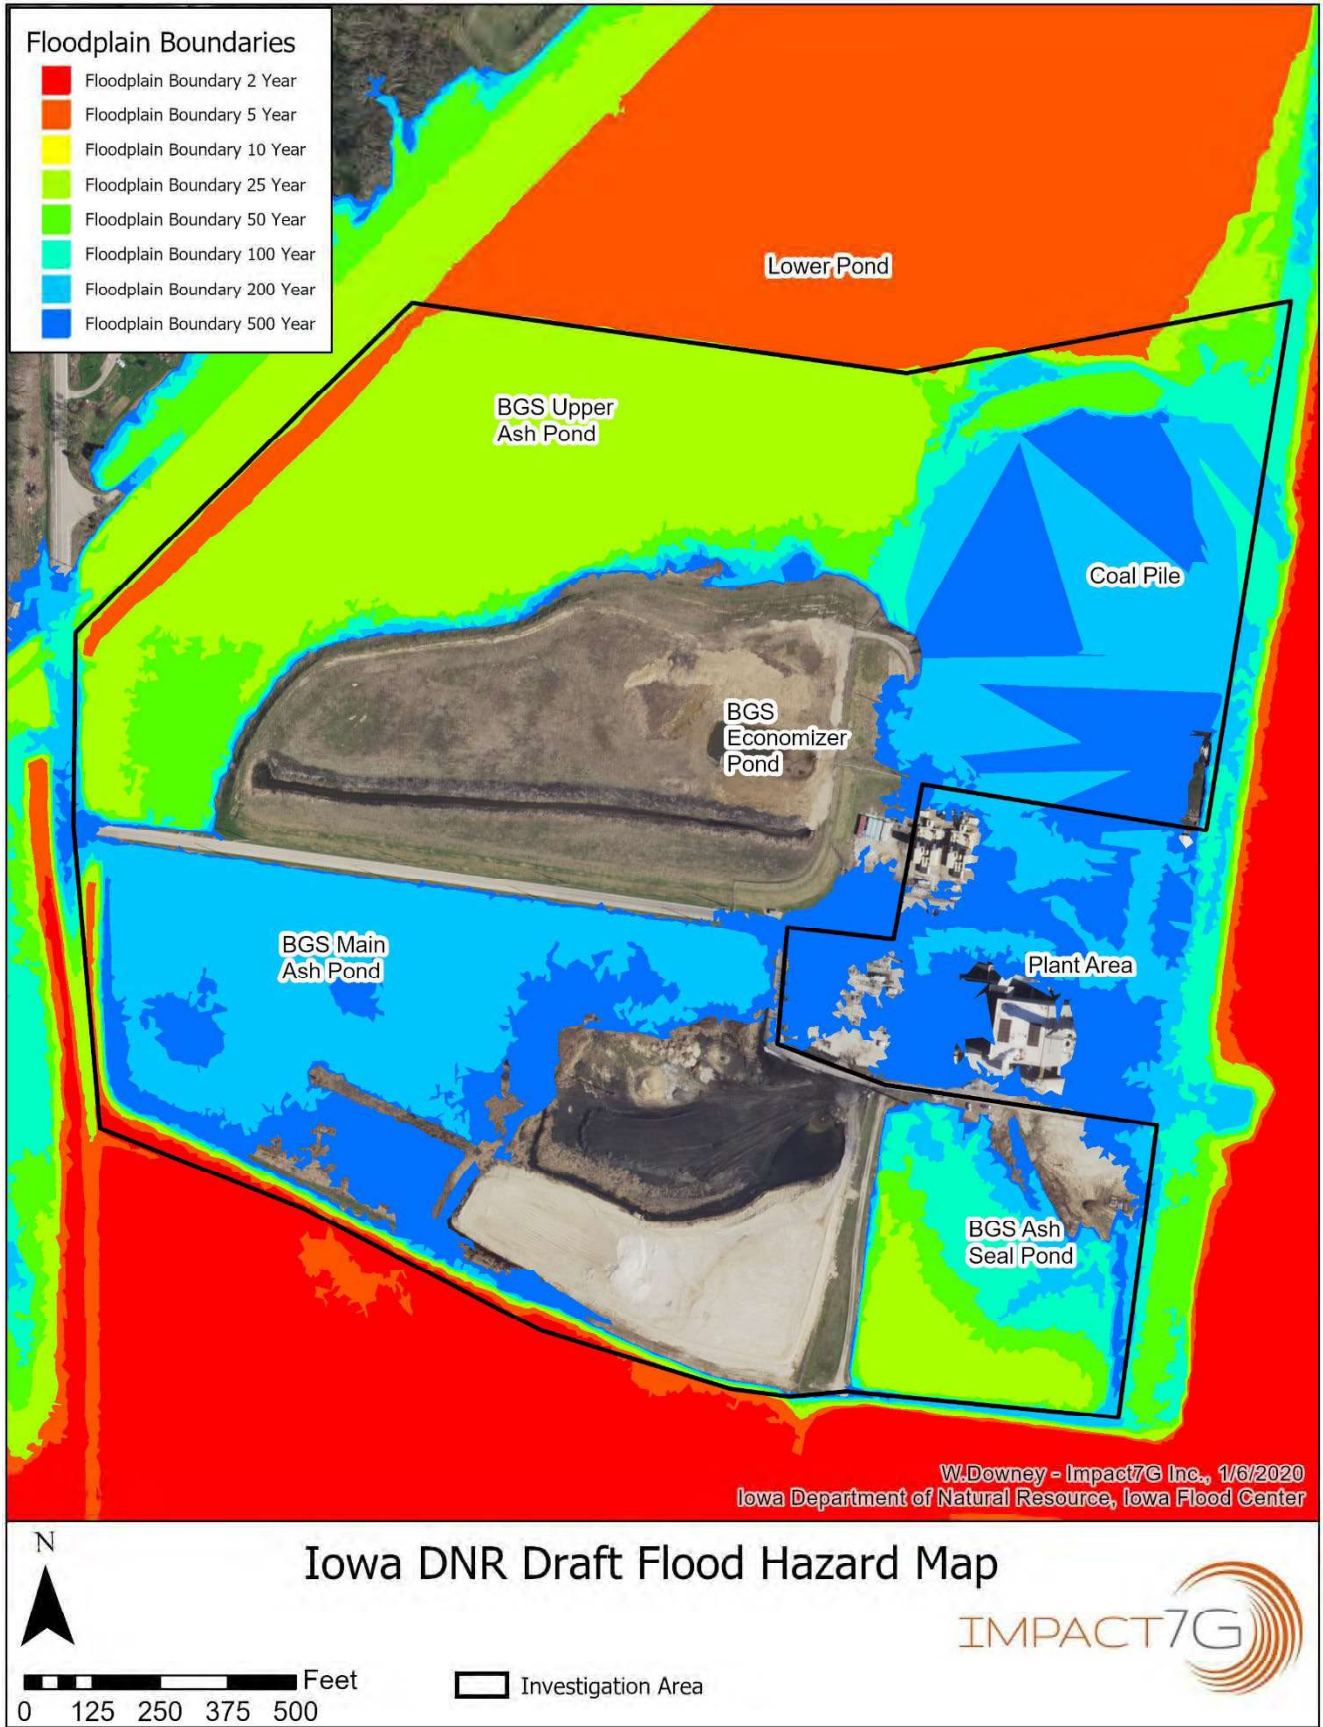
Figure H: IDNR/IFC Draft Flood Hazard Map

Forested wetlands are located along the southern boundary of the Investigation Area (datapoint S-07). This wetland area is subject to frequent flooding and high water tables and is dominated by typical floodplain forest species such as silver maple, green ash, and eastern cottonwood. Herbaceous vegetation and soils were not observable during field work due to the depth of flooding, as this area is within the two year flood plain of the Iowa Draft Flood Hazard Map (50% annual probability flood zone –Figure H).

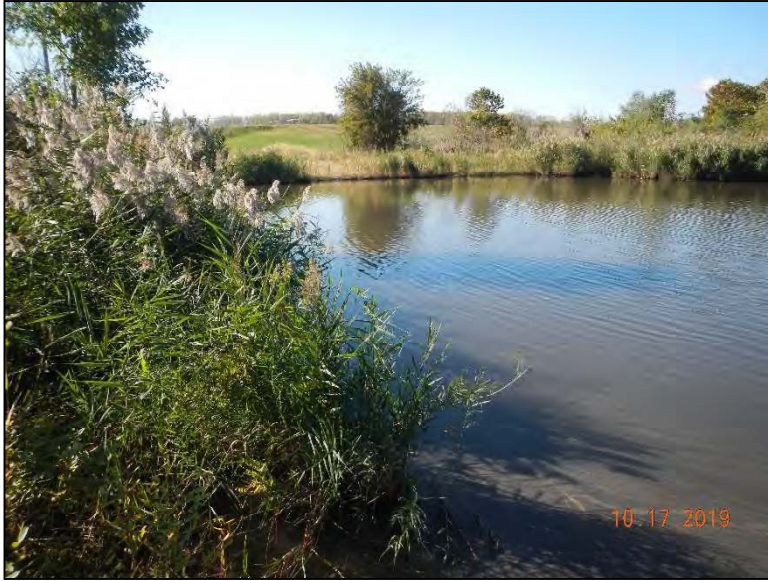
Photo 4: BGS Upper Ash Pond

Data Point S-04

Direction: looking southwest at delineation data point from across pond

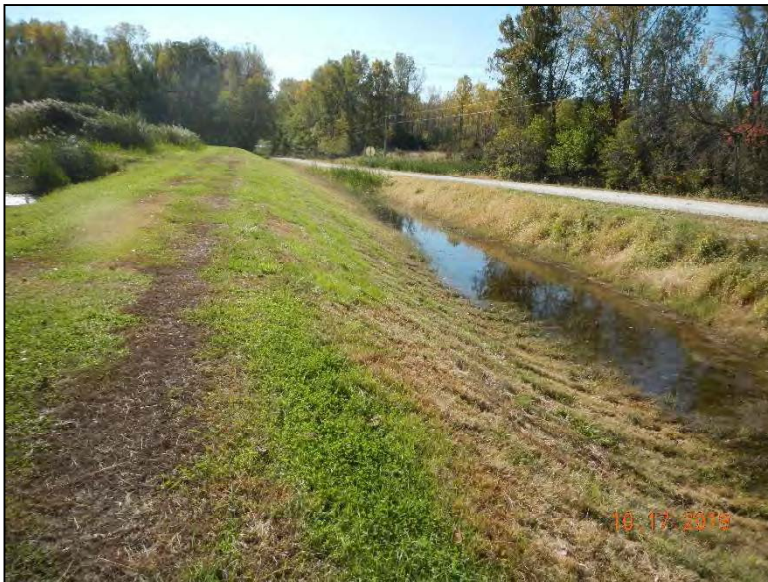
Photo 5: Emergent Wetland

Direction: looking south at emergent wetland at southwest corner of Investigation Area, within floodplain of Mississippi River

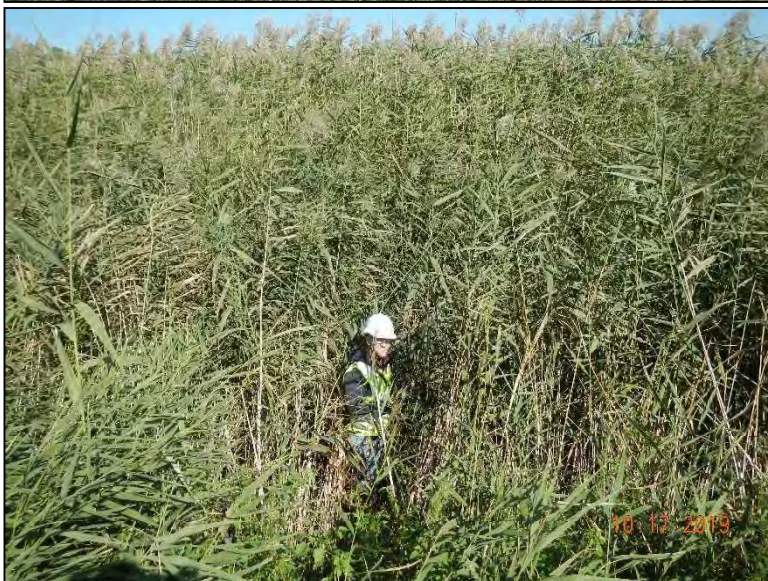
Photo 6: BGC Main Ash Pond

Data Point S-05

Direction: looking north at CCR treatment pond, dominated entirely by common reed

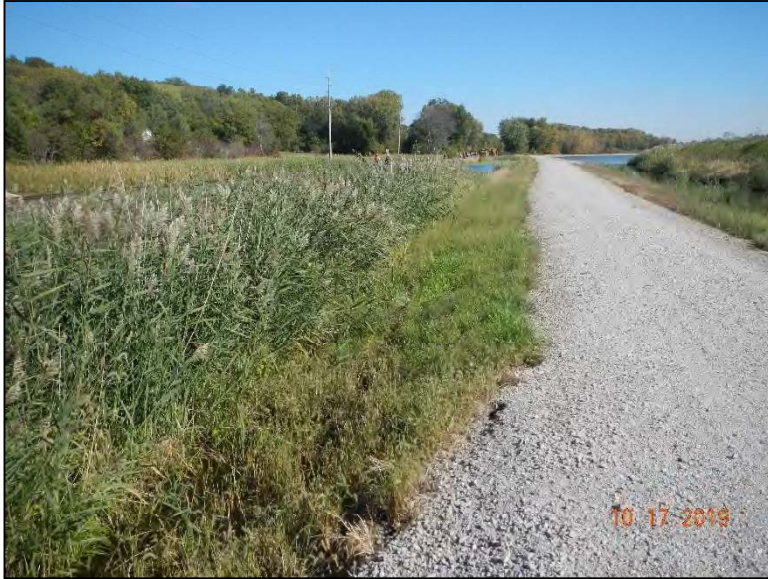
Photo 7: Emergent Wetland

Data Point S-06

Direction: looking northeast at emergent wetland between railway (left of photo) and BGS Upper Ash Pond (right of photo)

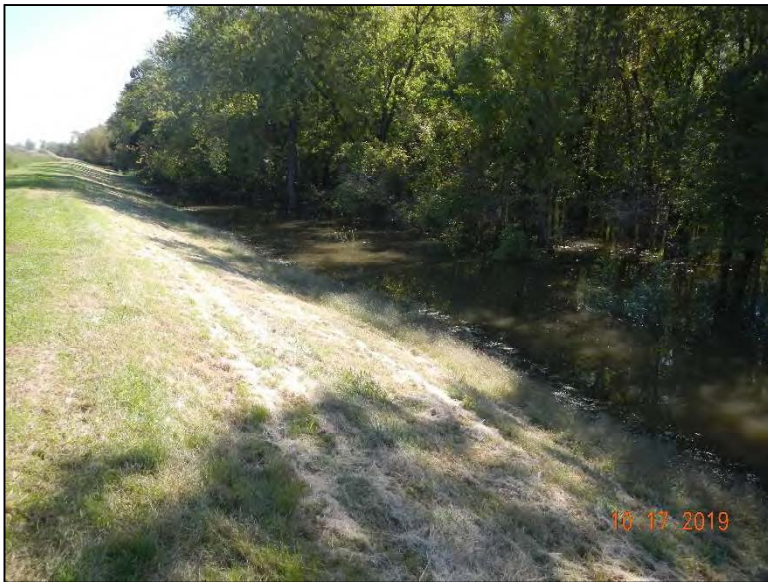
Photo 8: Forested Wetland

Data Point S-07

Direction: looking southeast at floodplain forest along southern boundary of Investigation Area
