Re: Notification of Completion of Closure pursuant to 40 CFR 257.100(b)(5)

FoxLake Ash Pond (Inactive CCR Surface Impoundment)

Ash Pond Closure Certification Report

Prepared for
Interstate Power and Light Company
Fox Lake Generating Station

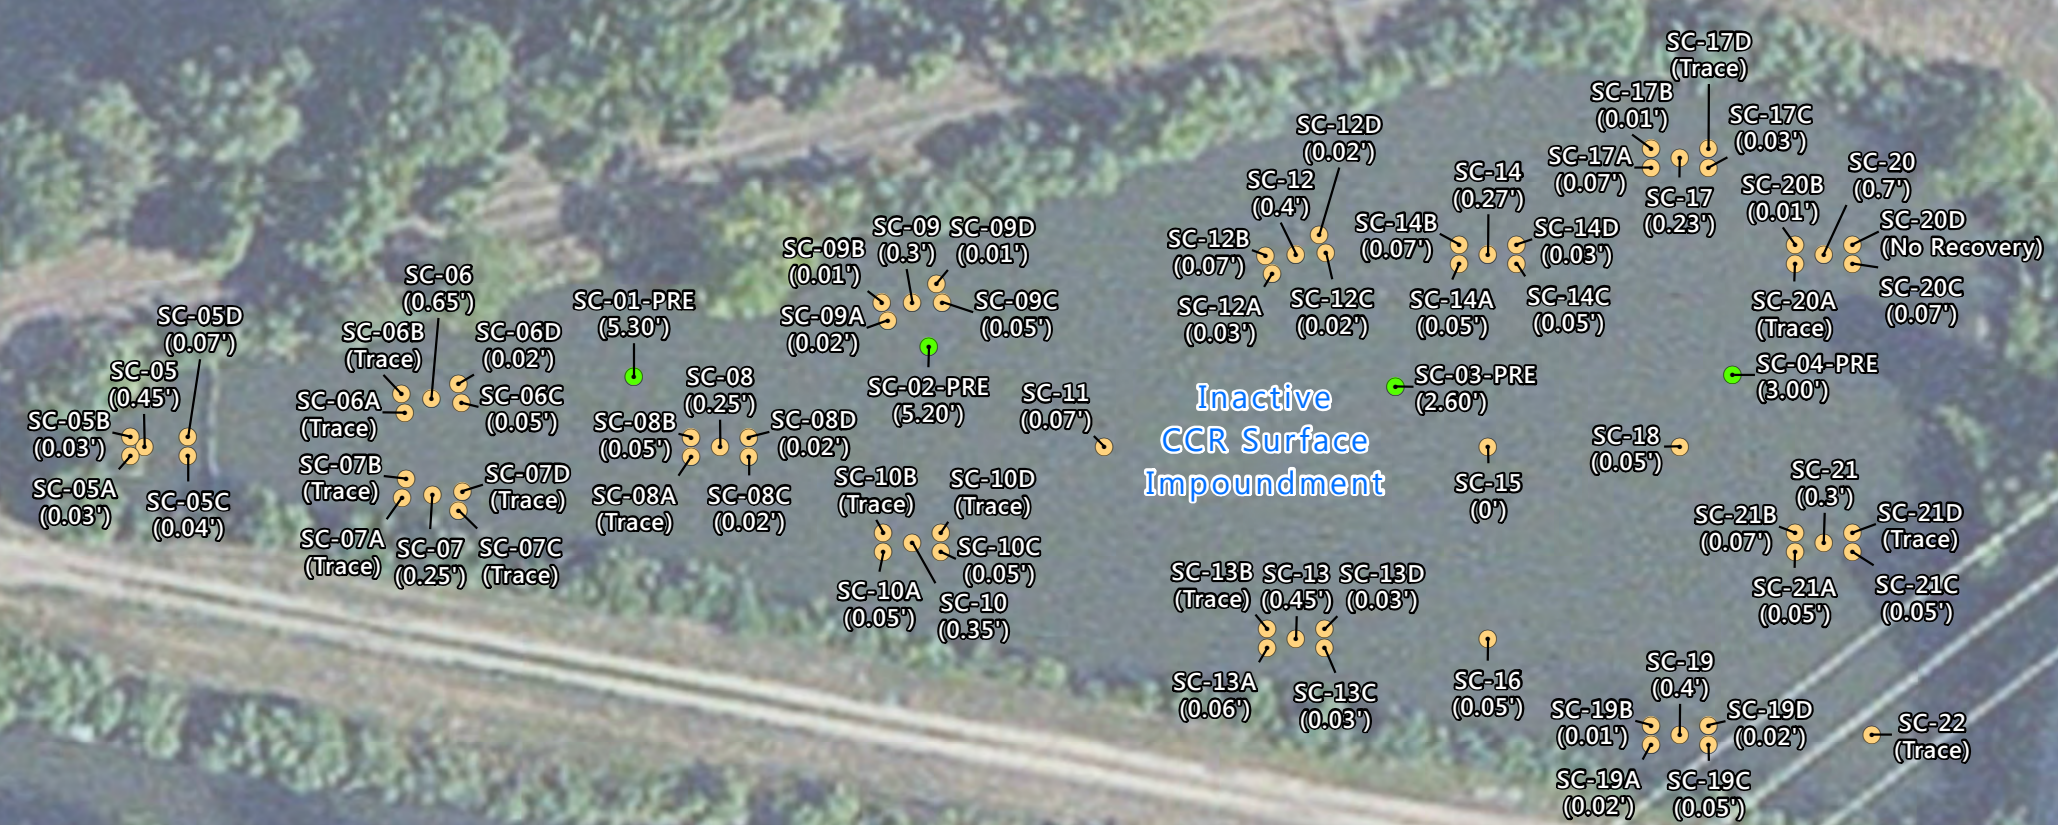
FIGURE 1

- Pre-Dredge Sediment Core Location
 - Post-Dredge Sediment Core Location
- Note:
Sediment core location labels include the loose sediment depth measurement in feet surrounded by parenthesis.

INTERSTATE POWER AND LIGHT COMPANY
FOX LAKE GENERATING STATION
SEDIMENT CORE LOCATIONS

Sediment cores were collected both prior to dredging and following dredging as a verification method to confirm loose sediment and CCR removal. Pre-dredge sediment cores were collected to better understand the depth of sediment required to be removed, determine native pond bottom material, and determine if there was a clear visual distinction between the soft sediment and native pond bottom deposits. The post-dredge sediment cores were collected to confirm removal of soft sediment. The pre-dredge cores were performed on July 15, 2016. Post-dredge cores were collected on August 1, 2016 and then resampled again on August 3, 4, and 5, 2016 in all areas where the August 1 cores revealed significant CCR and soft sediment present. This coring work was an iterative process where the dredging contractor was informed of cores that revealed CCR and soft sediment was still present and of cores that revealed *de minimis* levels of CCR and soft sediment.

A total of four (4) pre-dredge cores were collected with vibracore equipment from a small jon boat and seventy (70) post-dredge cores were collected using a push to refusal coring method from a small jon boat. The location and depth of soft sediment for each core is shown in Figure 1. Each sediment core was logged and nearly all cores recovered were photographed. Table 1 summarizes the observation results of the sediment cores and the photographs taken of the sediment cores are included in Appendix A.

On August 1, 2016, when JR Brennan felt its dredging operation was largely completed, Barr collected its first set of post-dredge sediment cores. On that date, eighteen (18) cores (SC-05 through SC-22) were removed from the pond bottom at the locations shown on Figure 1. Sediment cores that revealed a very small layer of soft sediment still present were determined to be *de minimis* if the soft sediment in the core was predominantly brown, light grey or olive in color, indicating it was comprised largely of native soil that had been loosened and resettled during the dredging process. Inspection of the sediment cores revealed five of the initial eighteen core locations had *de minimis* amounts of CCR or soft sediment as defined above. Based on the initial post-dredge coring results, JR Brennan was directed to continue its hydraulic dredging process so that the initial eighteen core locations and all subsequent core locations produced *de minimis* results. The *de minimis* layer in all final sediment cores ranged from none to no more than 0.07 foot of soft sediment as shown in Table 1.

The subsequent rounds of post-dredge coring work occurred on August 3–5, 2016, where four additional cores were placed surrounding each of the August 1 cores that failed to meet the *de minimis* criteria. For example, sediment core SC-05 was found to still have CCR and soft sediment present, and sediment cores SC-05A, SC-05B, SC-05C and SC-05D were taken in the area after it had been re-dredged. If predominantly black- or dark grey-colored soft sediment was found in any of the surrounding cores, the contractor was informed of that and in turn performed additional dredging until the *de minimis* criteria was met in subsequent verification cores.

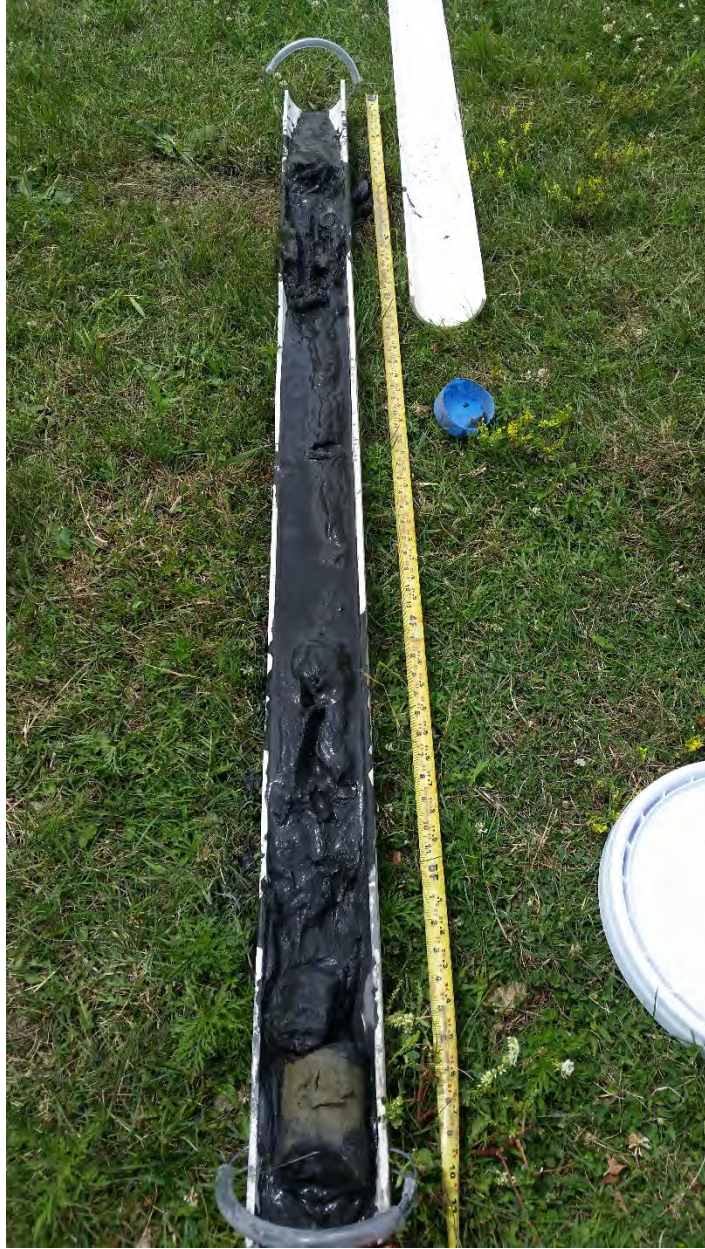
Photo #1 – SC-01-Pre-Dredge

Depth (ft.)	Sample Interval and number	Properties										Description	
		Moisture	Density or Consistency	Plasticity	Cohesiveness	Particles	Odor	Staining	Sheen	ASTM / USCS Classification	Graphic Log		
0	5.3	0-2	W	Loose	N	Low	Trace	None	Blk	Trace	Ashy silts (ML)		0-5.3 = Blk loose Ashy silts vfg ashy lumps softer than pudding
		2-4											
		4-5.3											
5.3	5.9	5.3-5.9	Moist	Stiff	low	Yes	N	N	N	N	CL		5.3-5.9 = olive blue to rusty brown stiff lean clay w/ some sand and trace gravel subang
													Refusal @ 6.0'
													lost 0.1' out bottom (clay) of tube

The four (4) pre-dredge sediment cores (SC-01 through SC-04) revealed a clear distinction between the overlying soft sediment and CCR material and the underlying hard native material with an average soft sediment thickness of about 4 feet. A review of the pre-dredge sediment core photos included in Appendix A revealed that the zone of CCR and soft sediment was predominantly black or dark grey in color while the underlying hard bottom native soils were brown, olive or light grey in color and visually classified as lean clay (CL). The clear distinction in color between the zone of CCR and the underlying native soils allowed for a sediment core visual inspection method to identify if CCR and soft sediment was removed from the bottom of the impoundment

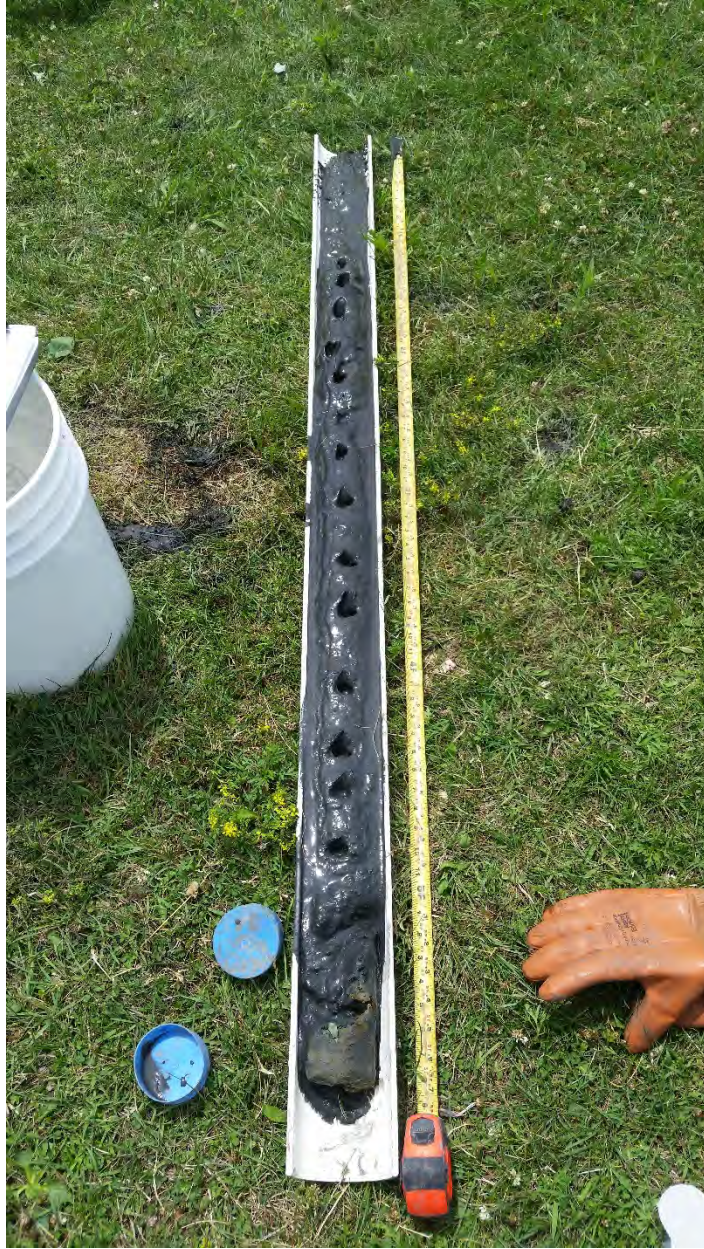
Photo #2 – SC-02-Pre-Dredge

Depth (ft.)	Sample Interval and number	Properties										Description	
		Moisture	Density or Consistency	Plasticity	Cohesiveness	Particles	Odor	Staining	Sheen	ASTM / USCS Classification	Graphic Log		
0	5.2	0-2	W	Loose	N	low	Ashy Bits	None Noted	Blk	Trace	ML		0-5.2 = Blk loose Ashy silts vfg ashly bits softer than pudding
		2-4											
		4-5.2											
5.2	5.6	5.2-5.6	M	Stiff	Yes	Yes	N	N	N		CL		5.2-5.6 = Olive blug to rusty brown stiff lean clay w/ some sand and gravel subgravel
													Refusal Refusal @ 5.7'

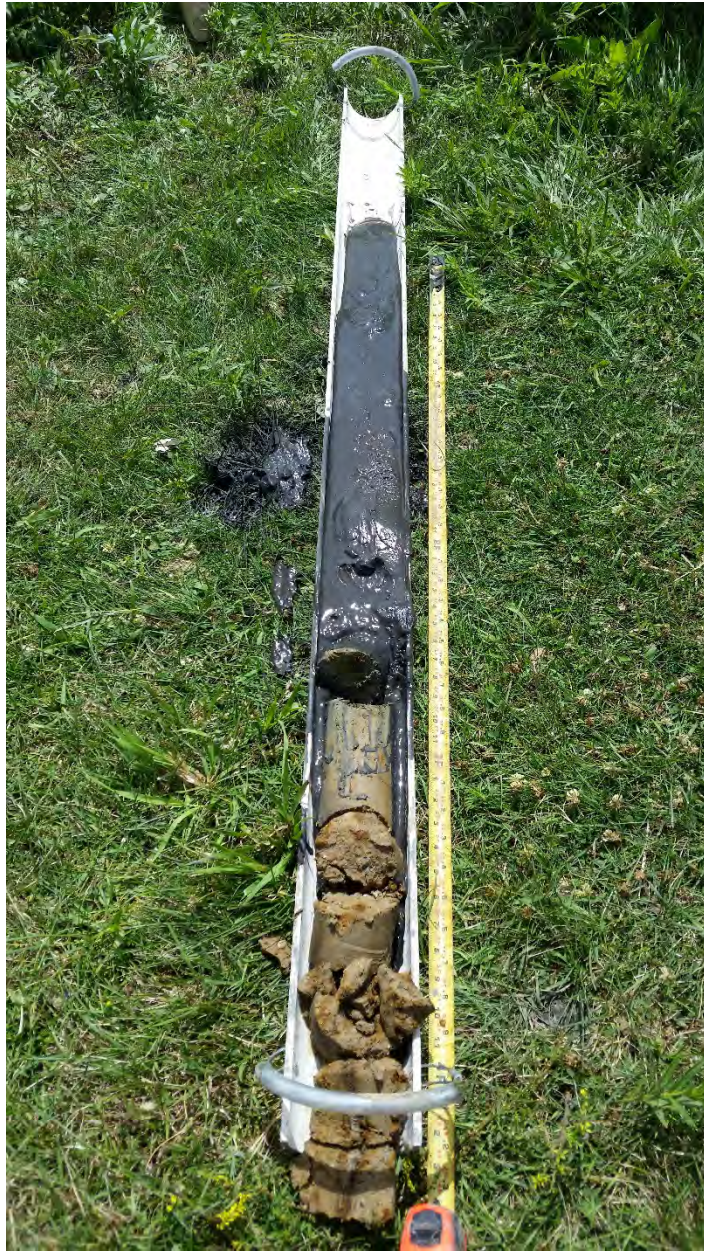
Photo #3 – SC-03-Pre-Dredge

Depth (ft.)	Sample Interval and number	Properties										Description
		Moisture	Density or Consistency	Plasticity	Cohesiveness	particles	Odor	Staining	Sheen	ASTM / USCS Classification	Graphic Log	
0	2.6	W	Loose	N	Low	Ash bits vfg	None Mixed	Blk	Trace	ML		0-2.6 = Blk loose Ashy silts vfg ash bits softer than puddling
2.6	4.1	M	stiff	low	yes	N	N	N	N	CL		2.6-4.1 = Olive blue/green to rusty brown lean clay w/ vfg → silt and gravel subround to sub angular
												Refusal @ 4.3 ft

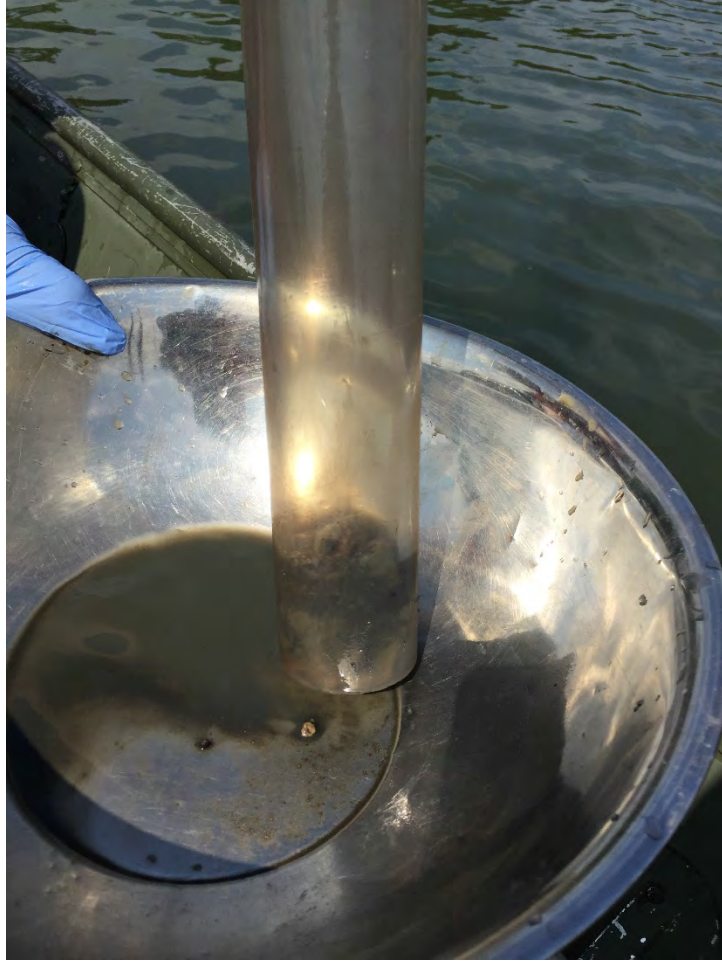
Photo #29 – SC-11

Depth (ft.)	Sample Interval and number	Properties										Description	
		Moisture	Density or Consistency	Plasticity	Cohesiveness	Particles	Odor	Staining	Sheen	ASTM / USCS Classification	Graphic Log		
0	8.9												Water
8.9	9.08	wet	soft				no						Some dark muck
8.97	8.97												
9.08	9.15	little hard					no						- Medium grey hard clay - some brown & mottled shades of grey - some gravel chunks
8.97	8.97

* Felt immediate hard resistance. Can't feel soft part w/ water depth or w/ tube *

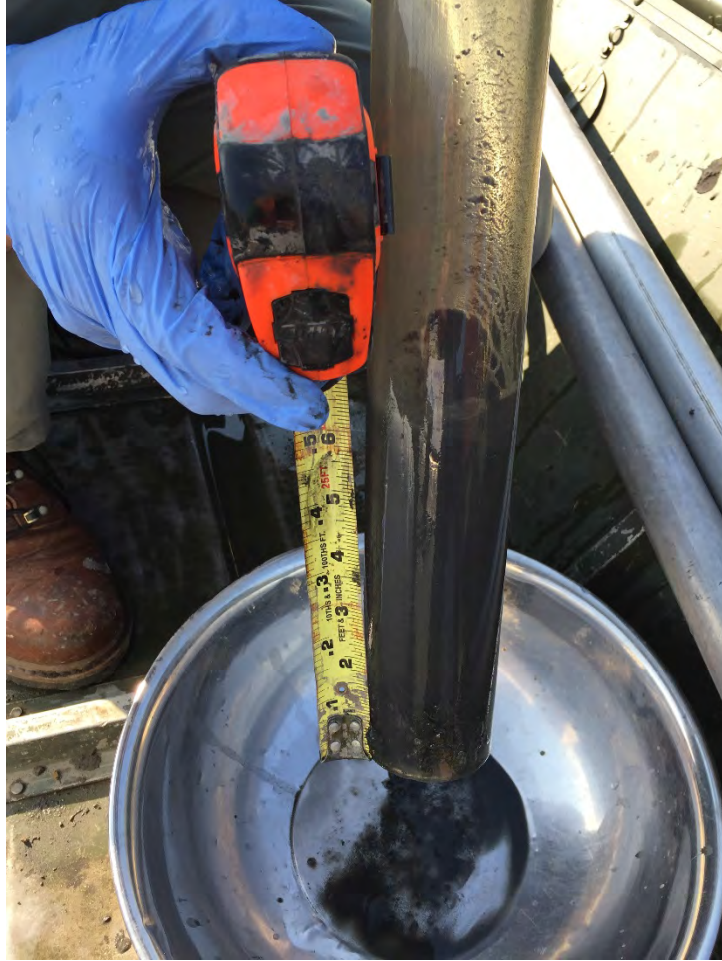
Photo #35 – SC-13

Depth (ft.)	Sample Interval and number	Properties										Description	
		Moisture	Density or Consistency	Plasticity	Cohesiveness	Particles	Odor	Staining	Sheen	ASTM / USCS Classification	Graphic Log		
0	8.1												Water
8.1	8.55	wet	soft				no						Consistent grey color, cohesive clayey texture w/ grit, w/ very pudding like consistency, small black specs throughout
8.55	8.65	some	hard				no			CH			Hard grey clay
													30' away from water discharge into pond

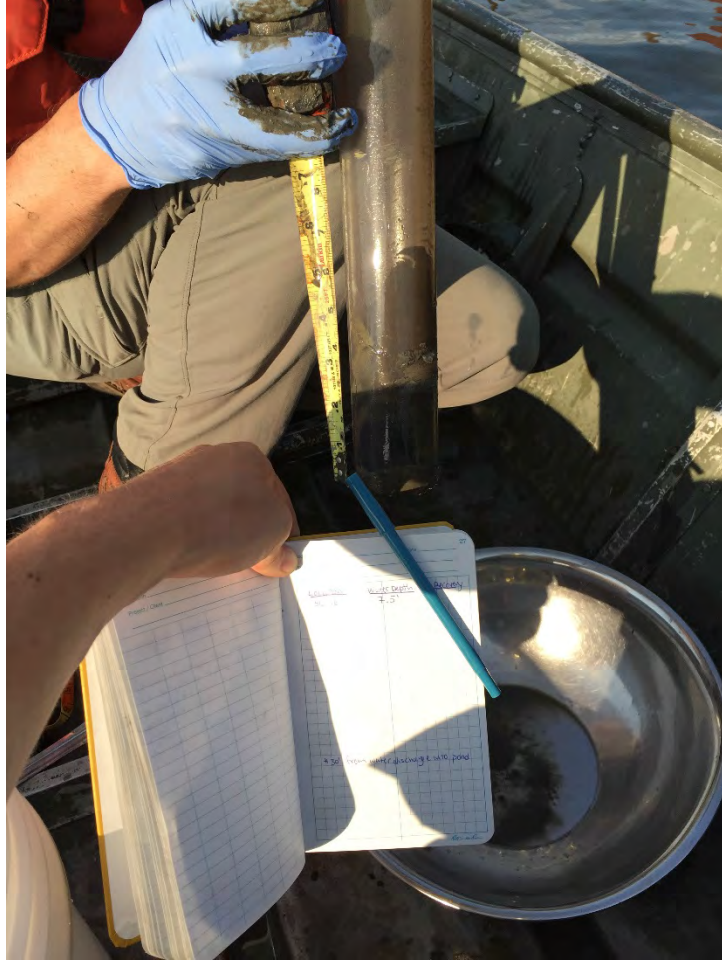
Photo #43 – SC-16

Depth (ft.)	Sample Interval and number	Properties										Description	
		Moisture	Density or Consistency	Plasticity	Cohesiveness	Particles	Odor	Staining	Sheen	ASTM / USCS Classification	Graphic Log		
0	7.5												Water
7.5	7.55	wet	Soft				no						Soupy grey sediment w/ clay balls
7.55	7.80	some	hard				no			CH			Hard brown clay
													30' from water discharge into pond
