ALLIANT ENERGY
Interstate Power and Light Company
Ottumwa Generating Station

CCR SURFACE IMPOUNDMENT

HISTORY OF CONSTRUCTION

Report Issued: September 29, 2016
Revision 0

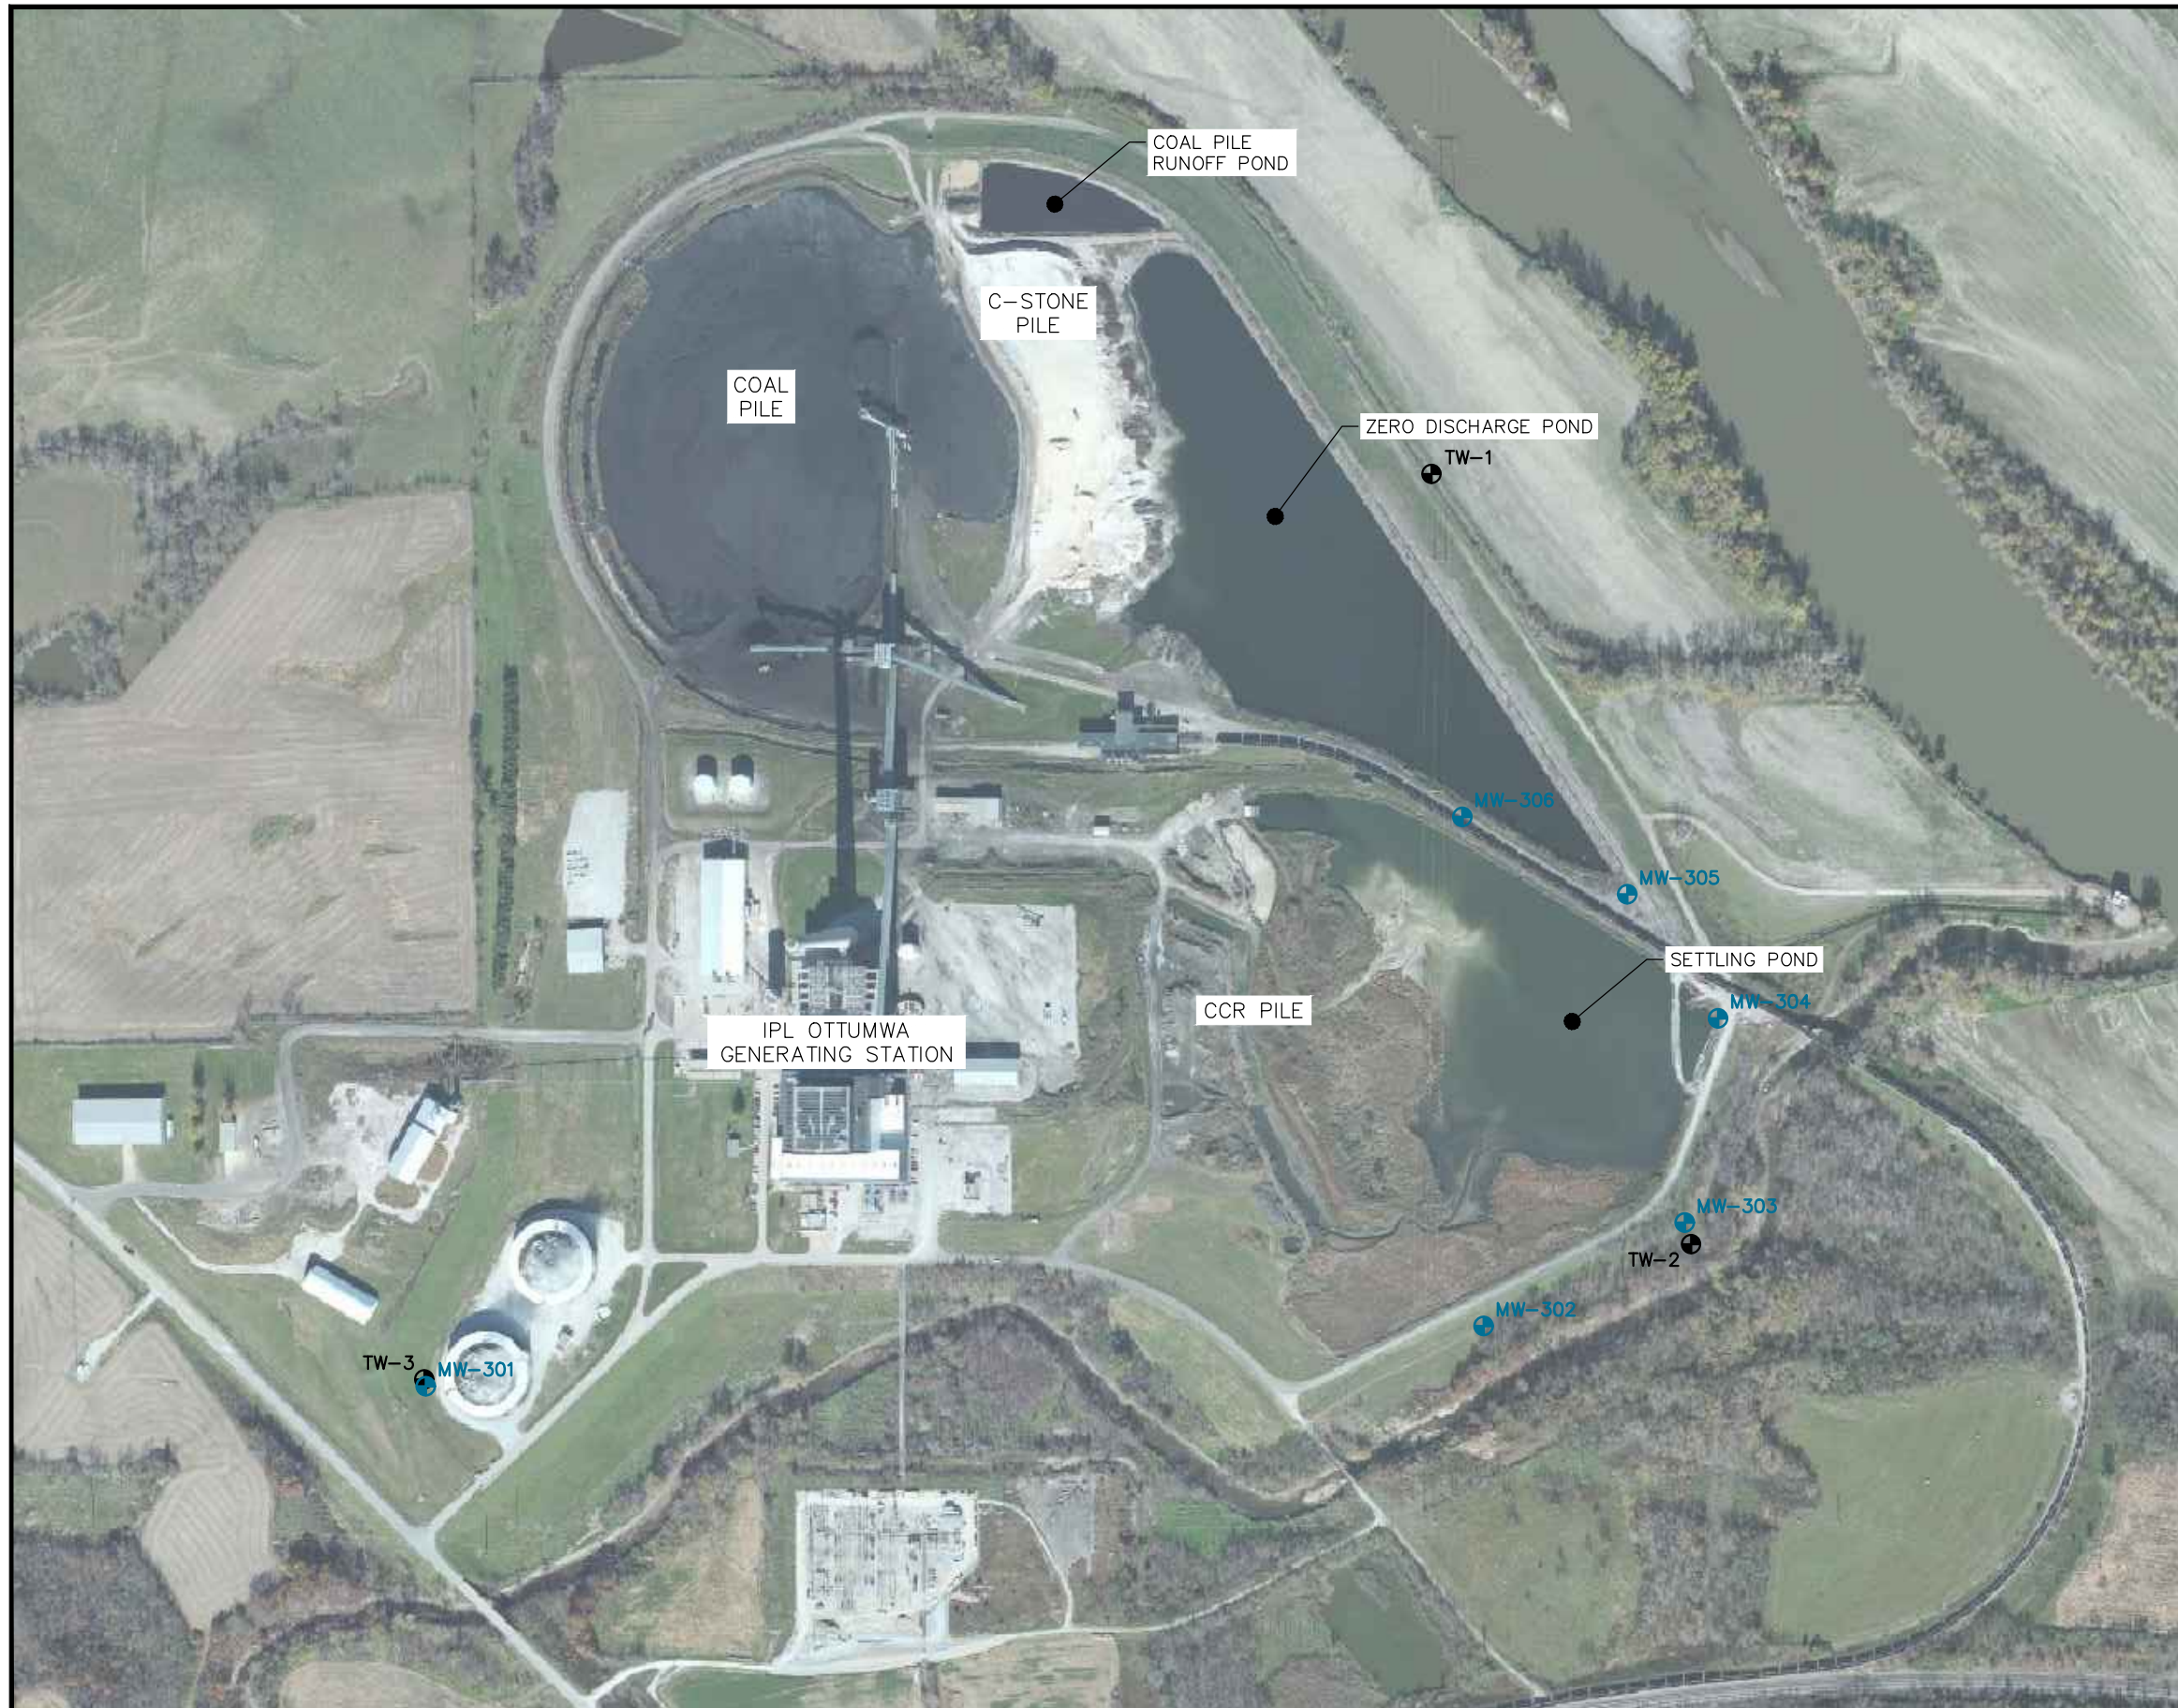
- NOTES:
1. MONITORING WELLS MW-301, MW-302, MW-304, WERE INSTALLED BY CASCADE DRILLING, LLP. UNDER THE SUPERVISION OF SCS ENGINEERS FROM NOVEMBER 11-12, 2015.
 2. MONITORING WELLS MW-303 AND MW-305 WERE INSTALLED BY CASCADE DRILLING LLP. UNDER THE SUPERVISION OF SCS ENGINEERS ON DECEMBER 7-8, 2015.
 3. MONITORING WELLS MW-301, MW-302, MW-304 AND MW-306 WERE SURVEYED BY FRENCH RENEKER ASSOCIATES, INC. ON DECEMBER 3, 2015.
 4. MONITORING WELLS MW-303 AND MW-305 WERE SURVEYED BY FRENCH-RENEKER ASSOCIATES, INC. ON FEBRUARY 11, 2016.

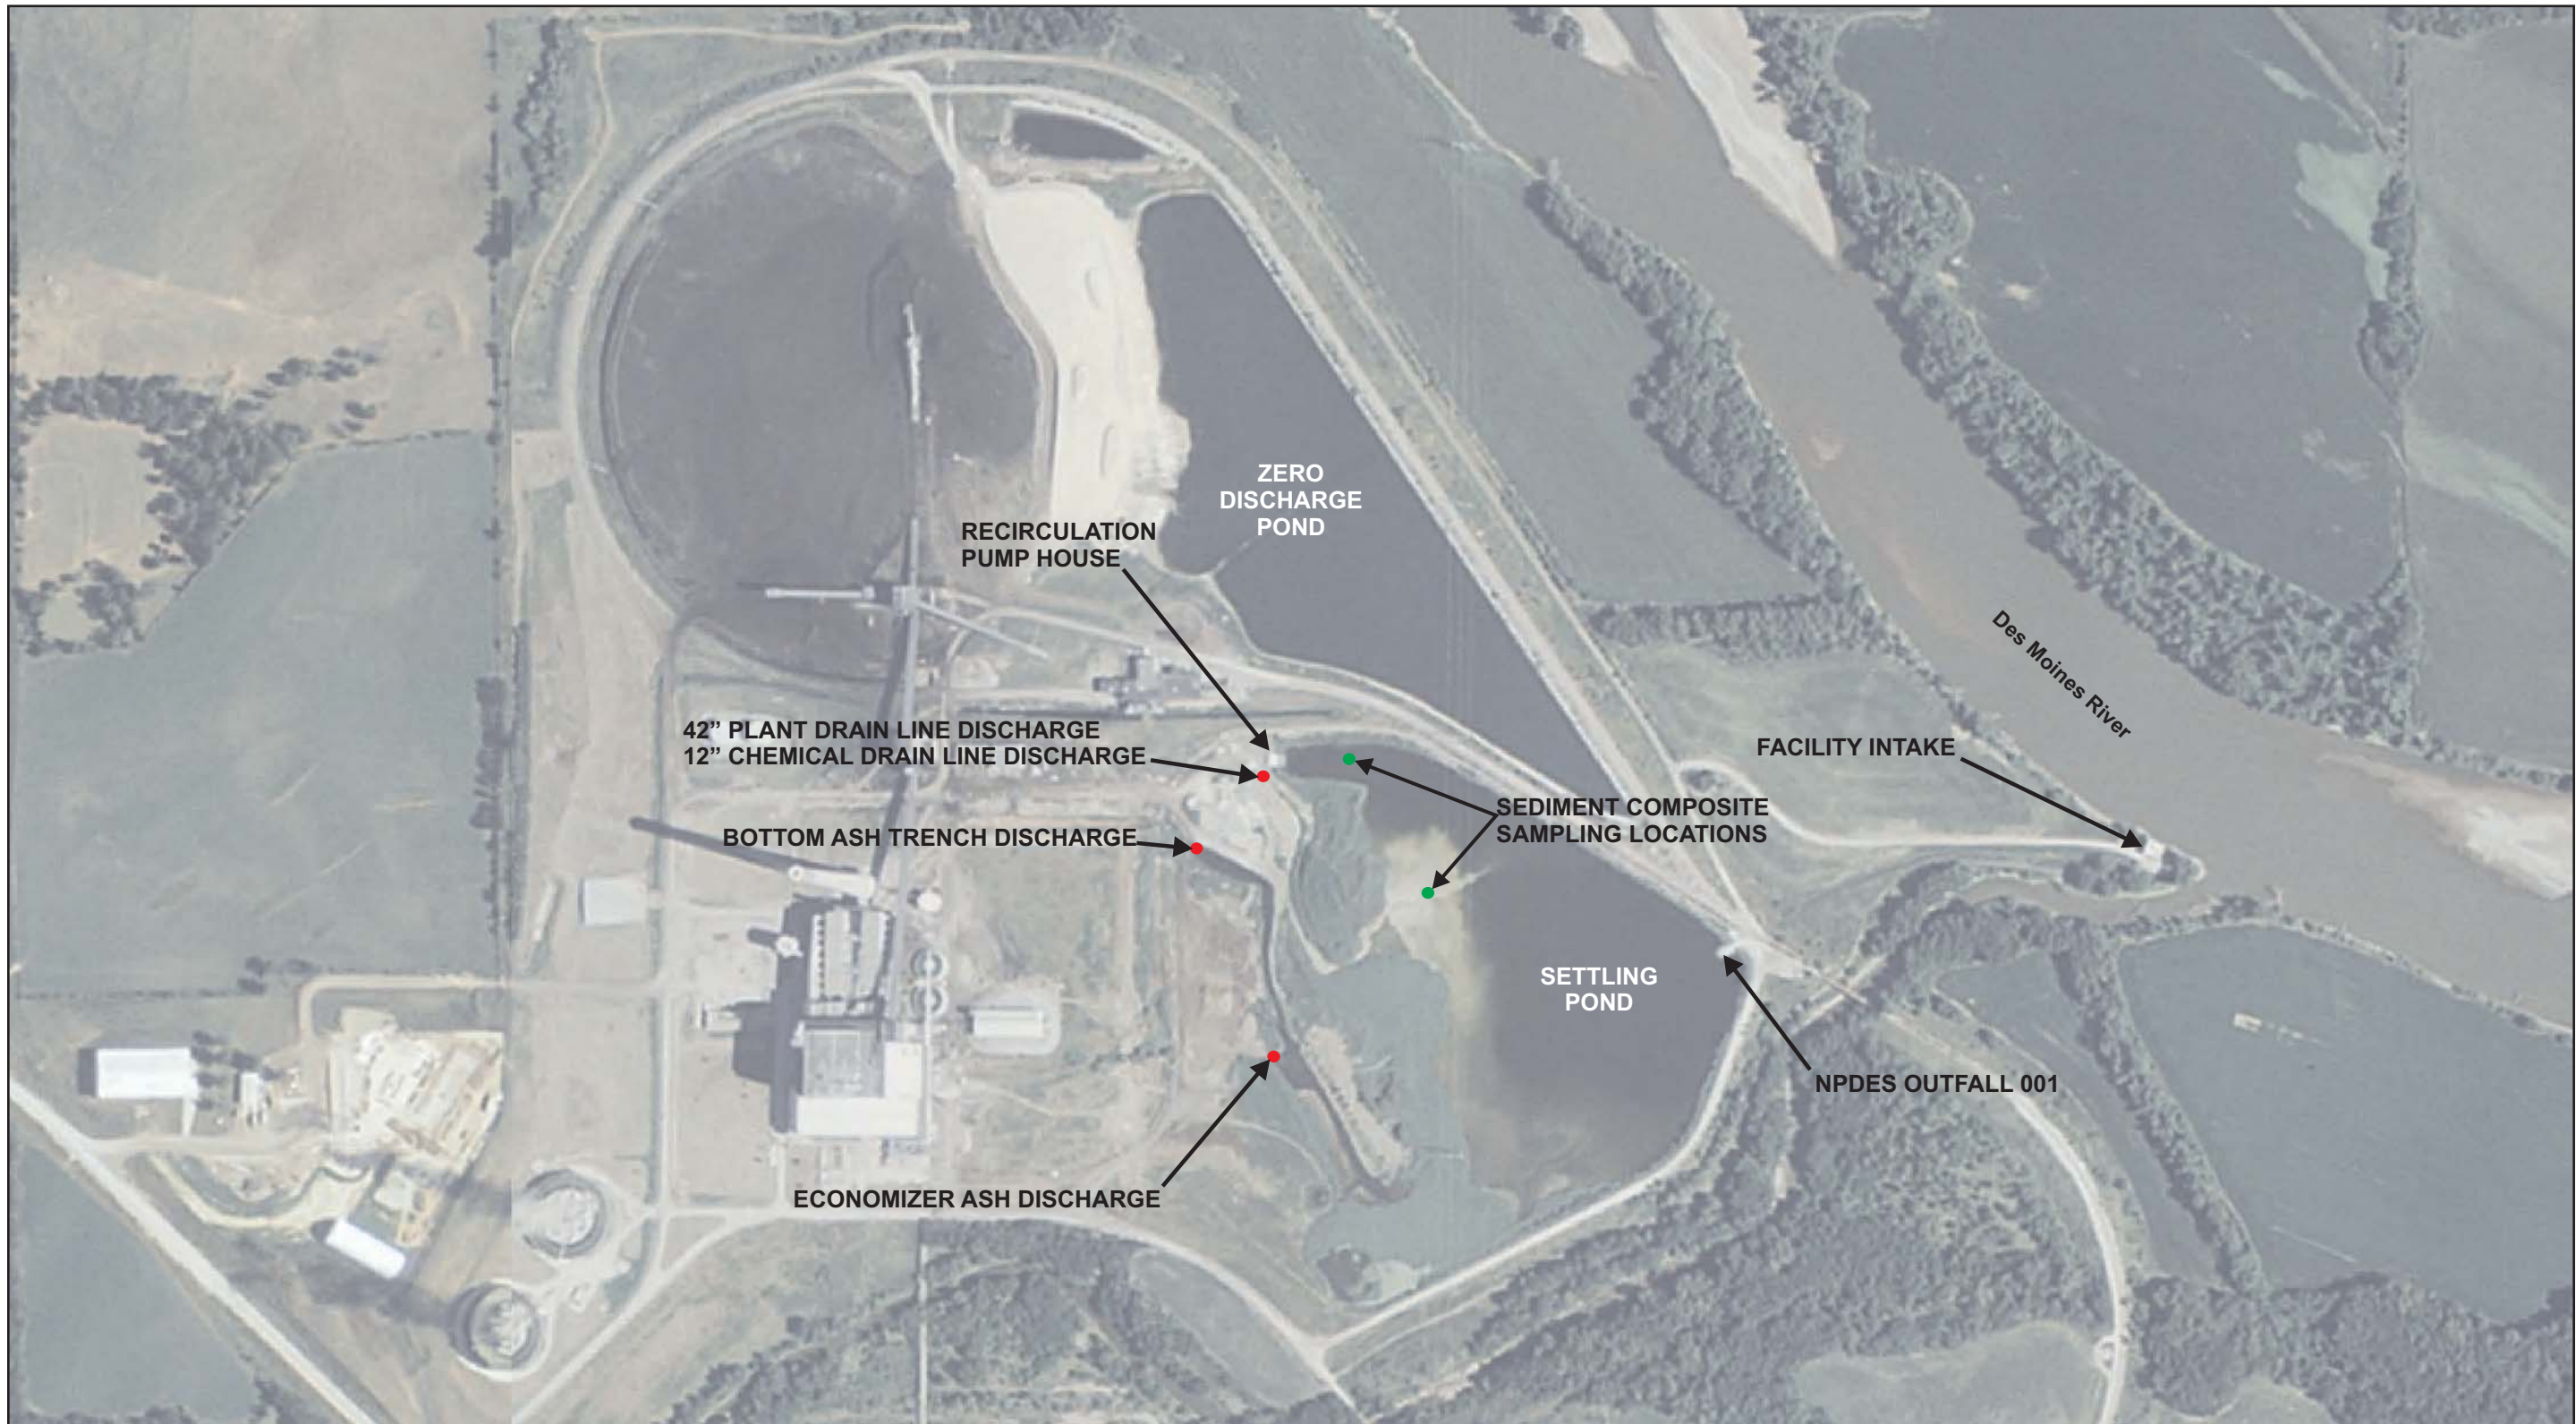
August 2005 aerial photo taken from the Iowa State University Information System Support and Resource Facility website.
