# Location Restriction Compliance Demonstration

Ottumwa Generating Station Surface Impoundments  
20775 Power Plant Road  
Ottumwa, Iowa 52501

Interstate Power and Light Company  
20775 Power Plant Road  
Ottumwa, Iowa 52501

25220083.00 | October 15, 2020

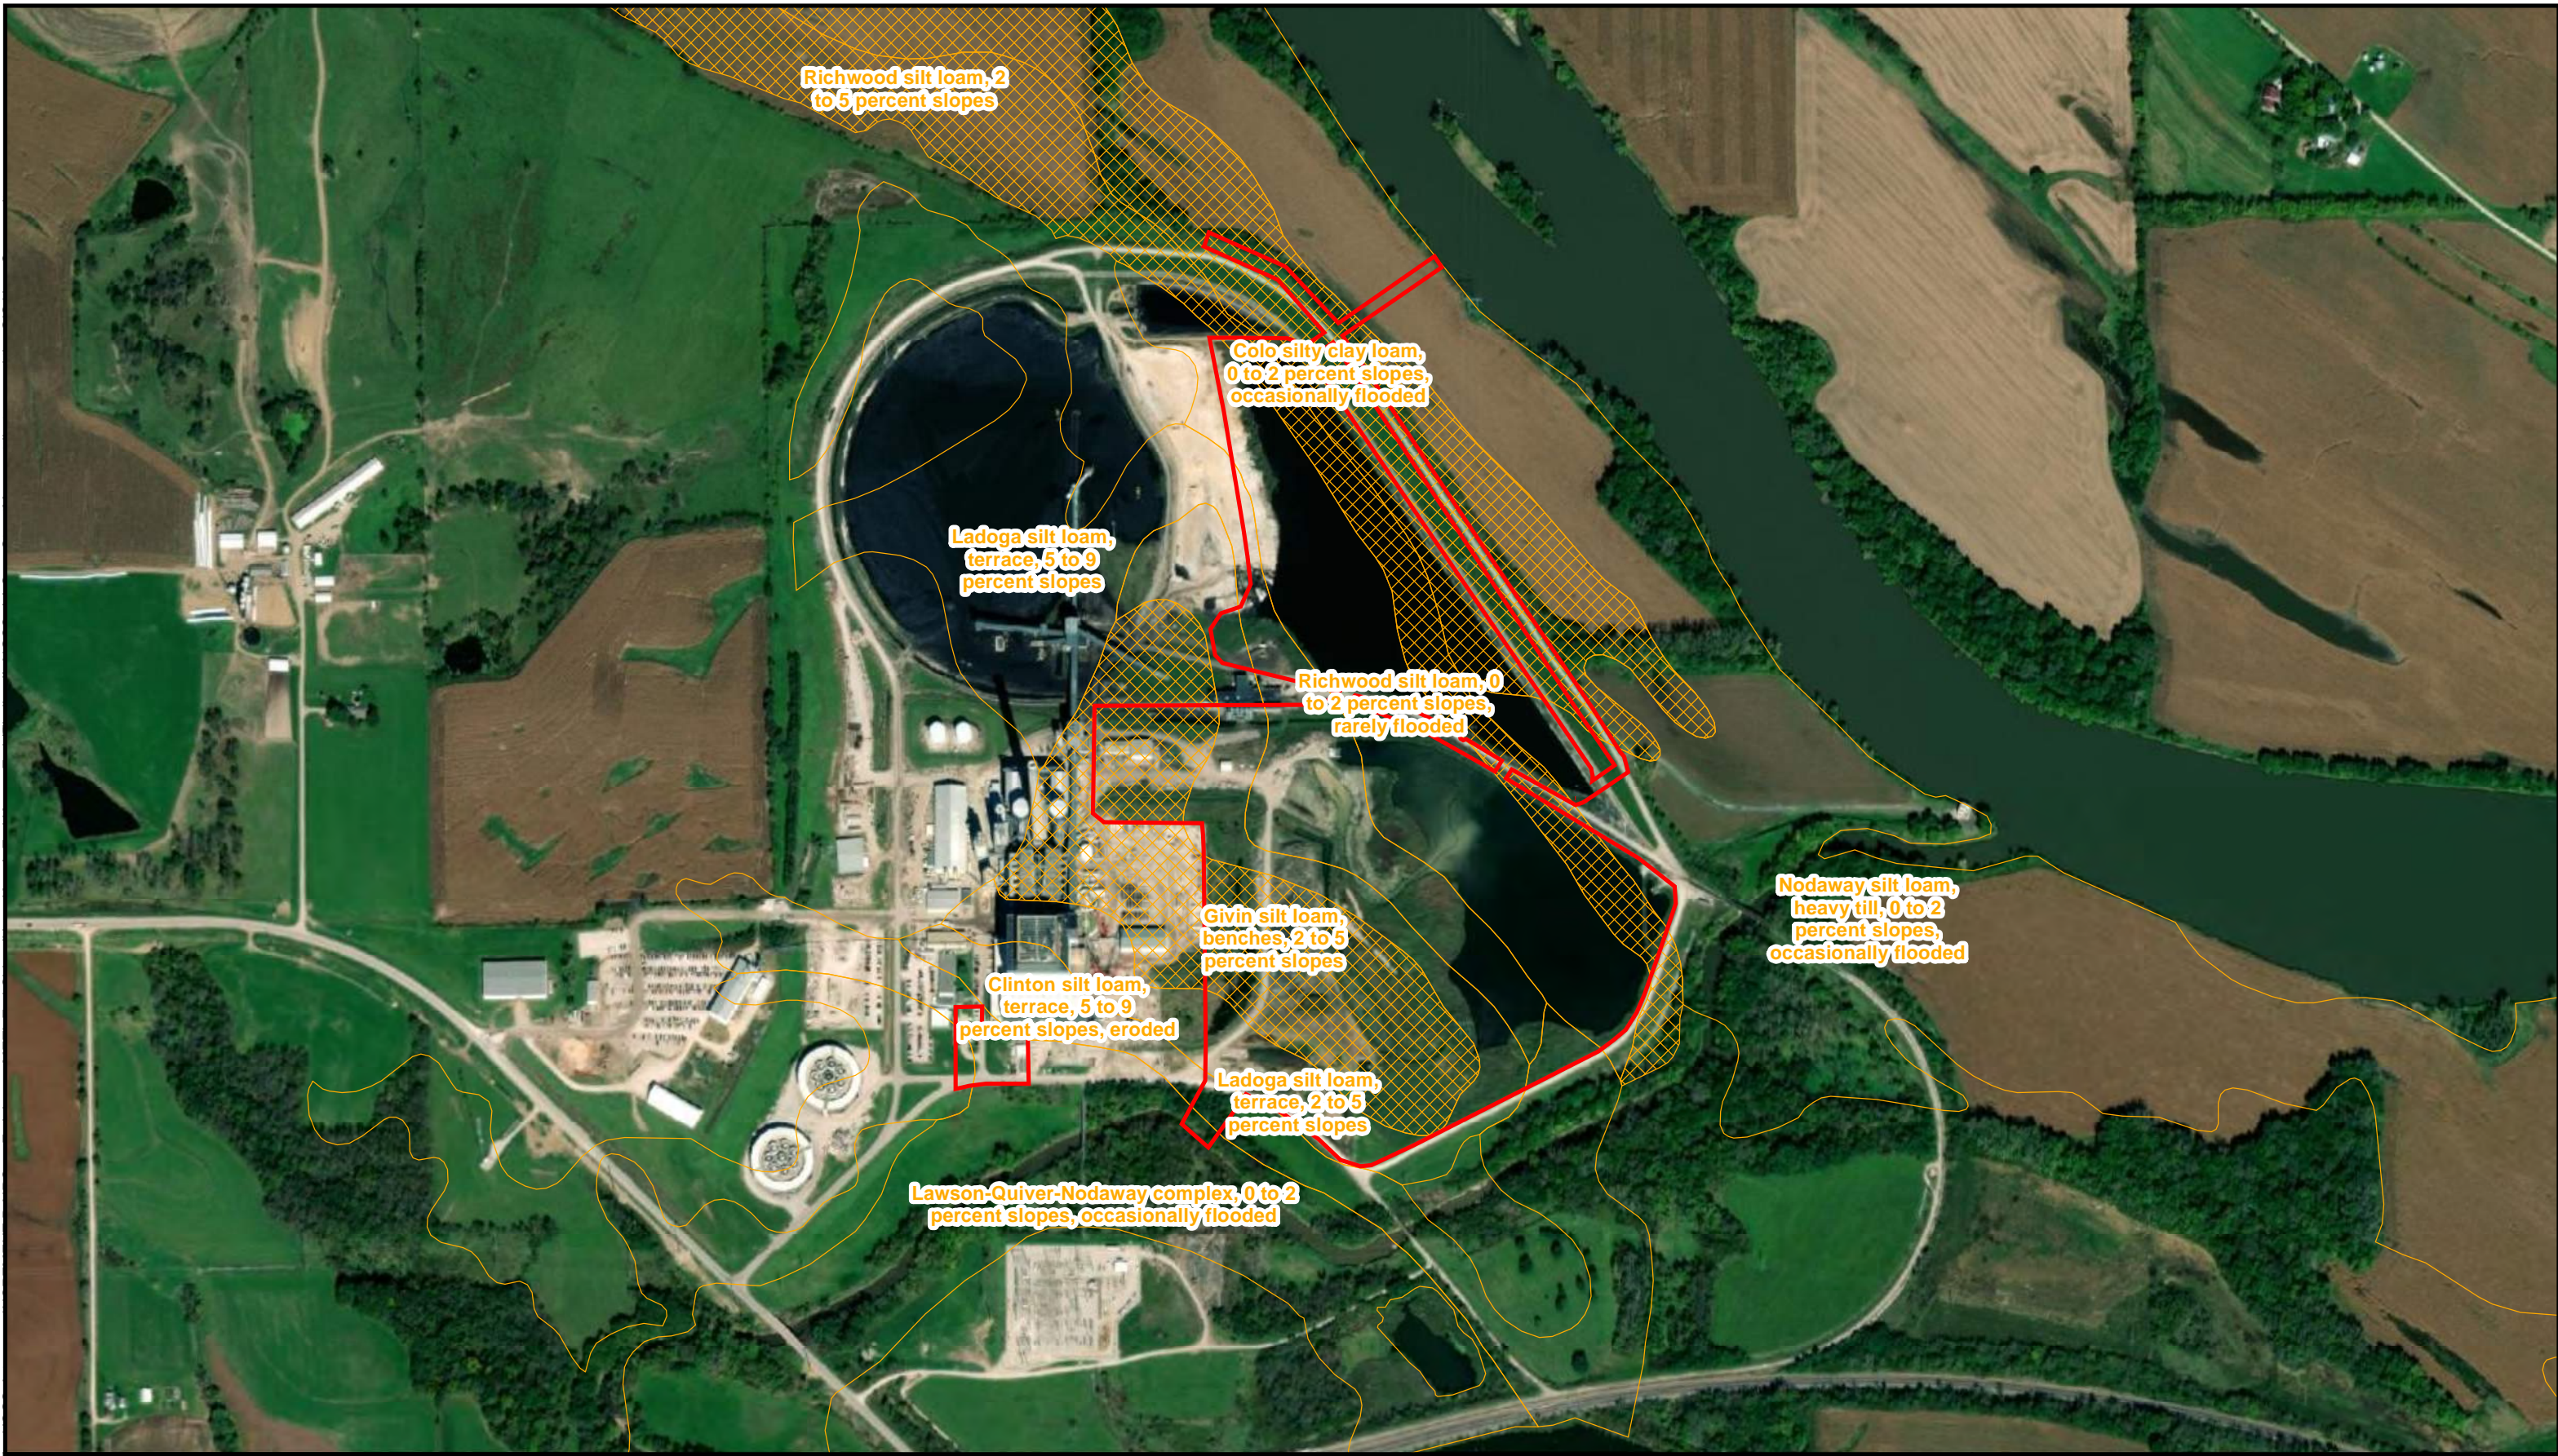
Figure A-3  
NRCS Soils and Areal Map  
Ottumwa Generating Station Pond  
Closure & Wastewater Treatment Project  
Interstate Power & Light Company  
Wapello County, IA

Richwood silt loam, 2 to 5 percent slopes

Colo silty clay loam, 0 to 2 percent slopes, occasionally flooded

Ladoga silt loam, terrace, 2 to 5 percent slopes

Lawson-Quiver-Nodaway complex, 0 to 2 percent slopes, occasionally flooded

U.S. Department of Agriculture (USDA) Natural Resources Conservation Service (NRCS) 2019 Soil Survey Geographic (SSURGO) digital data for Wapello County, Iowa. Figures A-2 and A-3 in Appendix A depict this data. The National Oceanic and Atmospheric Administration (NOAA) Palmer Drought Severity Index (PDSI) was also reviewed to evaluate precipitation conditions.

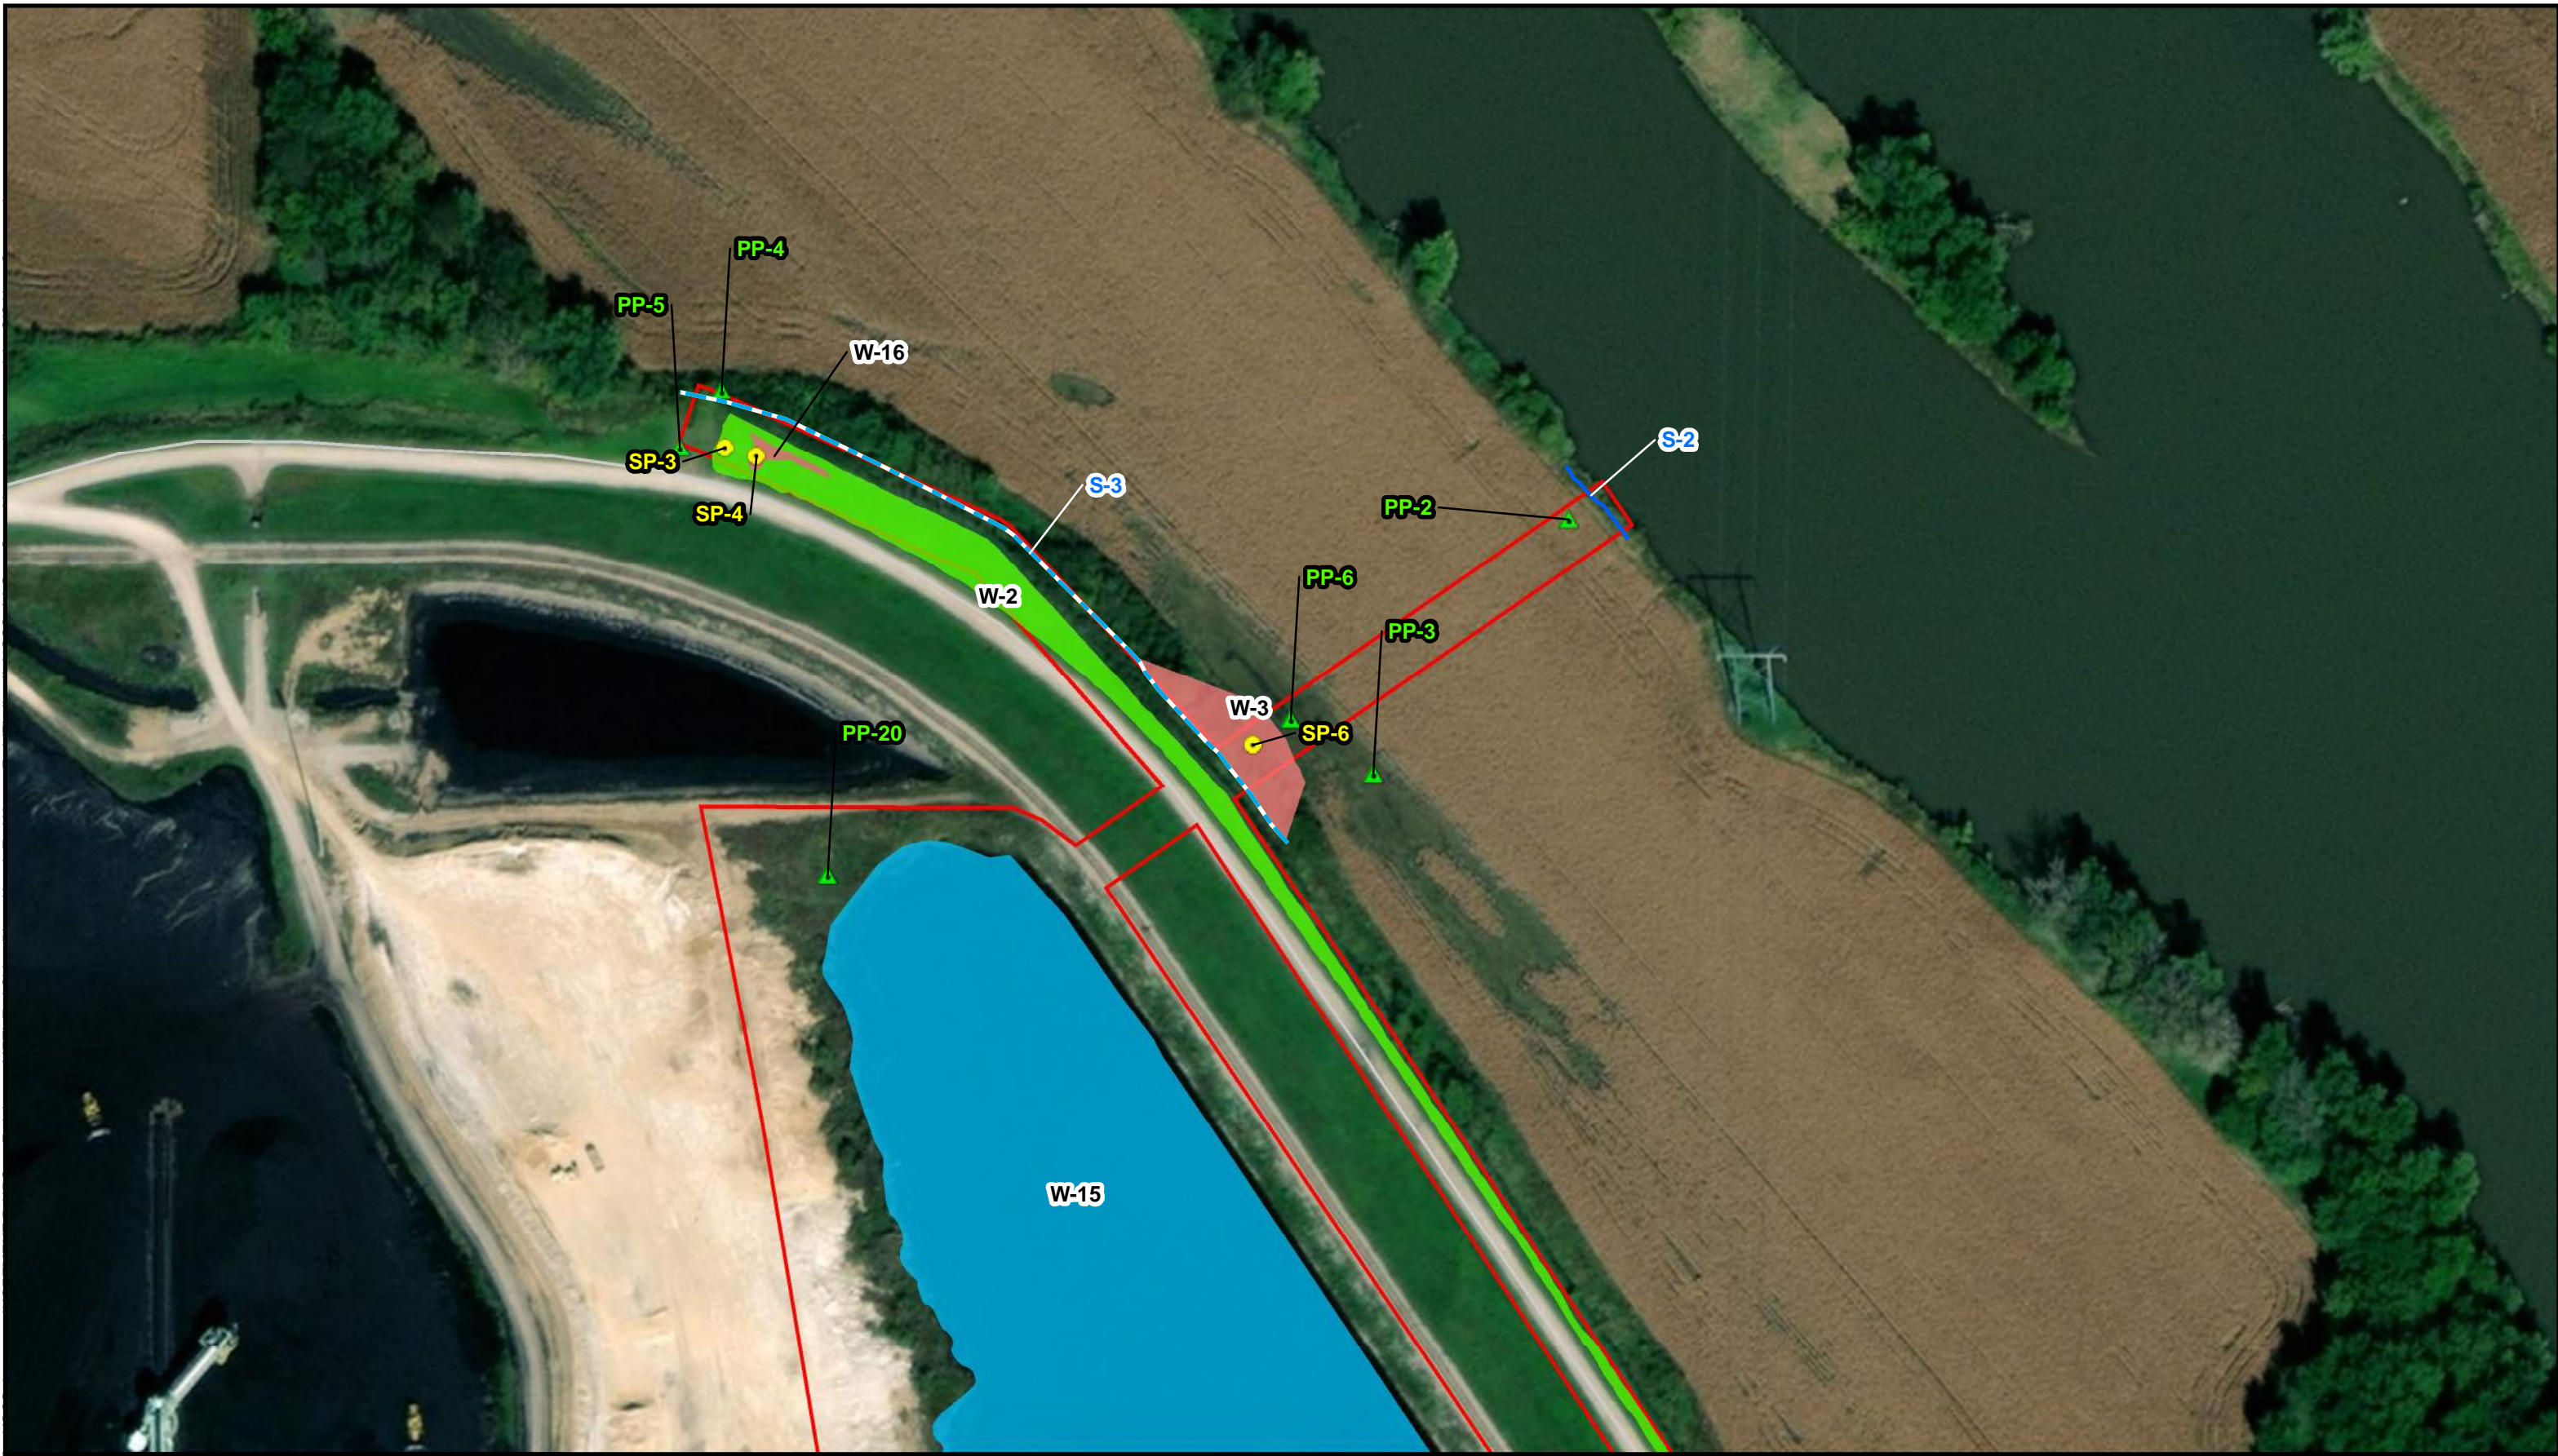
Figure A-4  
 Location Map of Wetlands and  
 Other Water Resources  
 Ottumwa Generating Station Pond  
 Closure & Wastewater Treatment Project  
 Interstate Power & Light Company  
 Wapello County, IA  
 Page 1 of 4

Survey Area	<b>Stream (S)</b>	<b>Wetland (W)</b>
Sample Plot (SP)	Ephemeral	PEM
Photograph Point (PP)	Intermittent	PSS
	Perennial	PUB

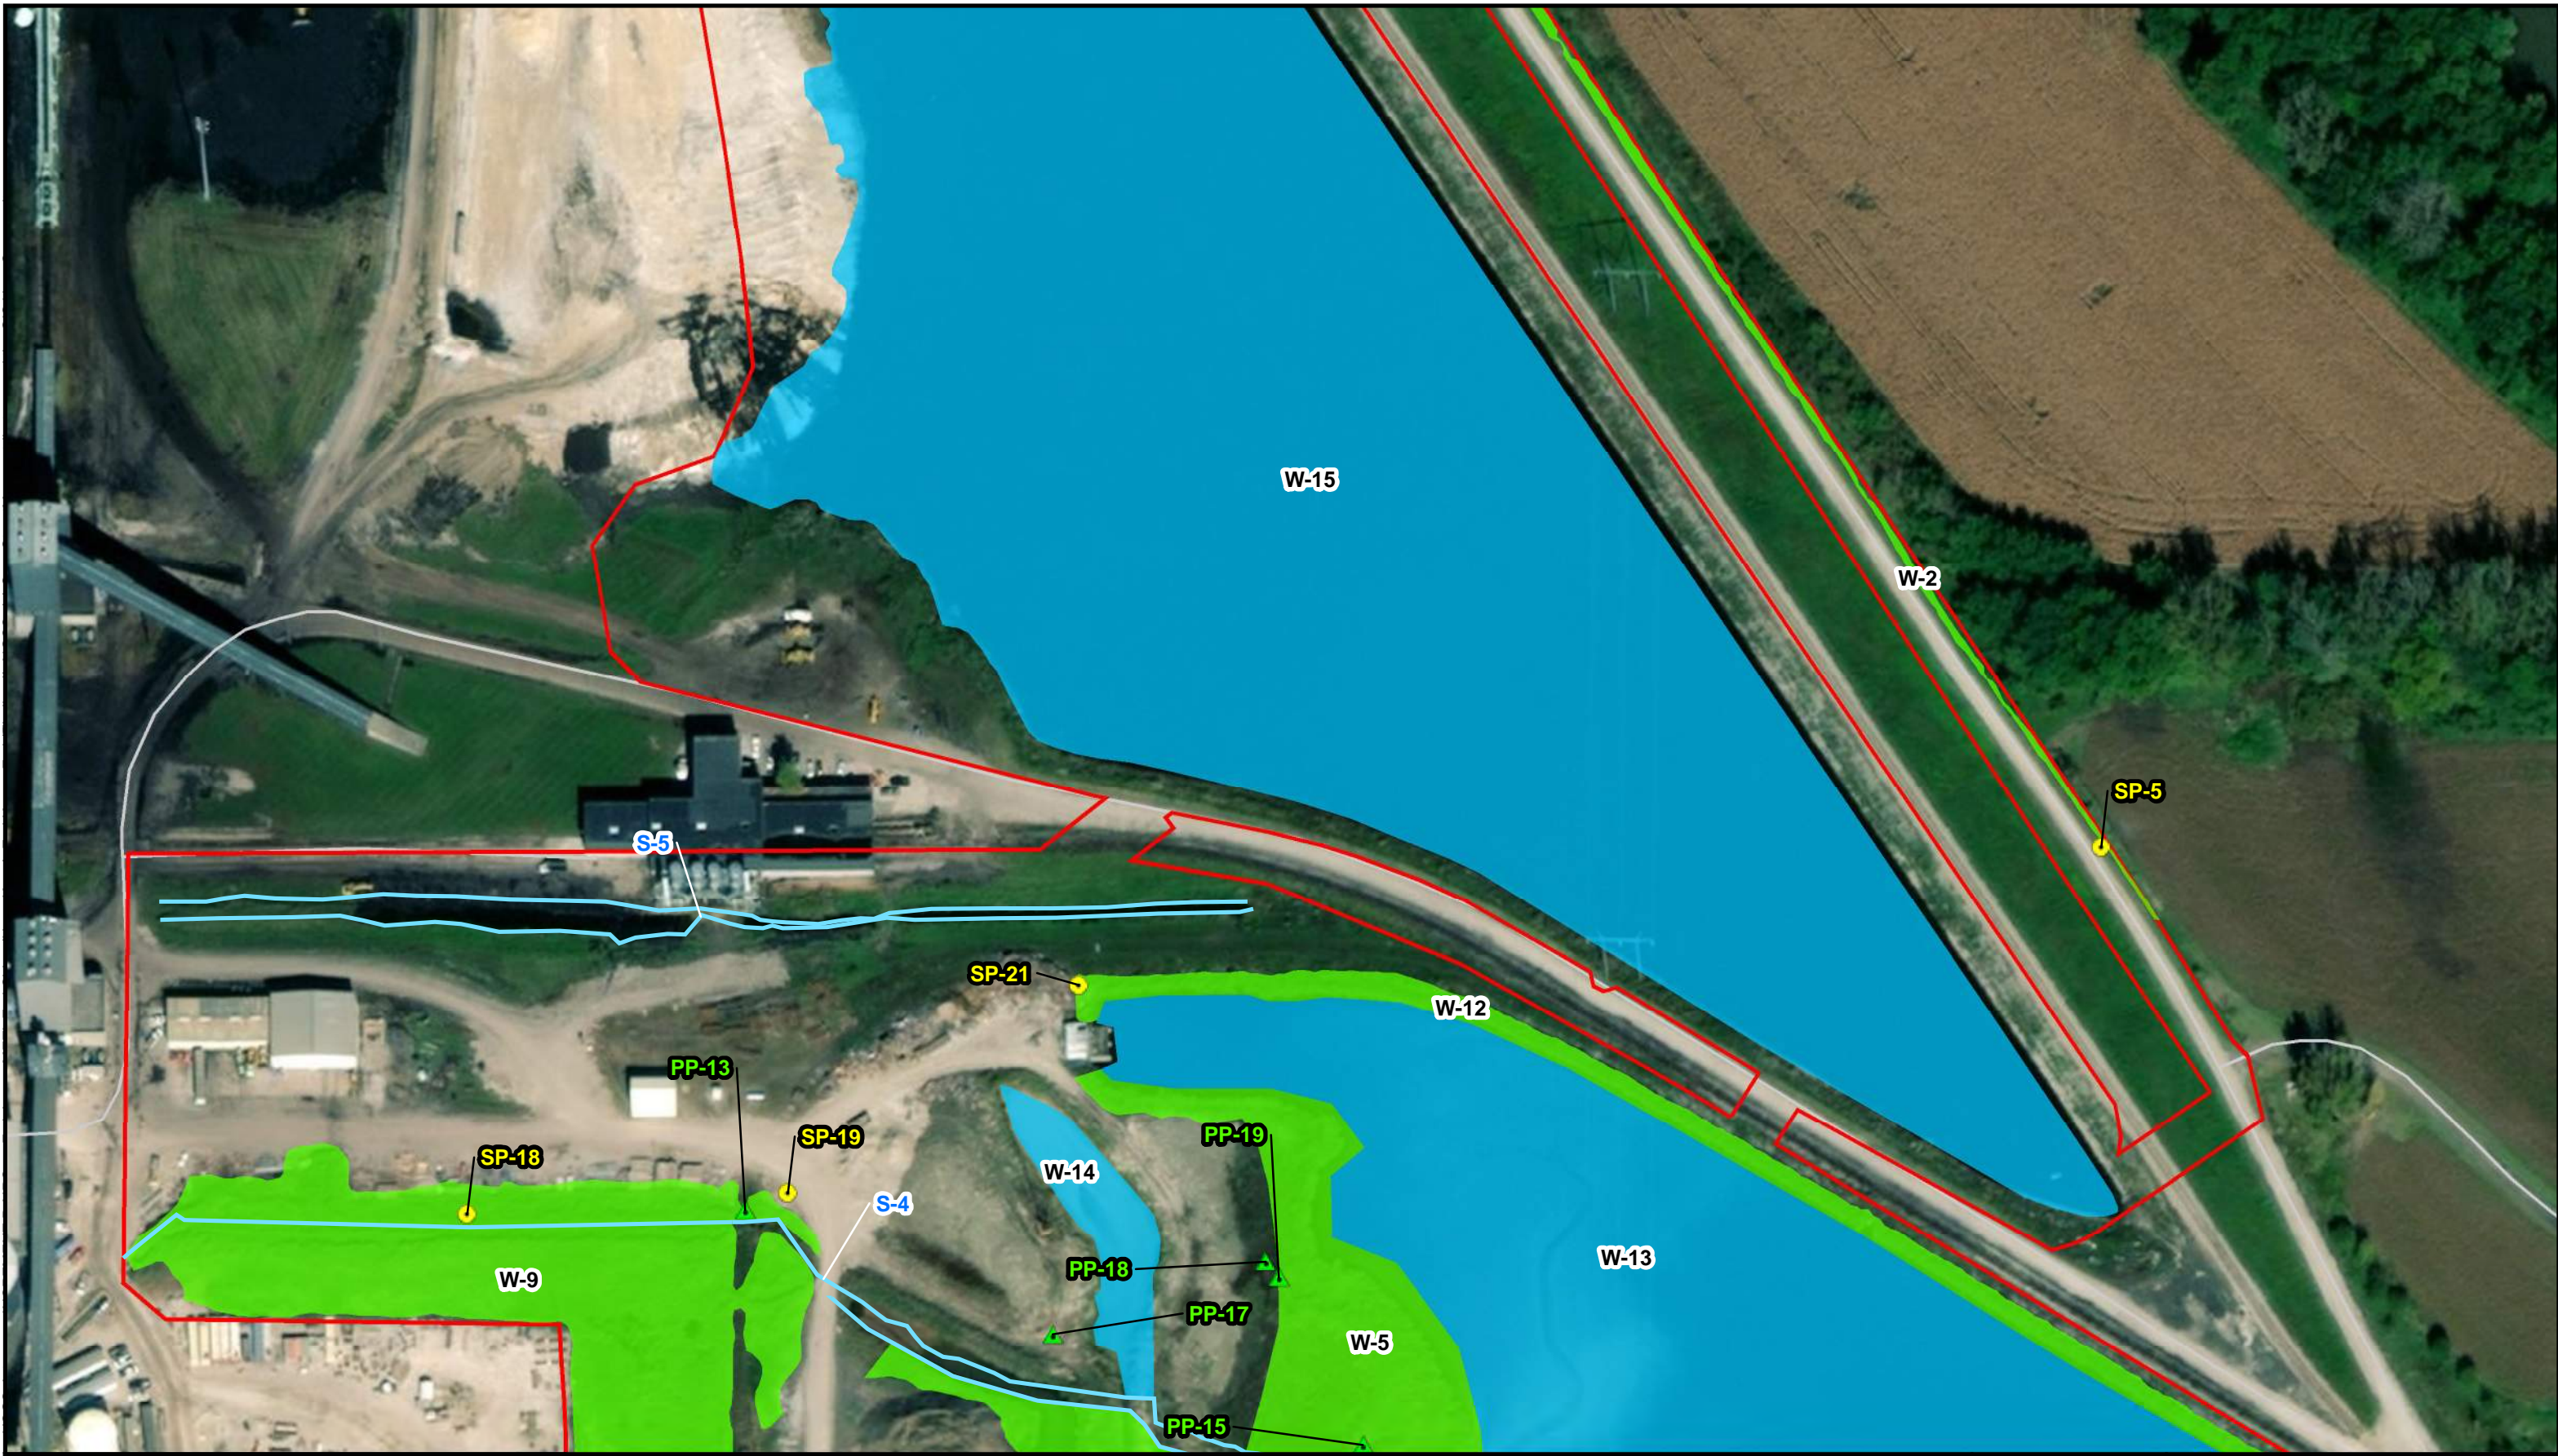
Figure A-4  
 Location Map of Wetlands and  
 Other Water Resources  
 Ottumwa Generating Station Pond  
 Closure & Wastewater Treatment Project  
 Interstate Power & Light Company  
 Wapello County, IA  
 Page 2 of 4

Survey Area		Stream (S)		Wetland (W)	
	Survey Area		Ephemeral		PEM
	Sample Plot (SP)		Intermittent		PSS
	Photograph Point (PP)		Perennial		PUB

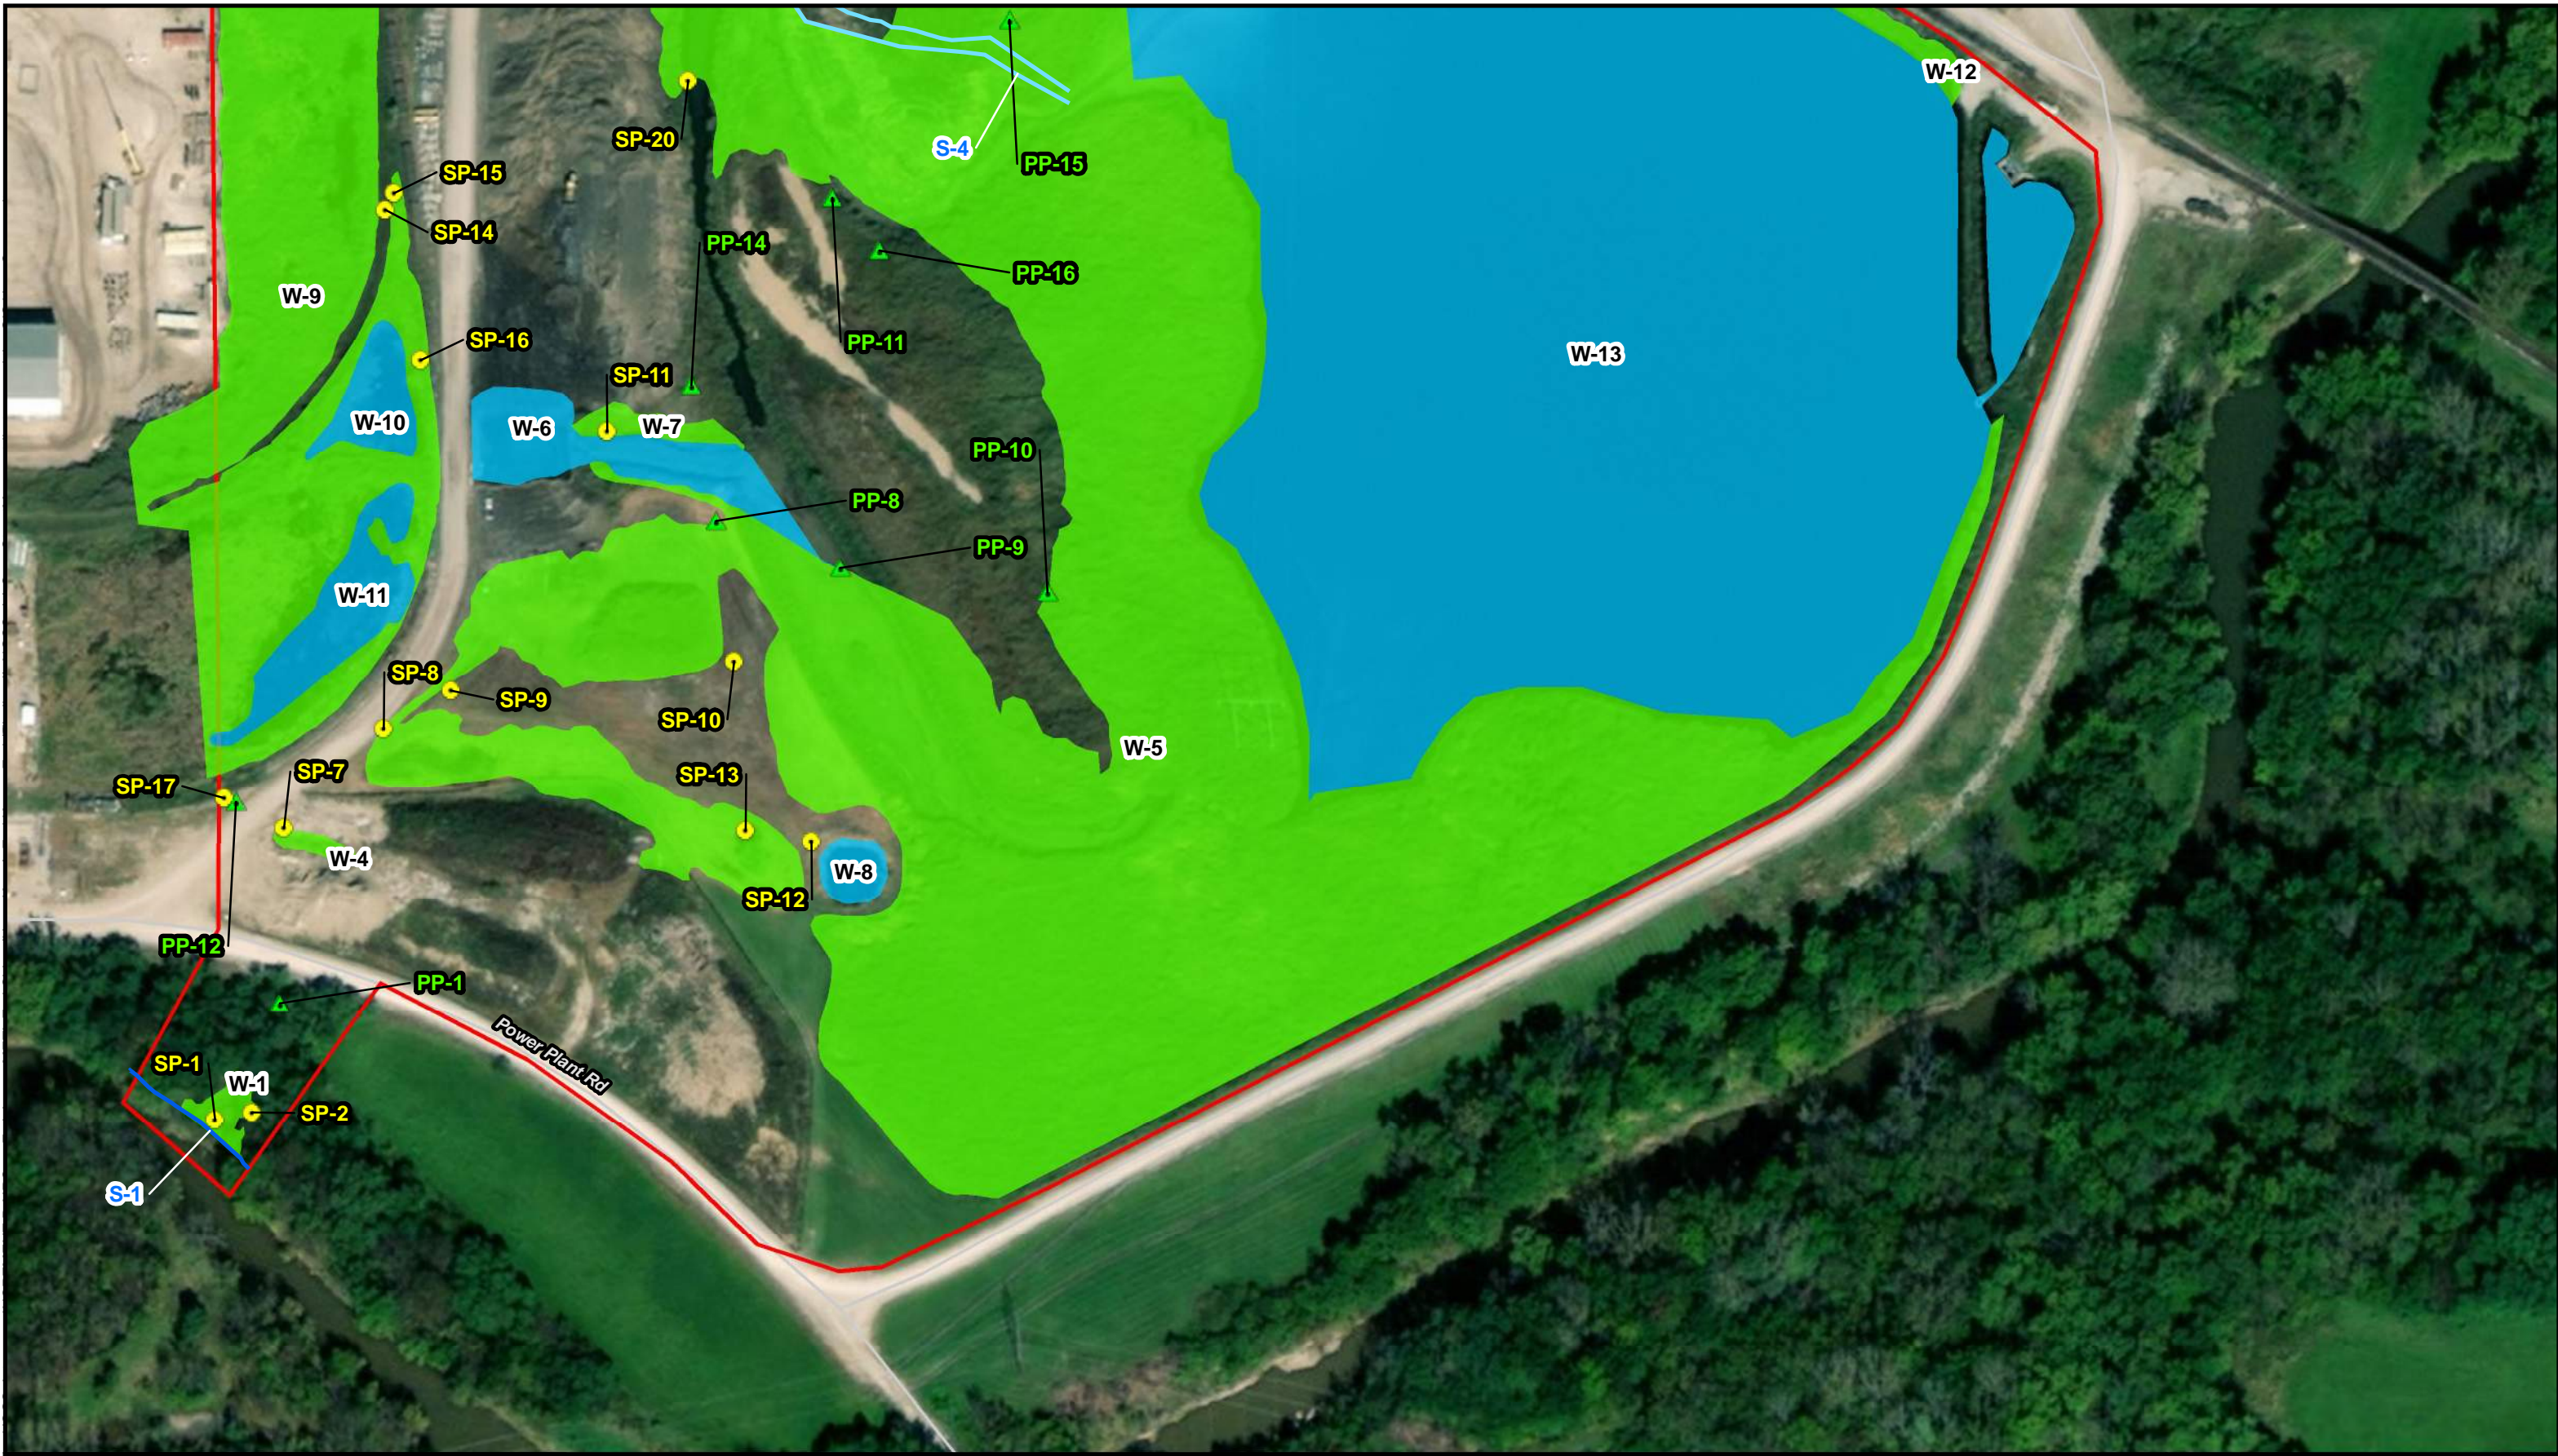
Figure A-4  
 Location Map of Wetlands and  
 Other Water Resources  
 Ottumwa Generating Station Pond  
 Closure & Wastewater Treatment Project  
 Interstate Power & Light Company  
 Wapello County, IA  
 Page 3 of 4

Survey Area	<b>Stream (S)</b>	<b>Wetland (W)</b>
Sample Plot (SP)	Ephemeral	PEM
Photograph Point (PP)	Intermittent	PSS
	Perennial	PUB

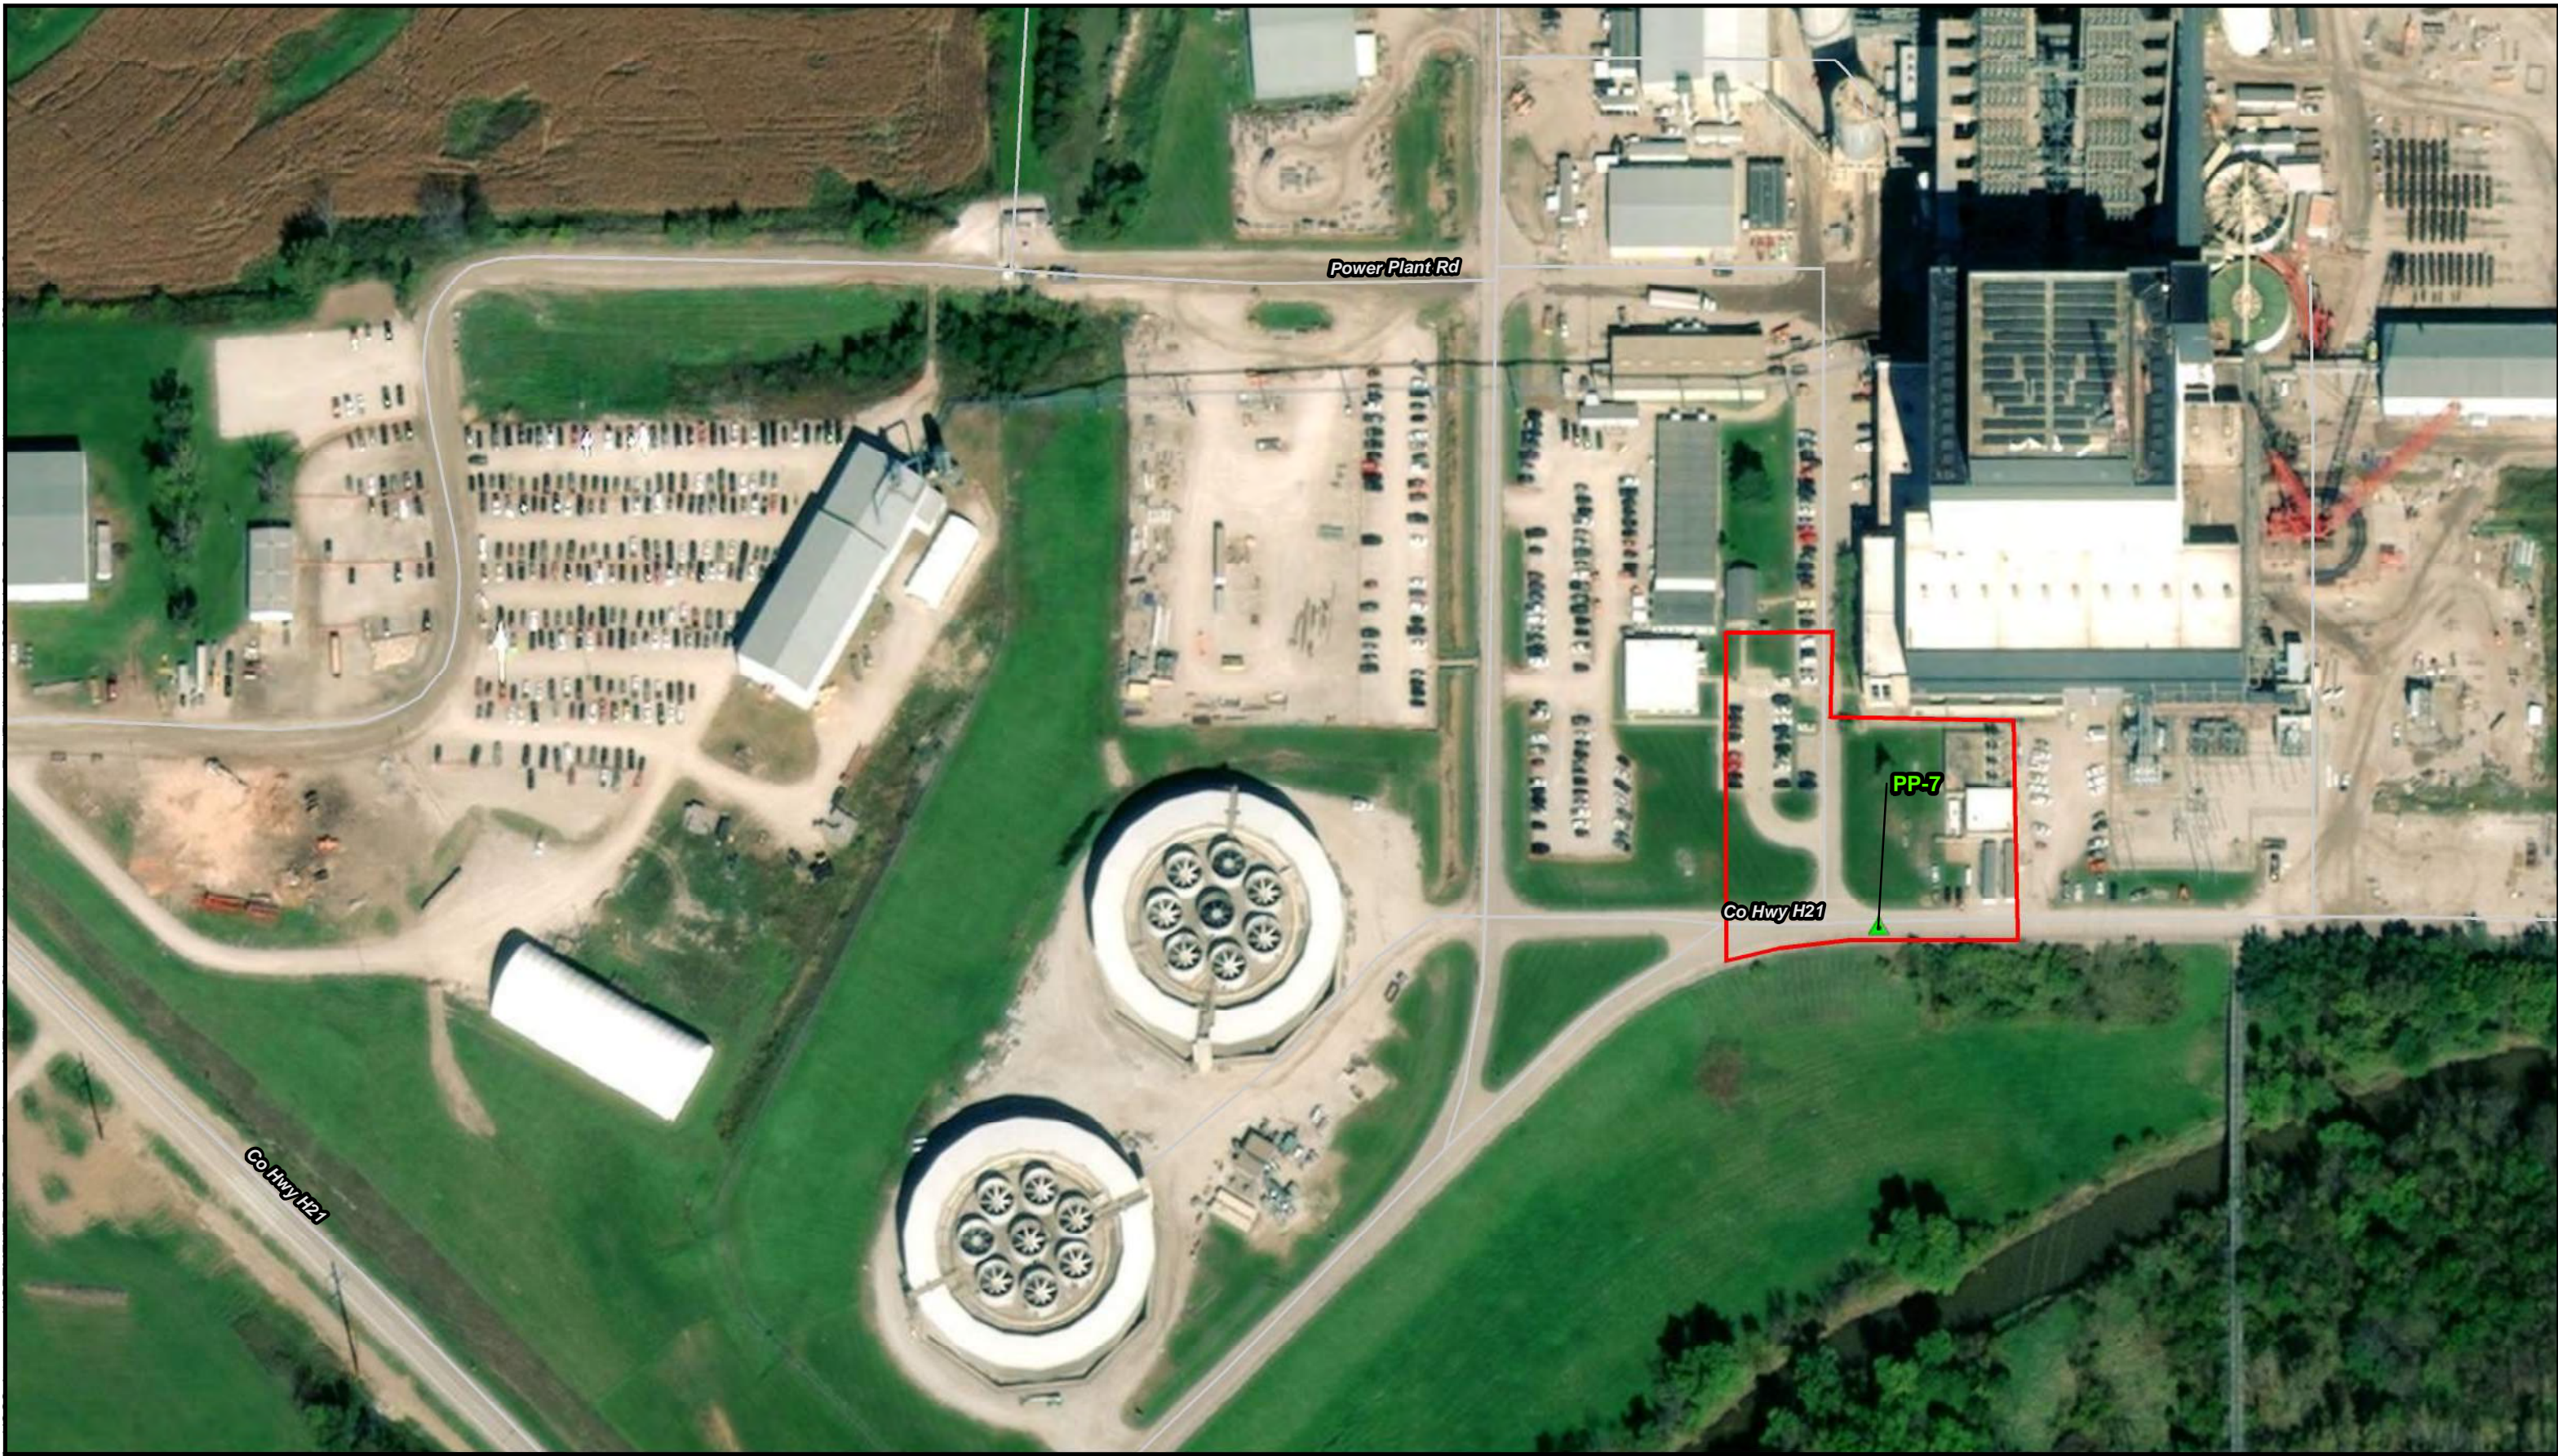
Figure A-4  
 Location Map of Wetlands and  
 Other Water Resources  
 Ottumwa Generating Station Pond  
 Closure & Wastewater Treatment Project  
 Interstate Power & Light Company  
 Wapello County, IA  
 Page 4 of 4

Survey Area	<b>Stream (S)</b>	<b>Wetland (W)</b>
Sample Plot (SP)	Ephemeral	PEM
Photograph Point (PP)	Intermittent	PSS
	Perennial	PUB
