# Location Restriction Compliance Demonstration

Ottumwa Generating Station Surface Impoundments  
20775 Power Plant Road  
Ottumwa, Iowa 52501

Interstate Power and Light Company  
20775 Power Plant Road  
Ottumwa, Iowa 52501

25220083.00 | October 15, 2020

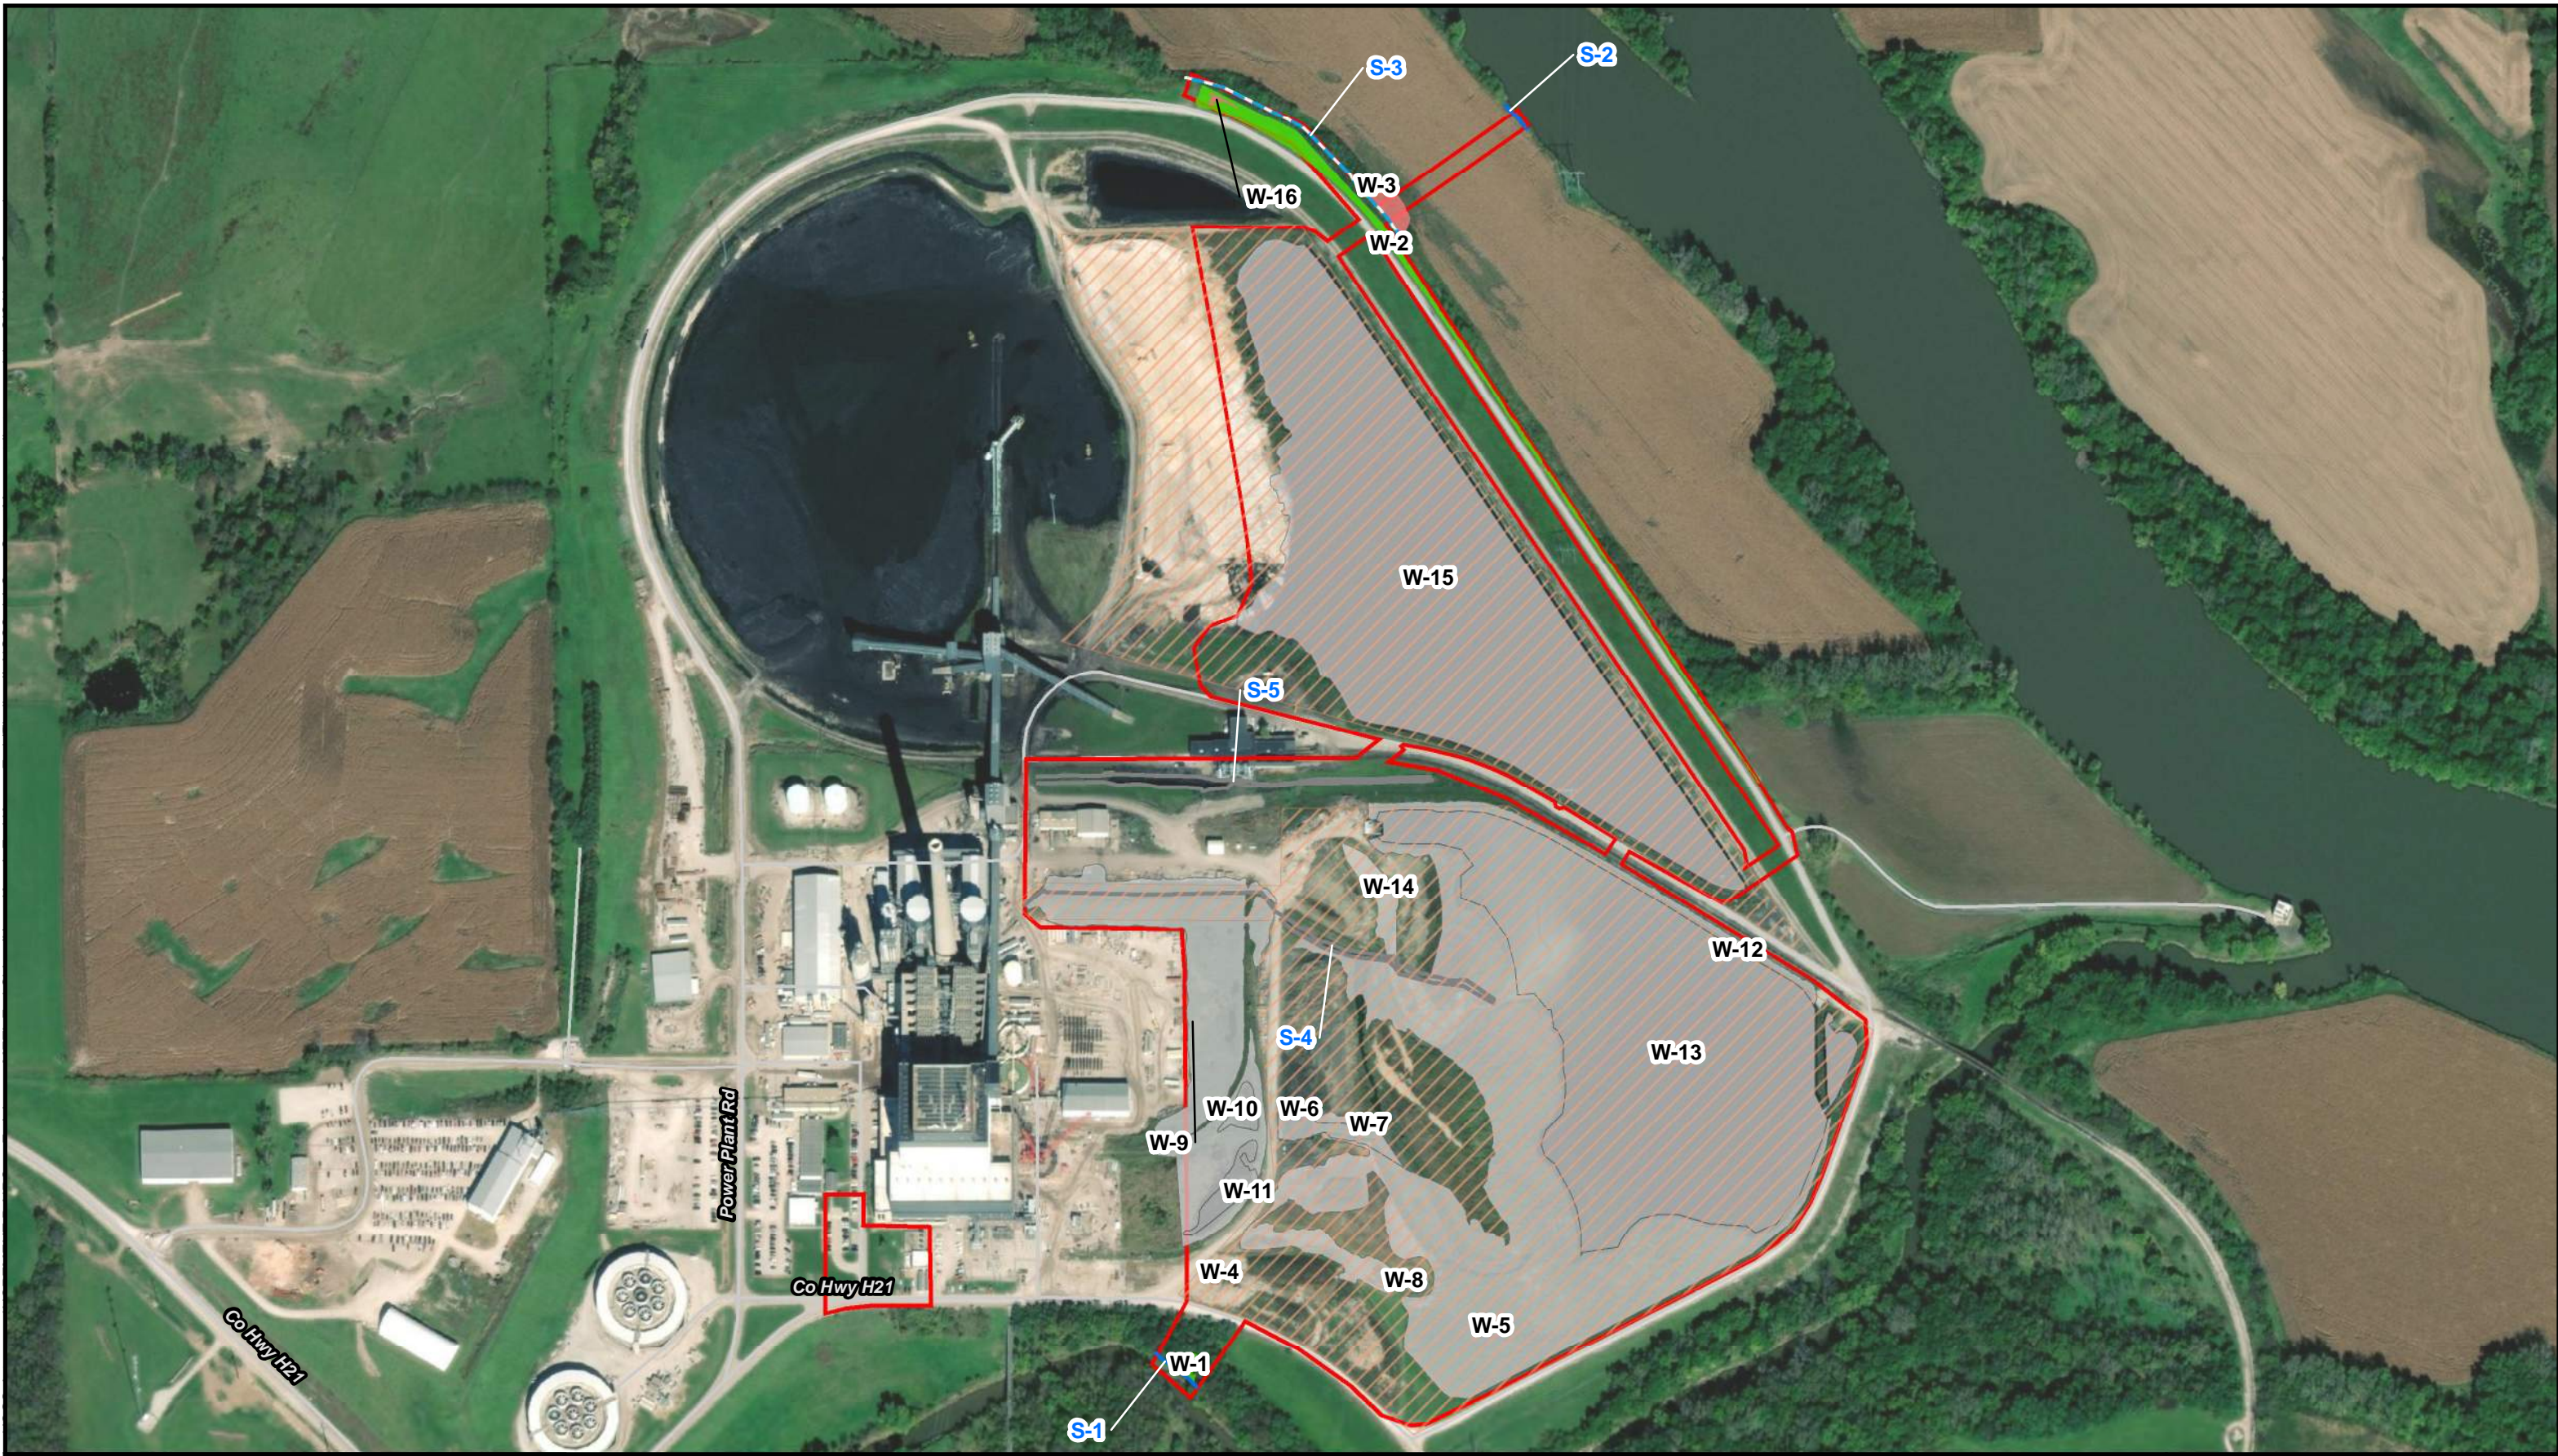
Survey Area	<b>Delineated Stream (S)</b>	<b>Delineated Wetland (W)</b>
Waste Treatment System	Perennial	PEM
	Intermittent	PSS
	Assumed Non-Jurisdictional	Assumed Non-Jurisdictional

Burns & McDonnell conducted a wetland delineation within the Survey Area to identify wetlands and other waterbodies. Sixteen areas with wetland characteristics and five streams were identified. Most of the areas with wetland characteristics delineated within the Survey Area were artificial, low-quality wetlands created within the areas of the Generating Station that transport or hold operational wastewaters and stormwater runoff (i.e., the waste treatment system). The dominant vegetation throughout these areas was common reed. This species is a vigorous growing plant that outcompetes most other plants in the vicinity and can thrive in highly disturbed wet areas. The isolated, artificial PEM and PUB areas within the bottom ash pond are unlikely to be jurisdictional since they are part of the waste treatment system, as defined in 40 CFR 120.2(3)(xv).

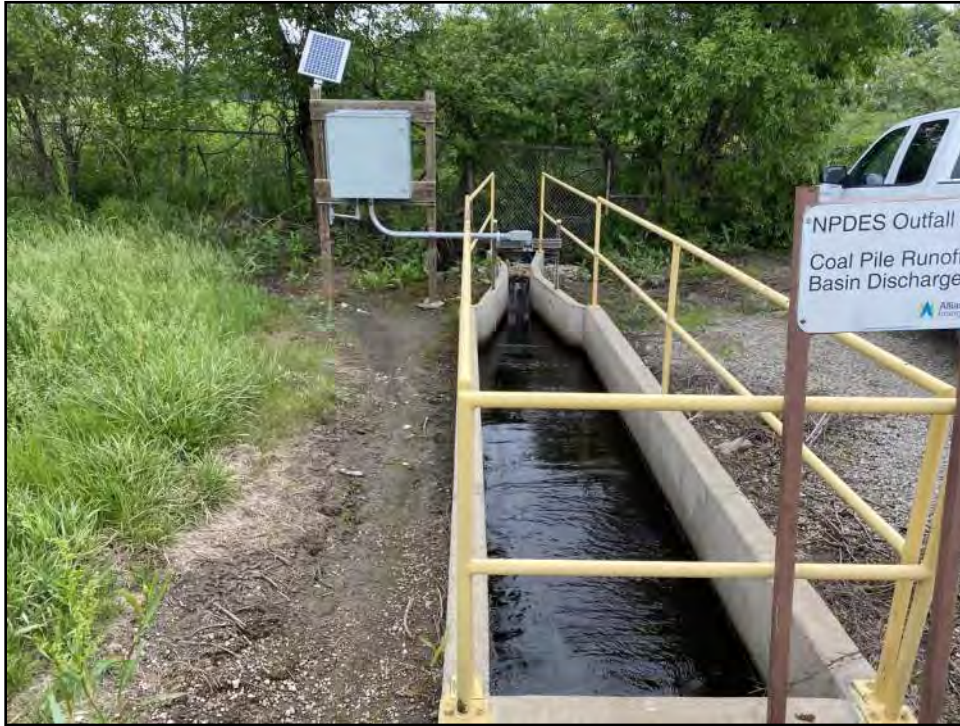
Photograph C-35: View of existing outfall feeding intermittent S-3 at PP-5, facing north.

Two ephemeral streams, extending for 2,429 linear feet, were delineated within the Survey Area. Ephemeral streams were characterized by a defined bed and bank and were constructed for wastewater discharge from the power plant to the ash ponds. Ephemeral streams ranged from approximately 4.5 to 12 feet in width at the ordinary high-water mark (OHWM) with bank heights ranging from 1 to 2 feet. At the time of delineation, water was observed at a depth of 0.5 to 1.5 feet. The substrates of the ephemeral streams were comprised typically of coal dust or silt. These streams flowed through industrialized ash pond areas within the boundaries of the power plant. Riparian vegetation included species such as common reed, black medick, black willow, field pennycress (*Thlaspi arvense*), field parsnip (*Pastinaca sativa*), and common milkweed (*Asclepias syriaca*). These streams are likely not jurisdictional because they are artificially created streams, and the water source is from the power plant.
