**ALLIANT ENERGY**  
**Interstate Power and Light Company**  
**Sutherland Generating Station**

**CCR SURFACE IMPOUNDMENT**

**HISTORY OF CONSTRUCTION**

Report Issued: March 05, 2018  
Revision 0

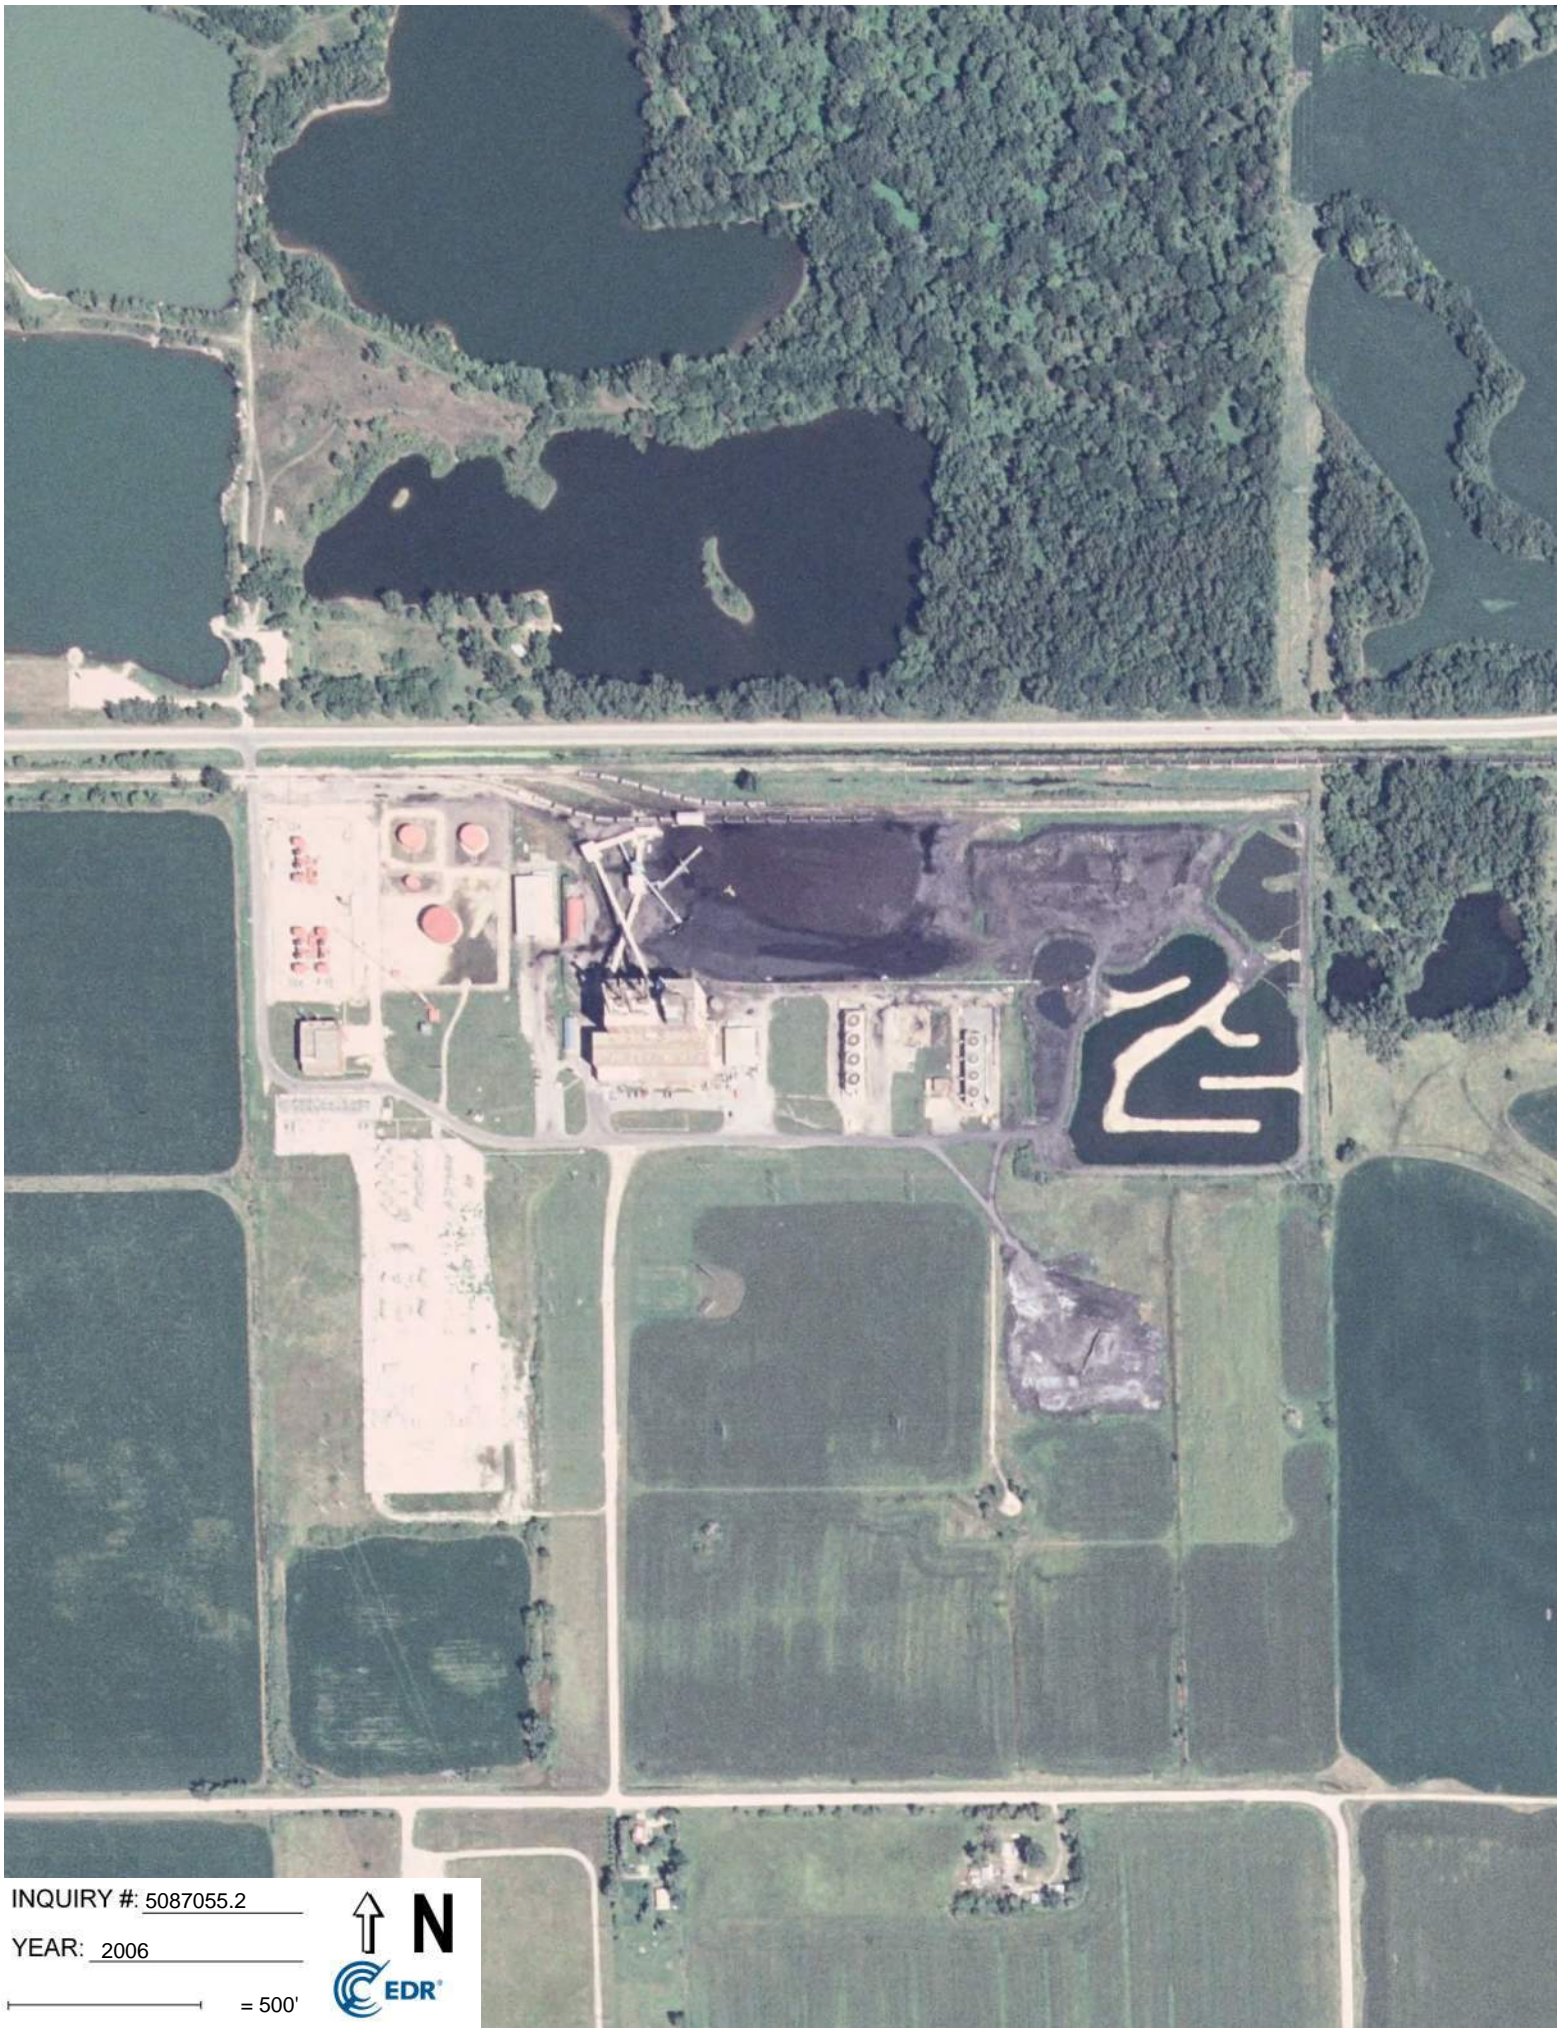
YEAR: 2006

- In 2006, the current configuration of the SGS Main Pond and SGS Polishing Pond were constructed (Appendix G). The existing intermediate finger berm located within the SGS Main Pond was stabilized by removing bottom ash material to approximately 1 foot above the normal water elevation within the SGS Main Pond. The berm was then compacted, followed by placement of geogrid and compacted AgPave (hydrated fly ash) along the berm crest. In addition to repairing the existing intermediate finger berm, new intermediate finger berms were constructed out of quarry shot rock and compacted AgPave. The new intermediate finger berms allowed access to the entire surface impoundment for maintenance dredging, as well as increased the detention time to enhance settling of suspended solids. A precast concrete mixing channel was installed in the the northwest corner of the SGS Main Pond. The installation of the mixing channel was completed in order to allow for chemical addition to settle out suspended

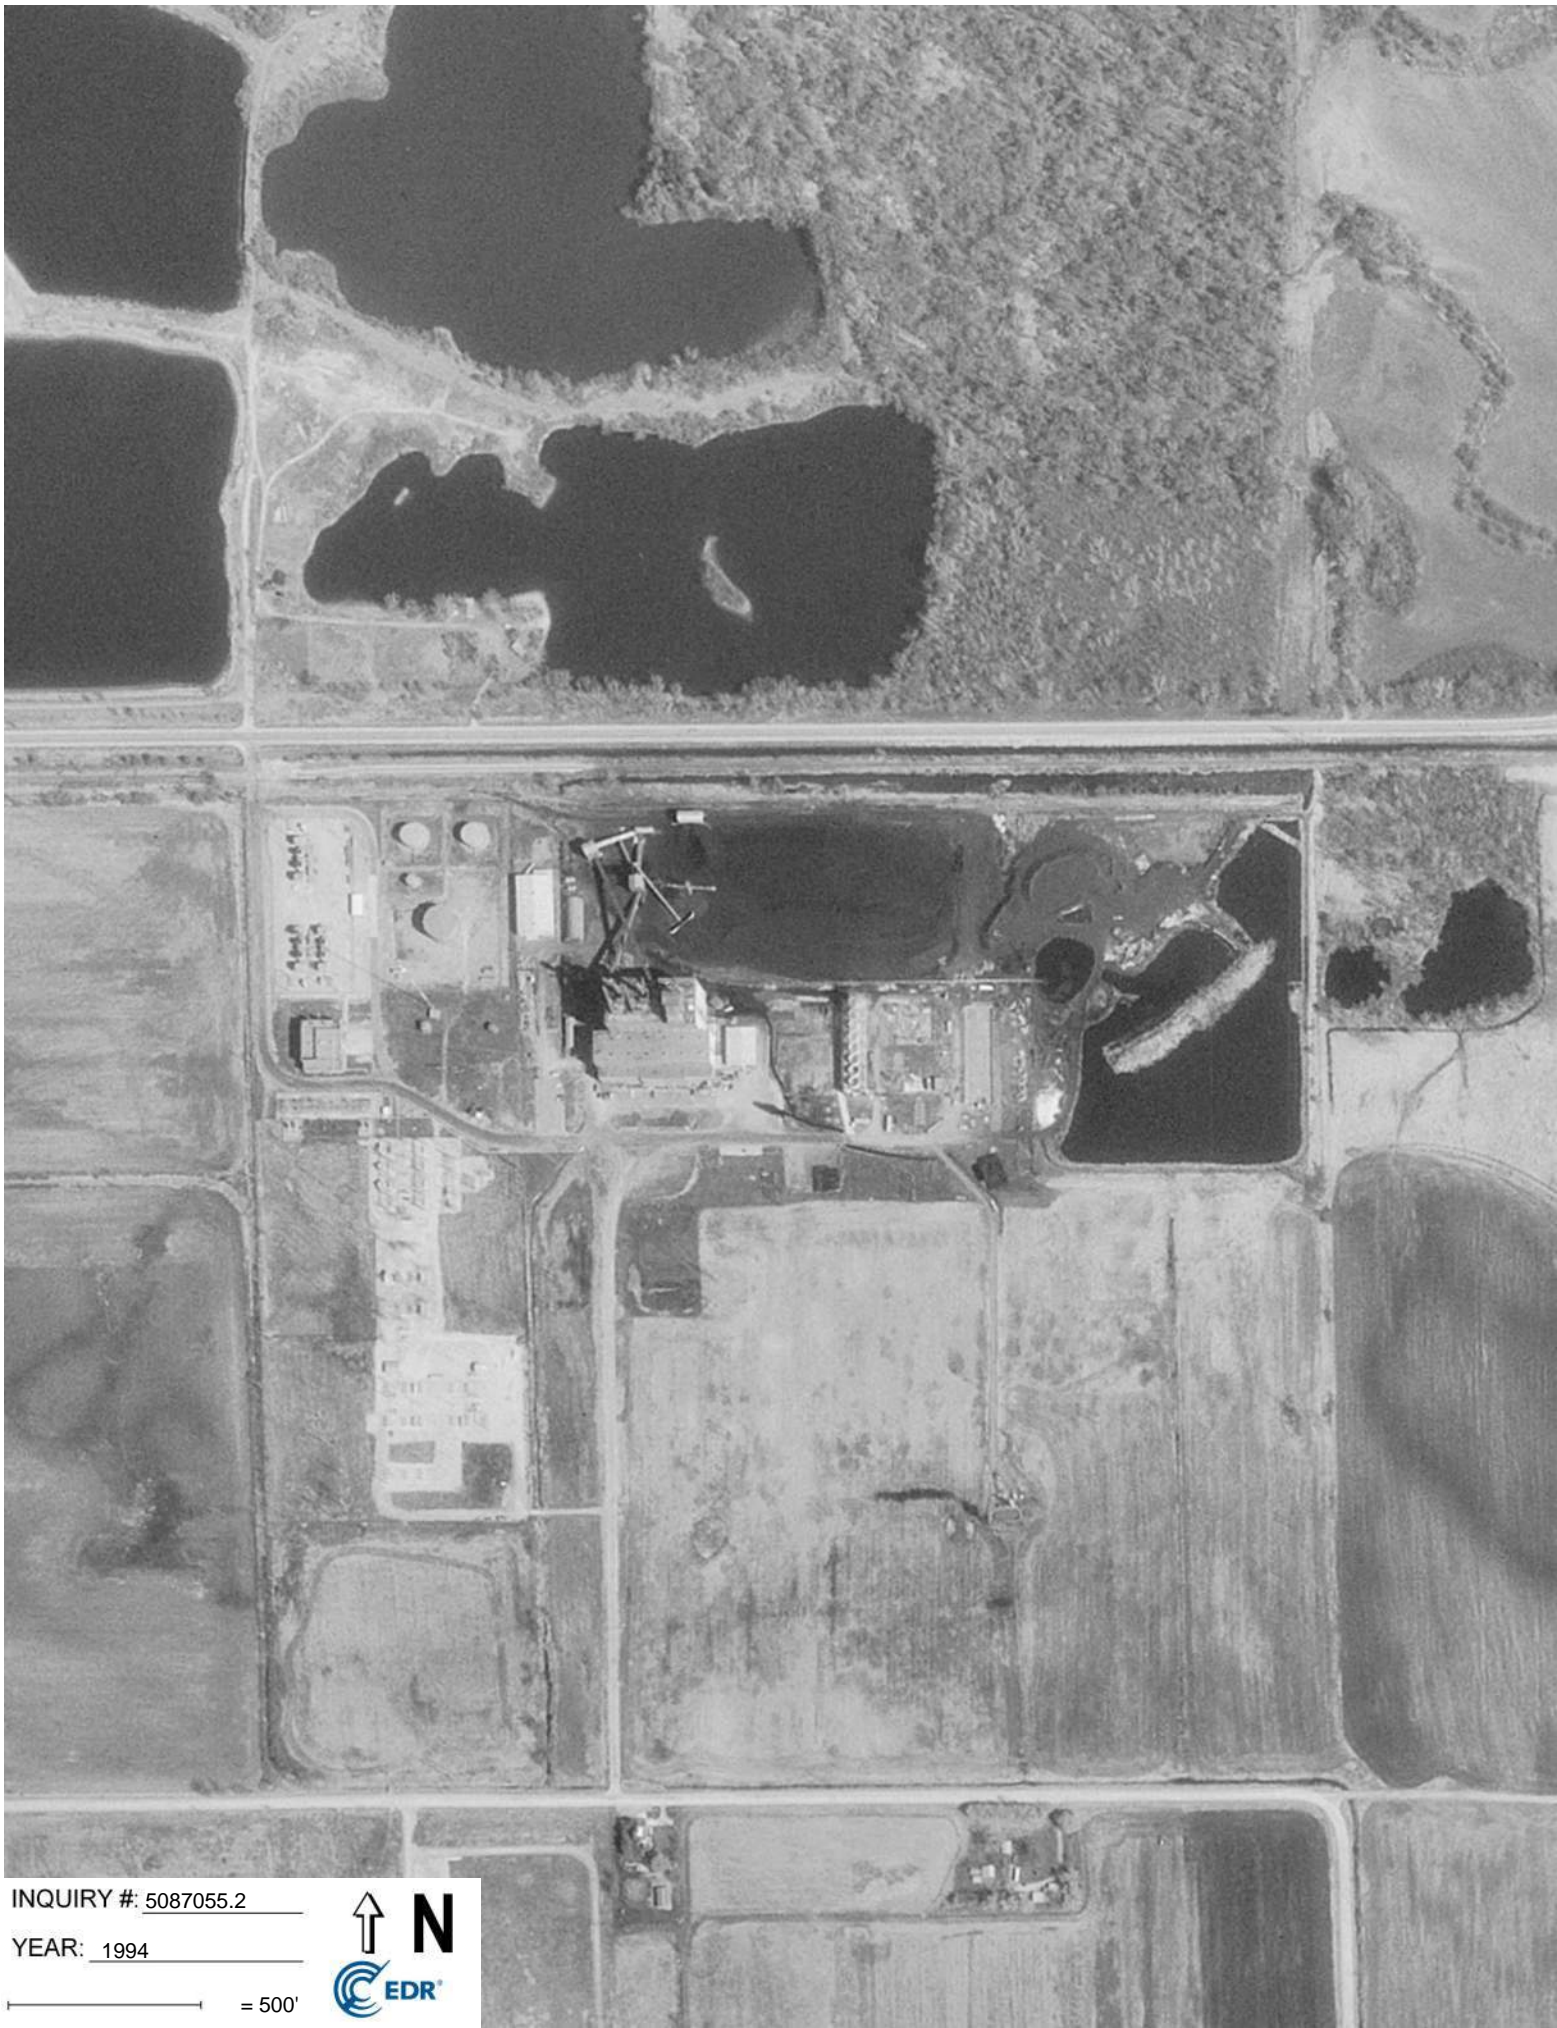
YEAR: 1994

A historical aerial photograph taken in 1994 identified the first significant reconfiguration of the CCR surface impoundment (Appendix B). At that time, the northwestern portion of the CCR surface impoundment was observed to have been filled in with what is presumed to be CCR. Additionally, the historical aerial photograph showed the addition of a primary settling pond that appeared to be constructed within the western portion of the original footprint of the CCR surface impoundment. The primary settling pond became the primary receiver of sluiced CCR, as well as process flows and storm water flows. The secondary settling pond, located east of the primary settling pond, was divided by an intermediate finger berm. Soil borings and CPT borings installed along the intermediate finger berm in 2006 indicated the berm was constructed completely out of bottom ash (Appendix E). From the historical aerial photograph, it appears the primary settling pond discharged into the northwest corner of the secondary settling pond. The water in the secondary settling pond would then flow to the southwest corner of the CCR surface impoundment and around the intermediate finger berm where it would then flow to the northeast corner of the secondary settling pond. The water would then flow through a hydraulic structure into a small discharge pond. There is no known readily available information regarding the hydraulic structures associated with the primary settling pond, secondary settling pond, or discharge pond at the time the historical aerial photograph was taken.

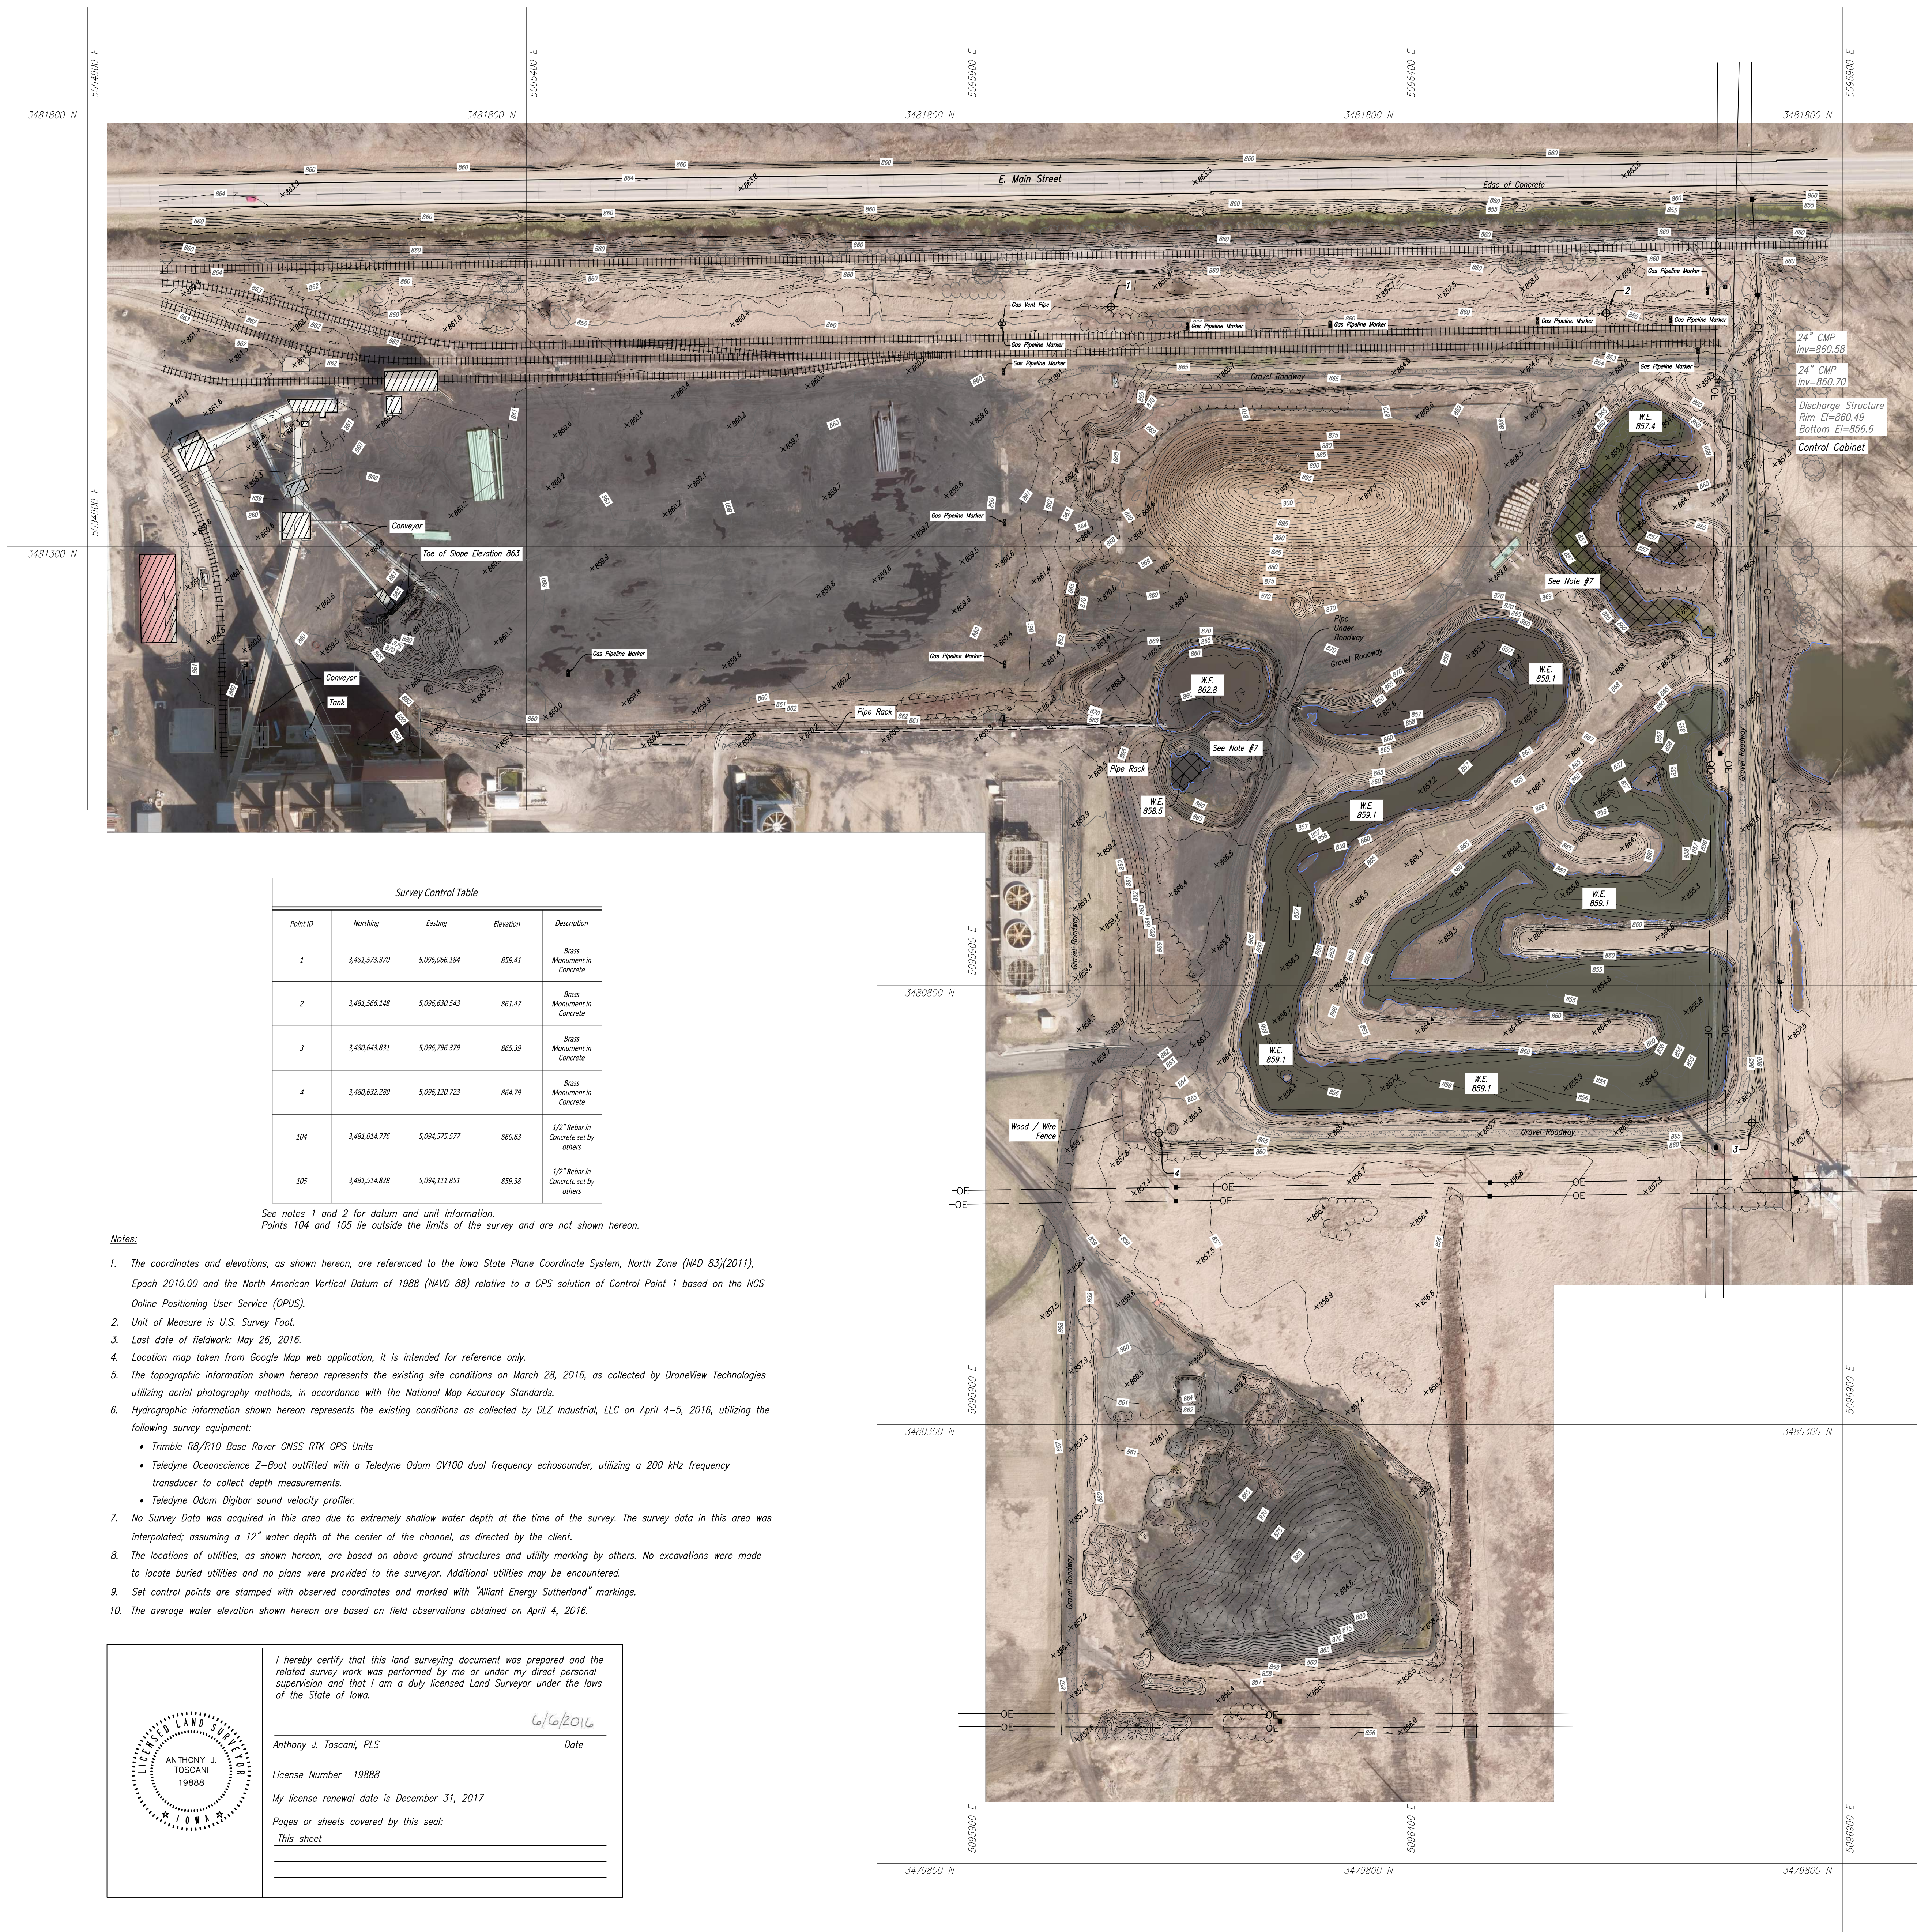
- Topographic Survey (2016) - Drawing prepared by DLZ identifies existing conditions of the CCR surface impoundments at the time the survey was completed in 2016. Drawing identifies topographic contours of the area, as well as locations of existing hydraulic structures (Appendix G).
