**Subject: Phase 2, Modules 10 and 11 Liner Construction Documentation Report
Addendum #1
Dry Ash Disposal Facility (WDNR License #3025)
Wisconsin Power and Light Company – Columbia Energy Center
Portage, Wisconsin**

Construction Documentation Report Addendum No.1

Phase 2, Modules 10 and 11 Liner Construction
Columbia Dry Ash Disposal Facility
Pardeeville, Wisconsin

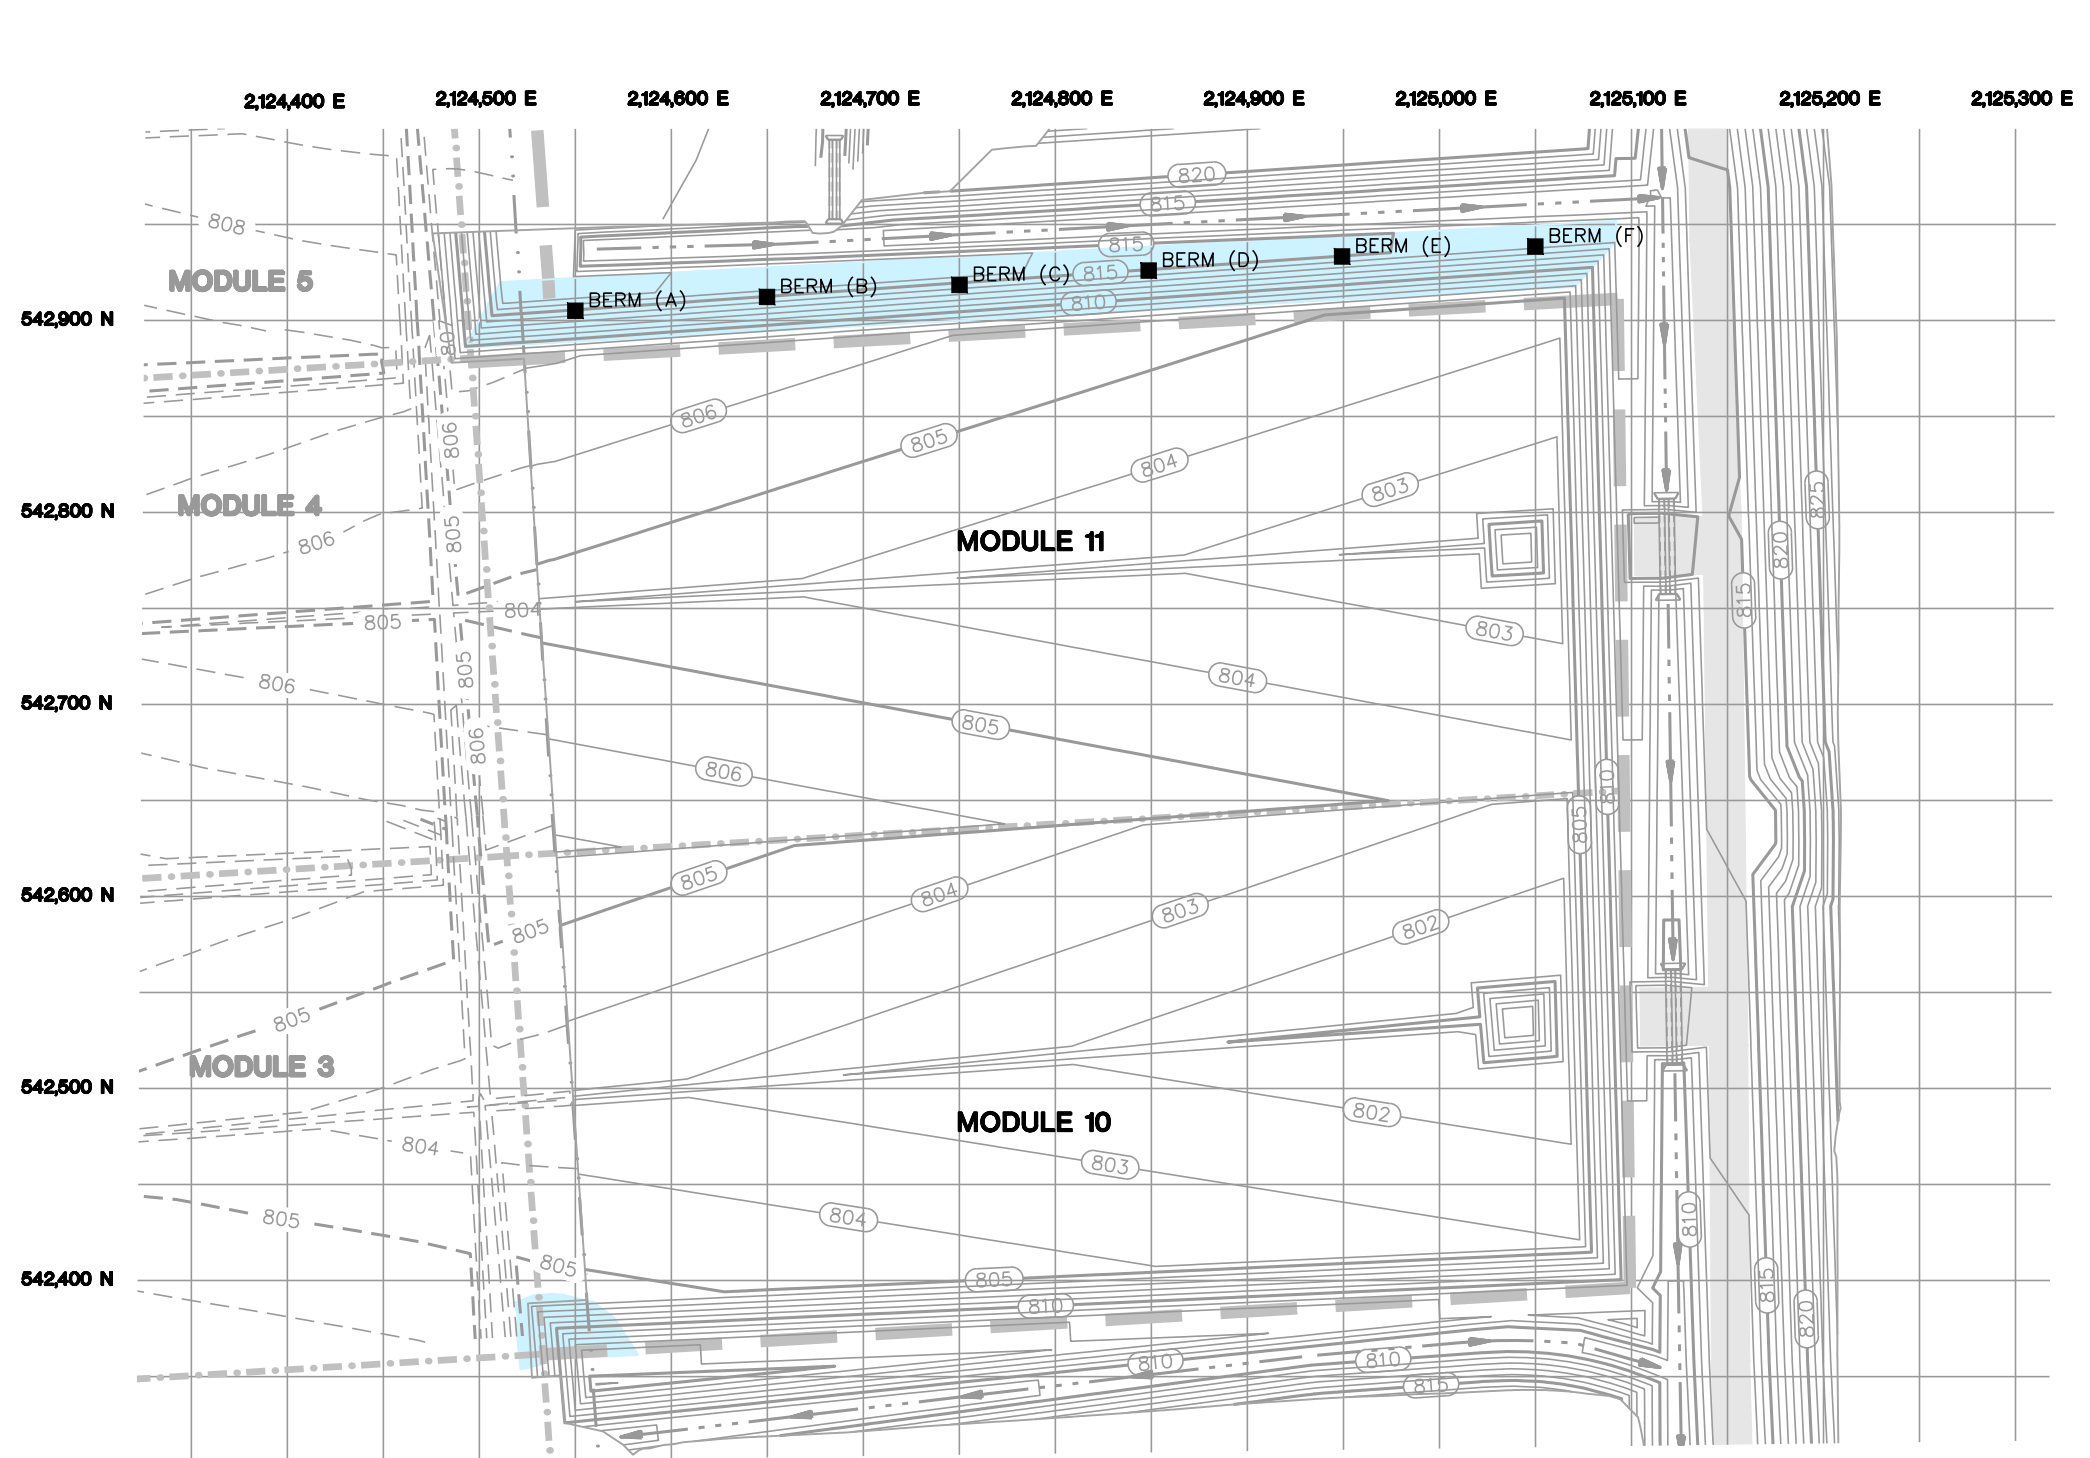
- NOTES:**
1. CONTOURS REPRESENT PROPOSED MODULE 10/11 BASE GRADES AND PERIMETER GRADES.
 2. DASHED CONTOURS REPRESENT DOCUMENTED BASE GRADES IN MODULES 3, 4, AND 5.
 3. DENSITY TESTING IN THE SOUTHWEST CORNER OF MODULE 10 ARE PROVIDED AS SEC LOCATIONS IN TABLE 2.

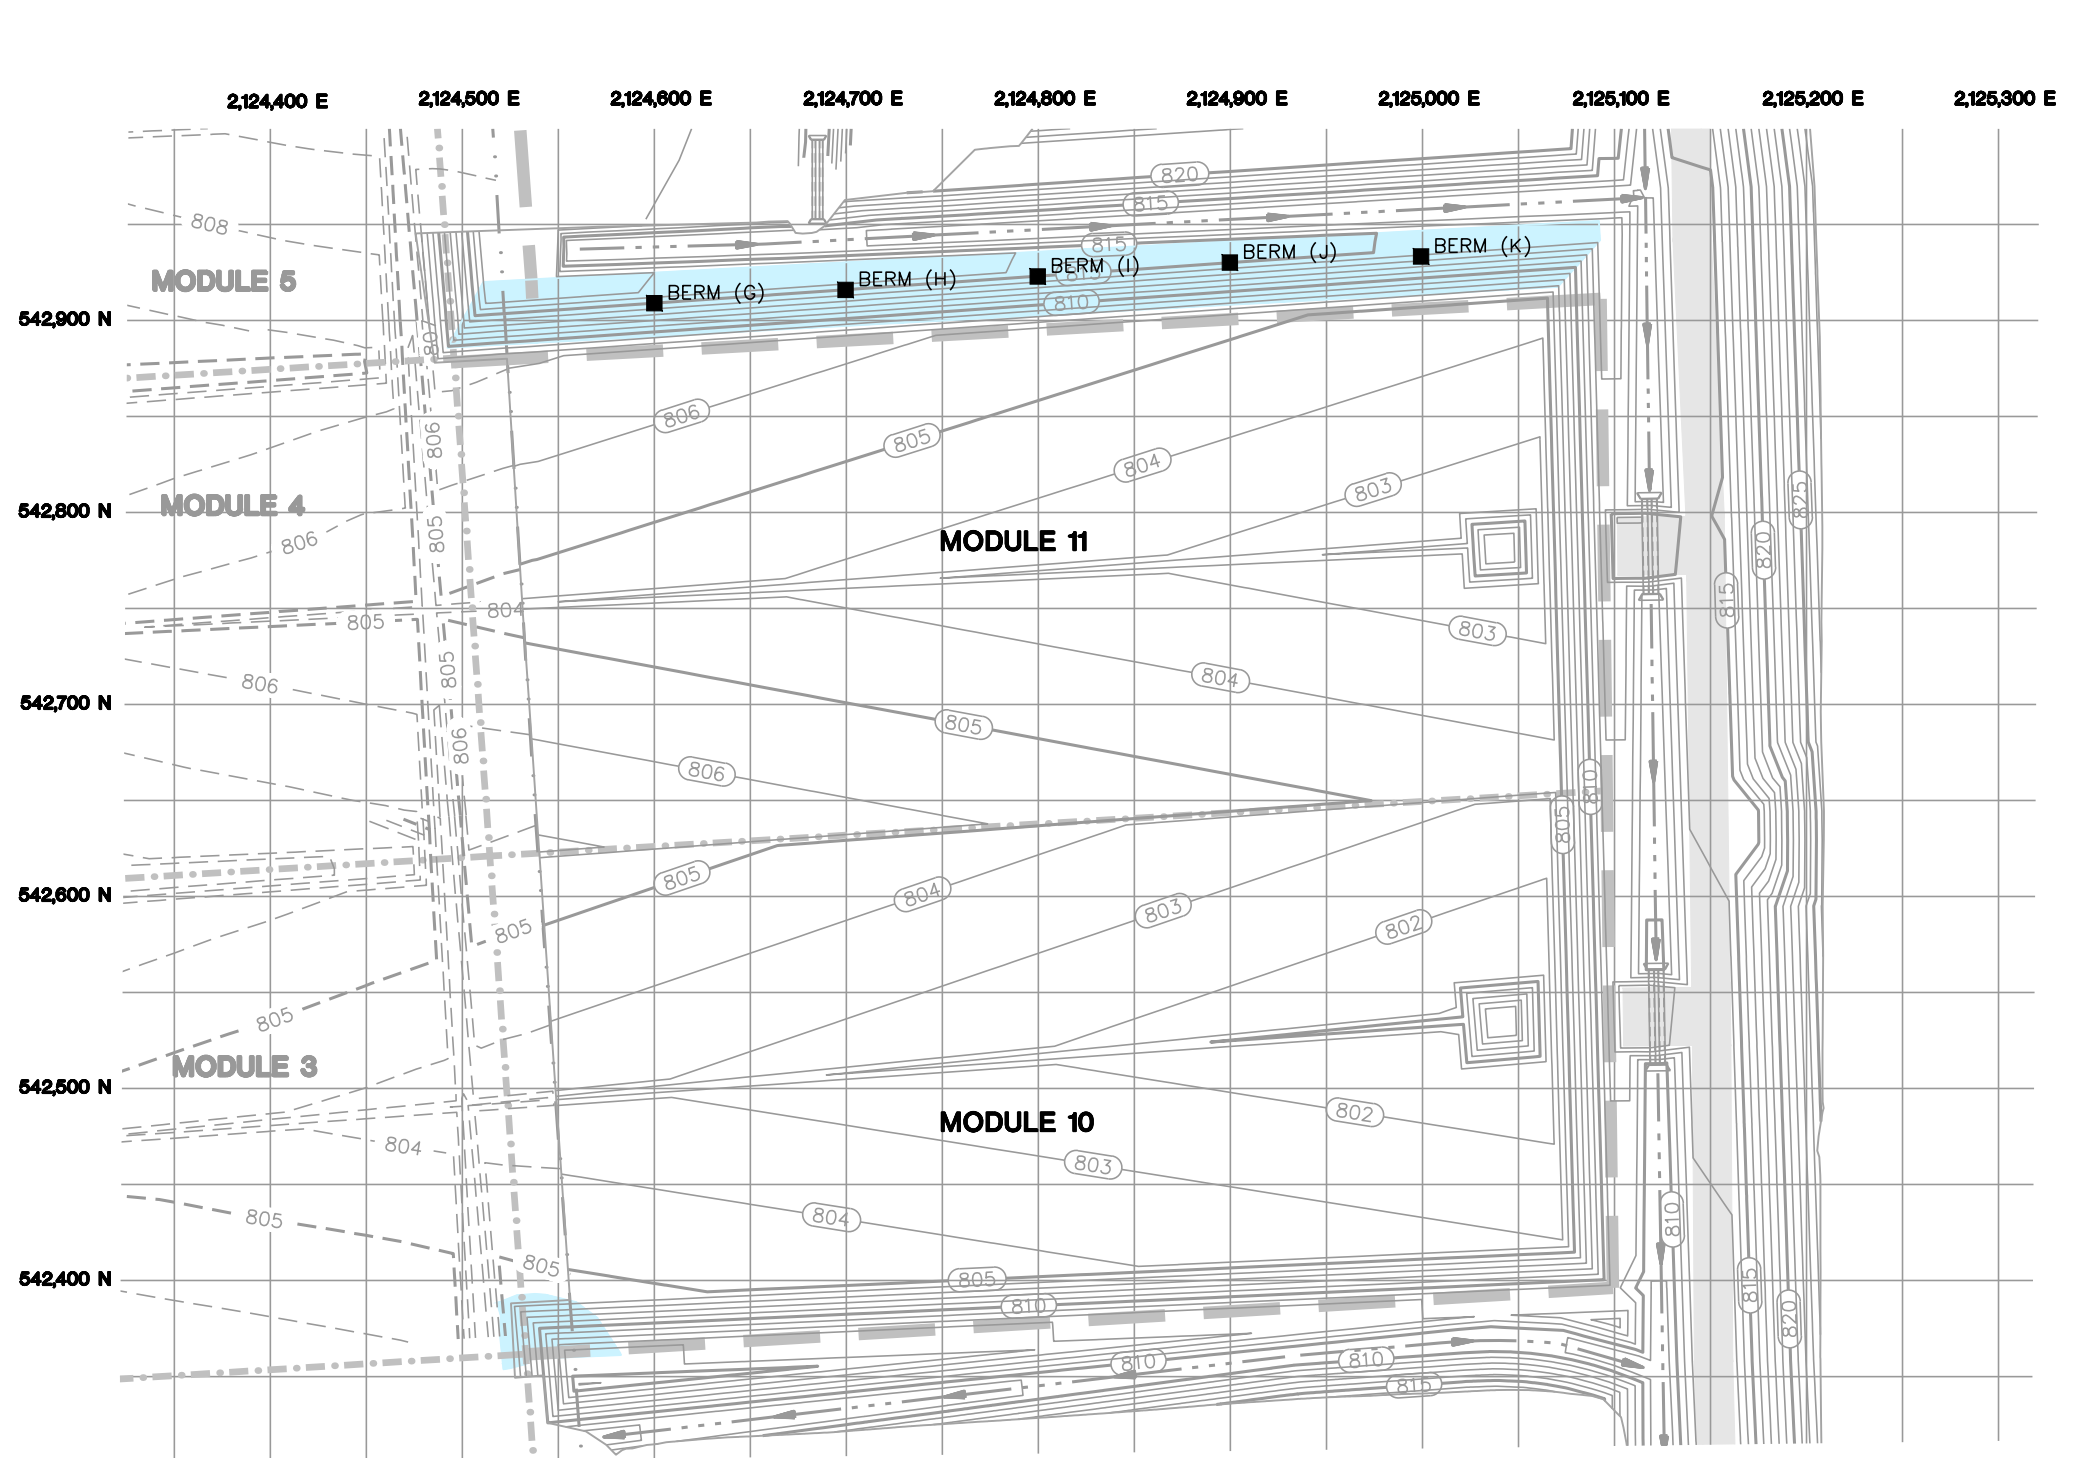
- NOTES:
1. CONTOURS REPRESENT PROPOSED MODULE 10/11 BASE GRADES AND PERIMETER GRADES.
 2. DASHED CONTOURS REPRESENT DOCUMENTED BASE GRADES IN MODULES 3, 4, AND 5.
 3. DENSITY TESTING IN THE SOUTHWEST CORNER OF MODULE 10 ARE PROVIDED AS SEC LOCATIONS IN TABLE 2.

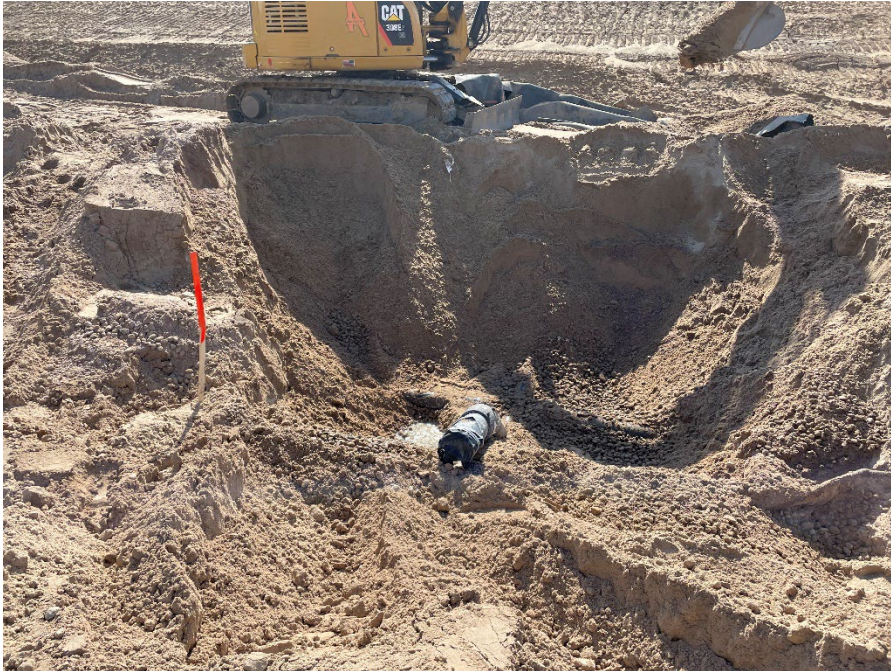
Photo 5: Removing and capping the leachate cleanout risers in Modules 3 and 4.
(Looking west)
(4/27/2023)

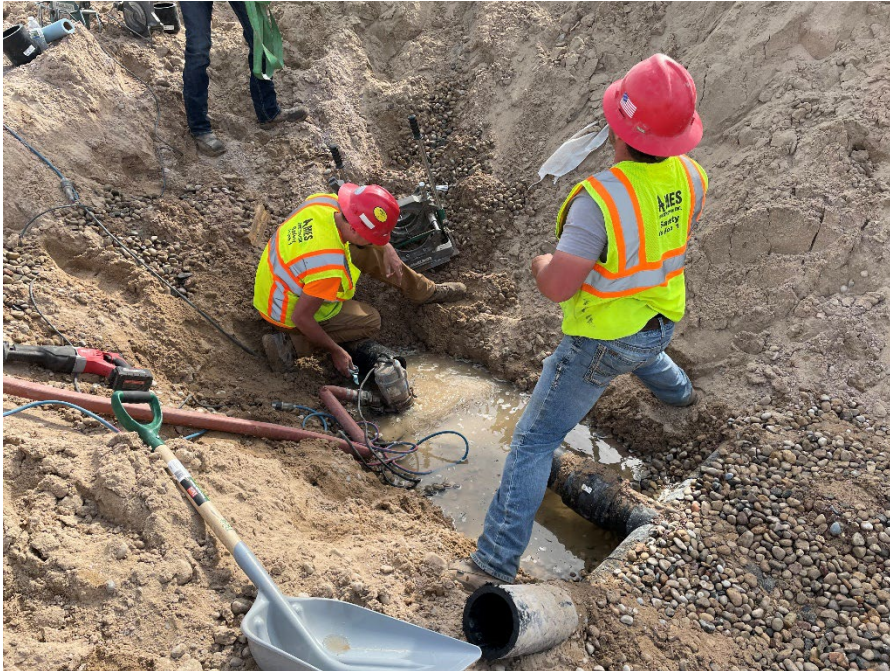
Photo 7: Removing an approximate 3-foot section of the leachate collection piping south of the “T” in Module 4.
(Looking down)
(4/28/2023)

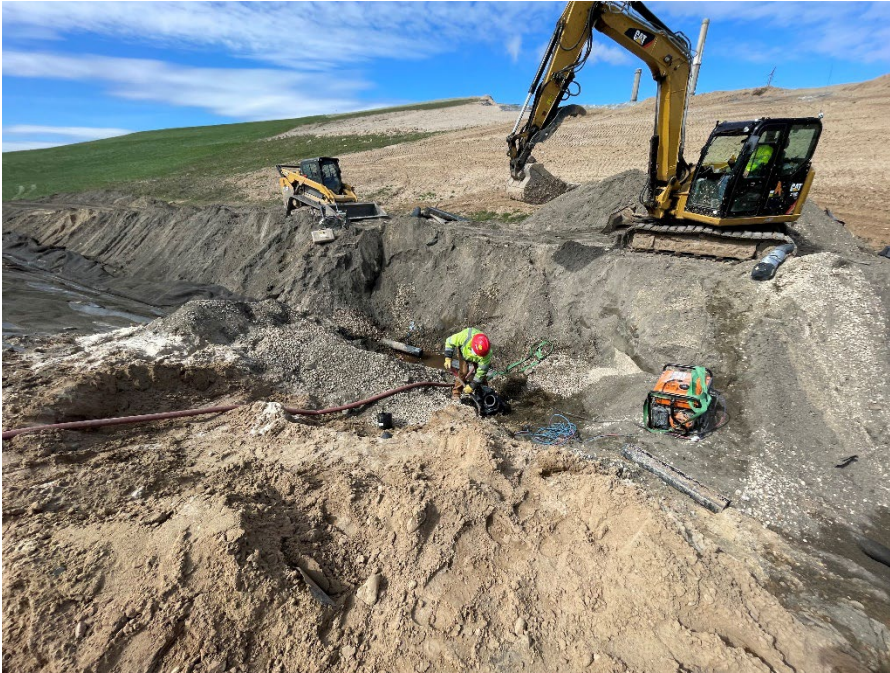
Photo 9: Removing an approximate 3-foot section of the leachate collection piping south of the Module 3 “T”.
(Looking southwest)
(5/2/2023)

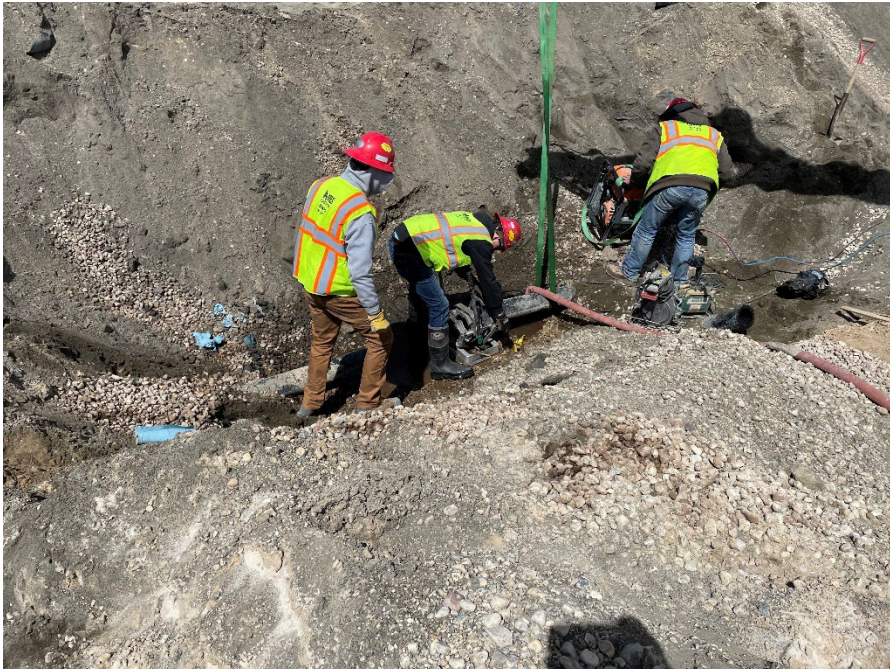
Photo 12: Fusion welding the caps on the leachate collection pipes and cleanout risers in Module 3 at leachate header plug location. (Looking northwest) (5/2/2023).

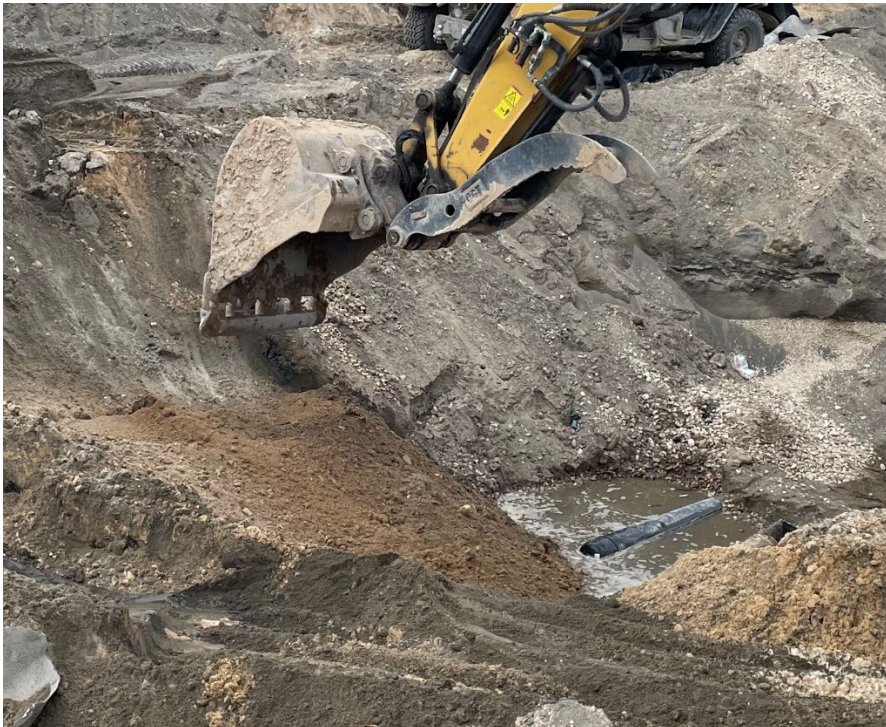
Photo 14: Placement of bentonite mixed sand for the leachate header plug. (Looking northwest) (5/2/2023)

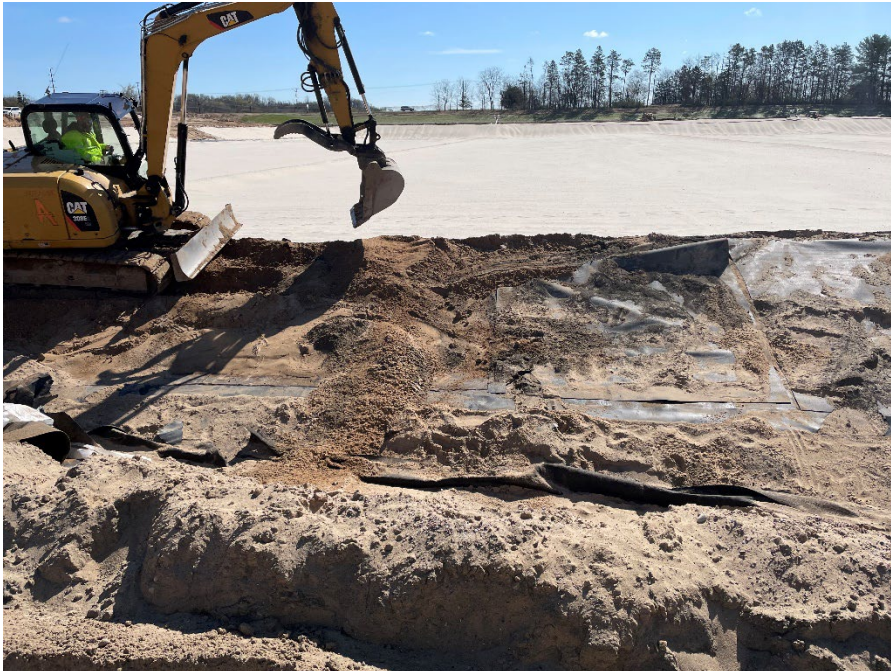
Photo 16: Removing the geomembrane flap on the berm between Modules 3/4 and 10/11. (Looking west) (5/3/2023)

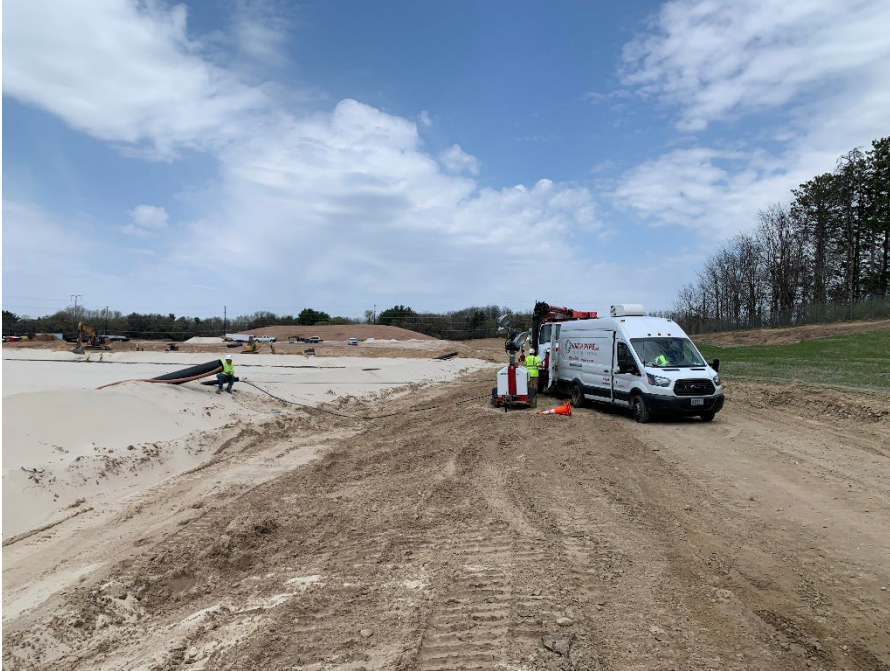
Photo 19: Jetting and televising the leachate collection pipes in Modules 10 and 11. (Looking north) (5/4/2023)

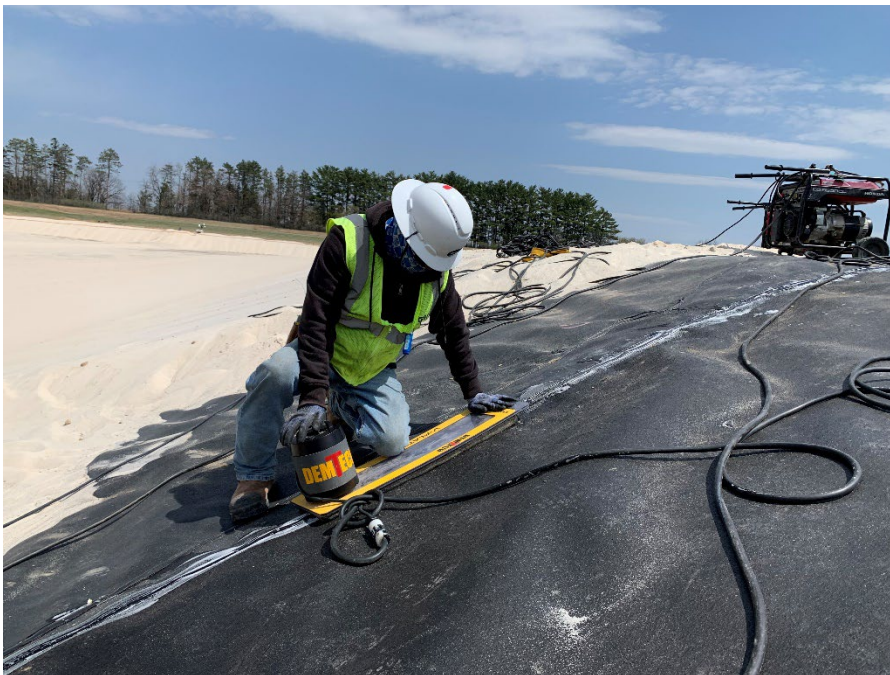
Photo 26: Vacuum box testing of extrusion seams. (Looking east) (5/4/2023)

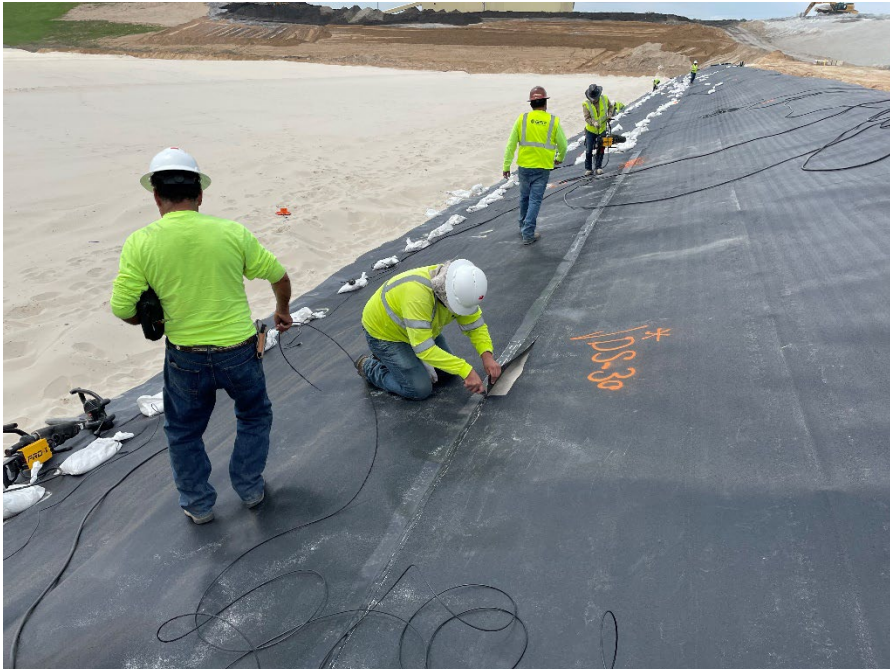
Photo 28: Collecting geomembrane destruct samples. (Looking west) (5/5/2023)

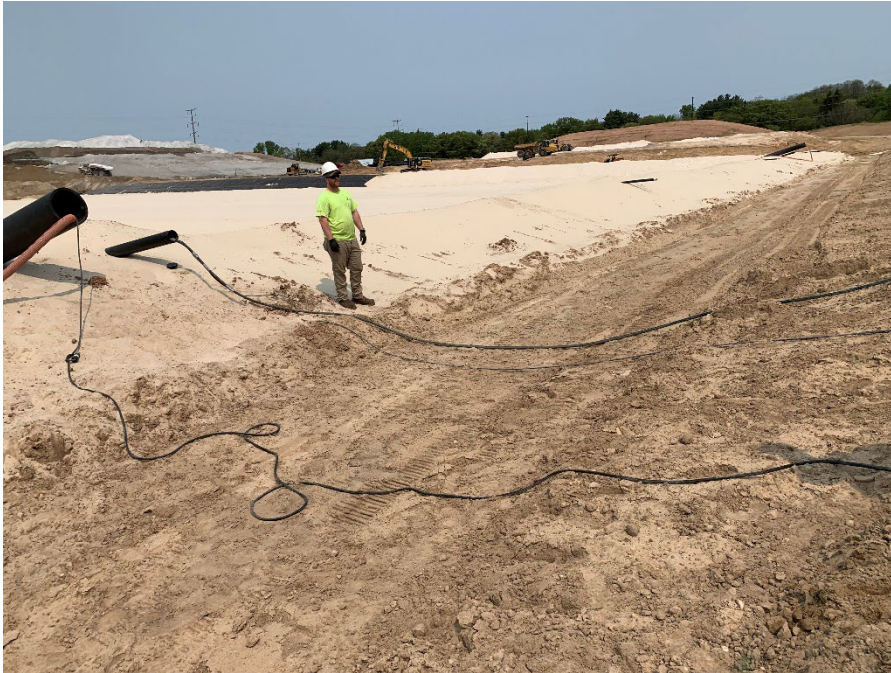
Photo 39: Re-televising the leachate collection pipes in Modules 10 and 11.
(Looking northwest)
(5/18/2023)

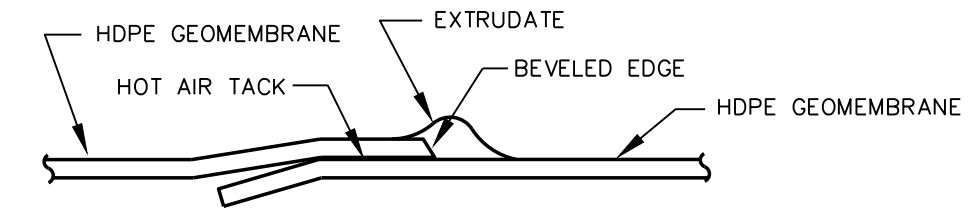
1
6
EXTRUSION WELD
(NOT TO SCALE)

NOTES:
1. EXCLUSIVELY EXTRUSION WELDS WERE USED FOR TEMPORARY GEOMEMBRANE INSTALLATION AND REPAIRS.

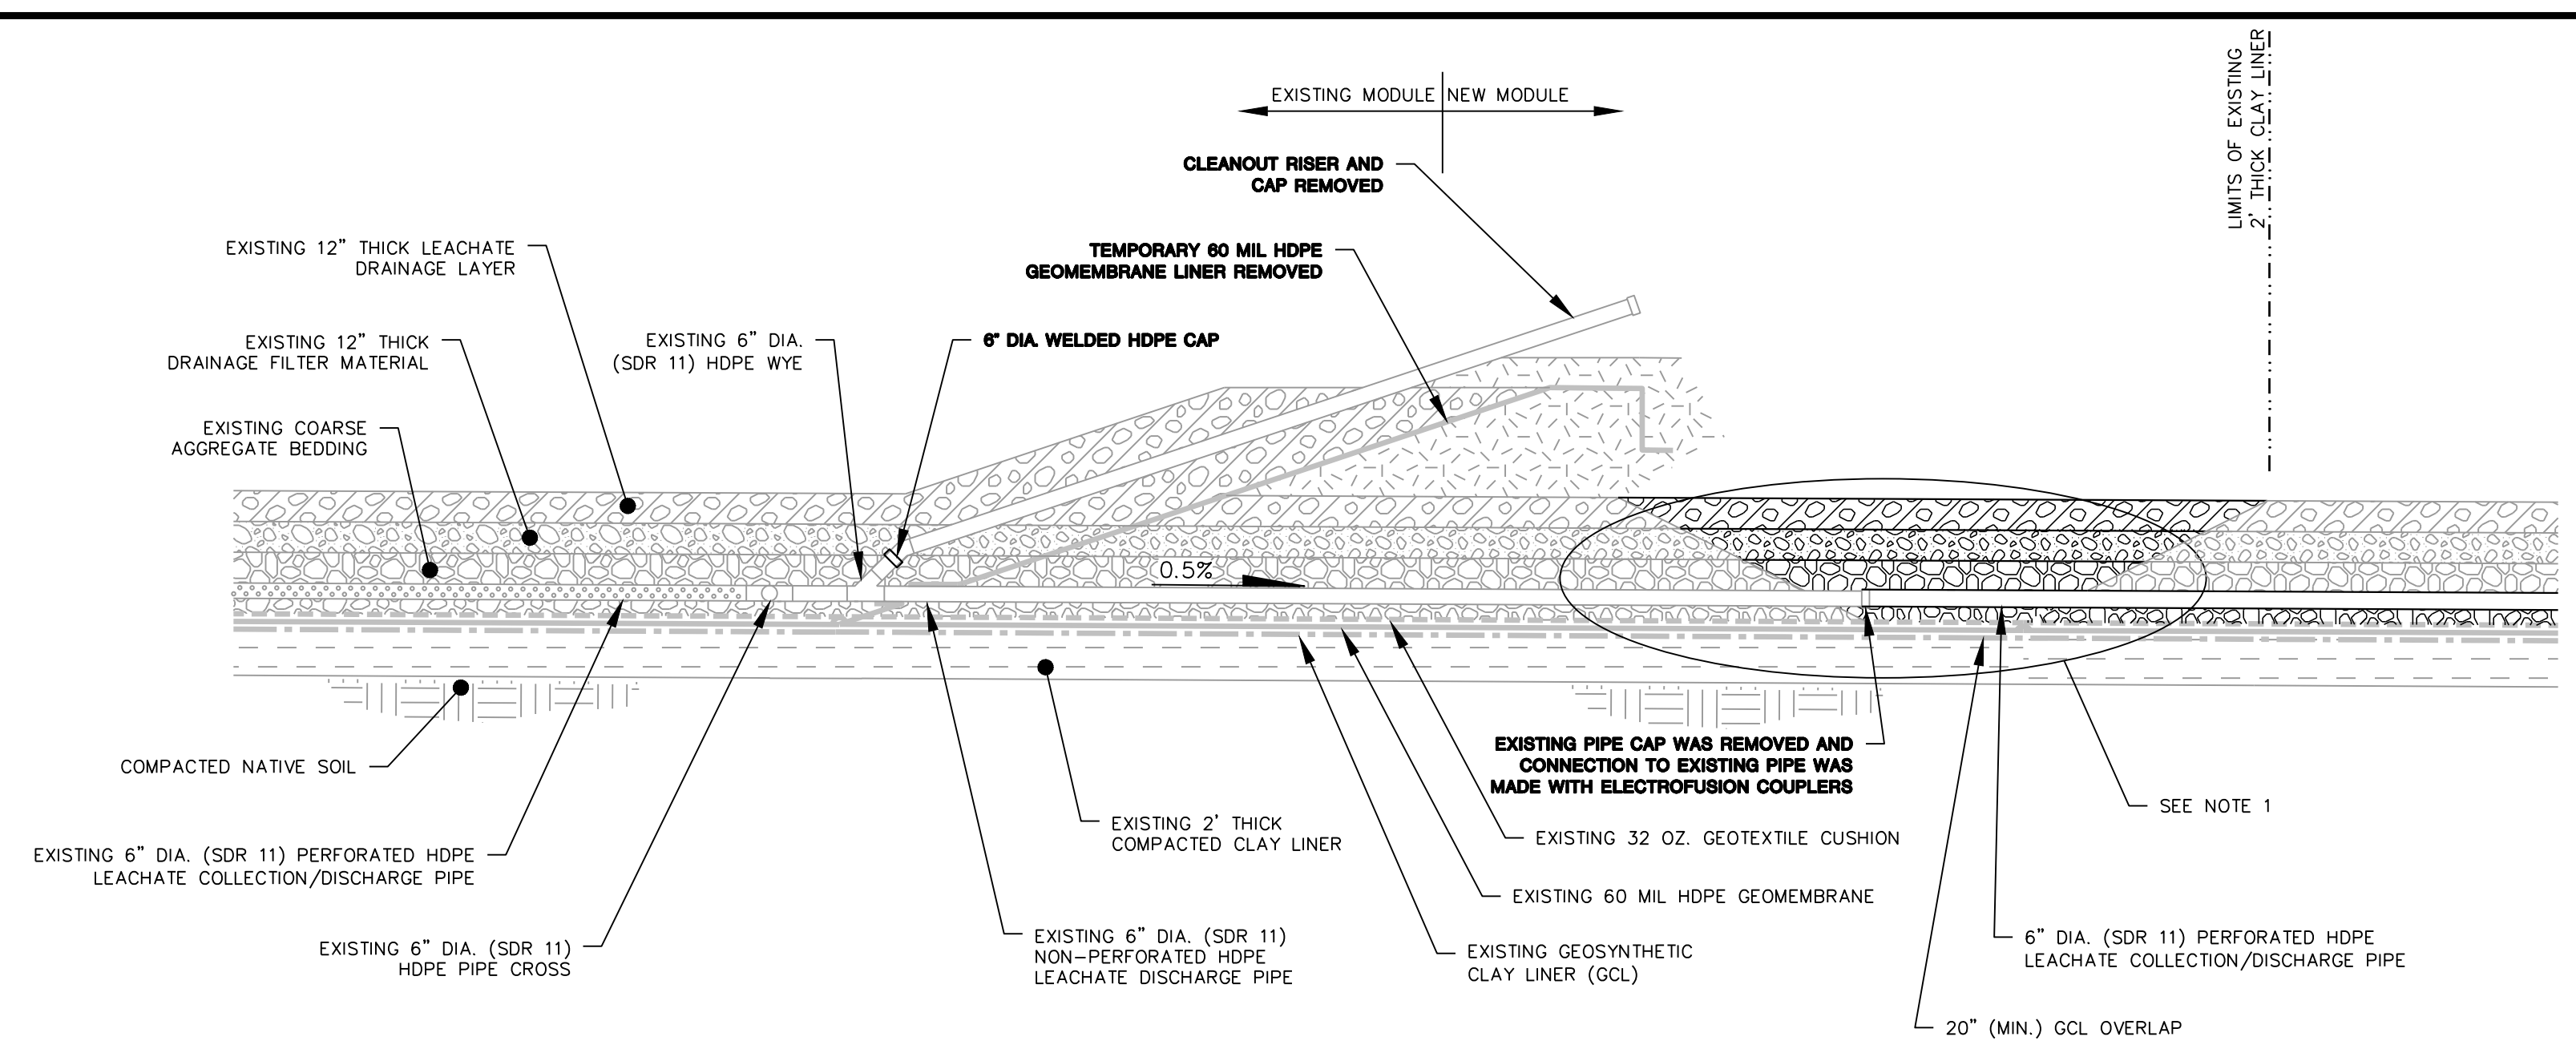
1
3 **MODULE 3-4 - MODULE 10-11 TIE-IN**
 SCALE: 1" = 5'

NOTES:
 1. LEACHATE DRAINAGE MATERIAL, DRAINAGE FILTER MATERIAL, AND COARSE AGGREGATE BEDDING WERE PLACED AFTER PIPE CONNECTION WAS MADE.

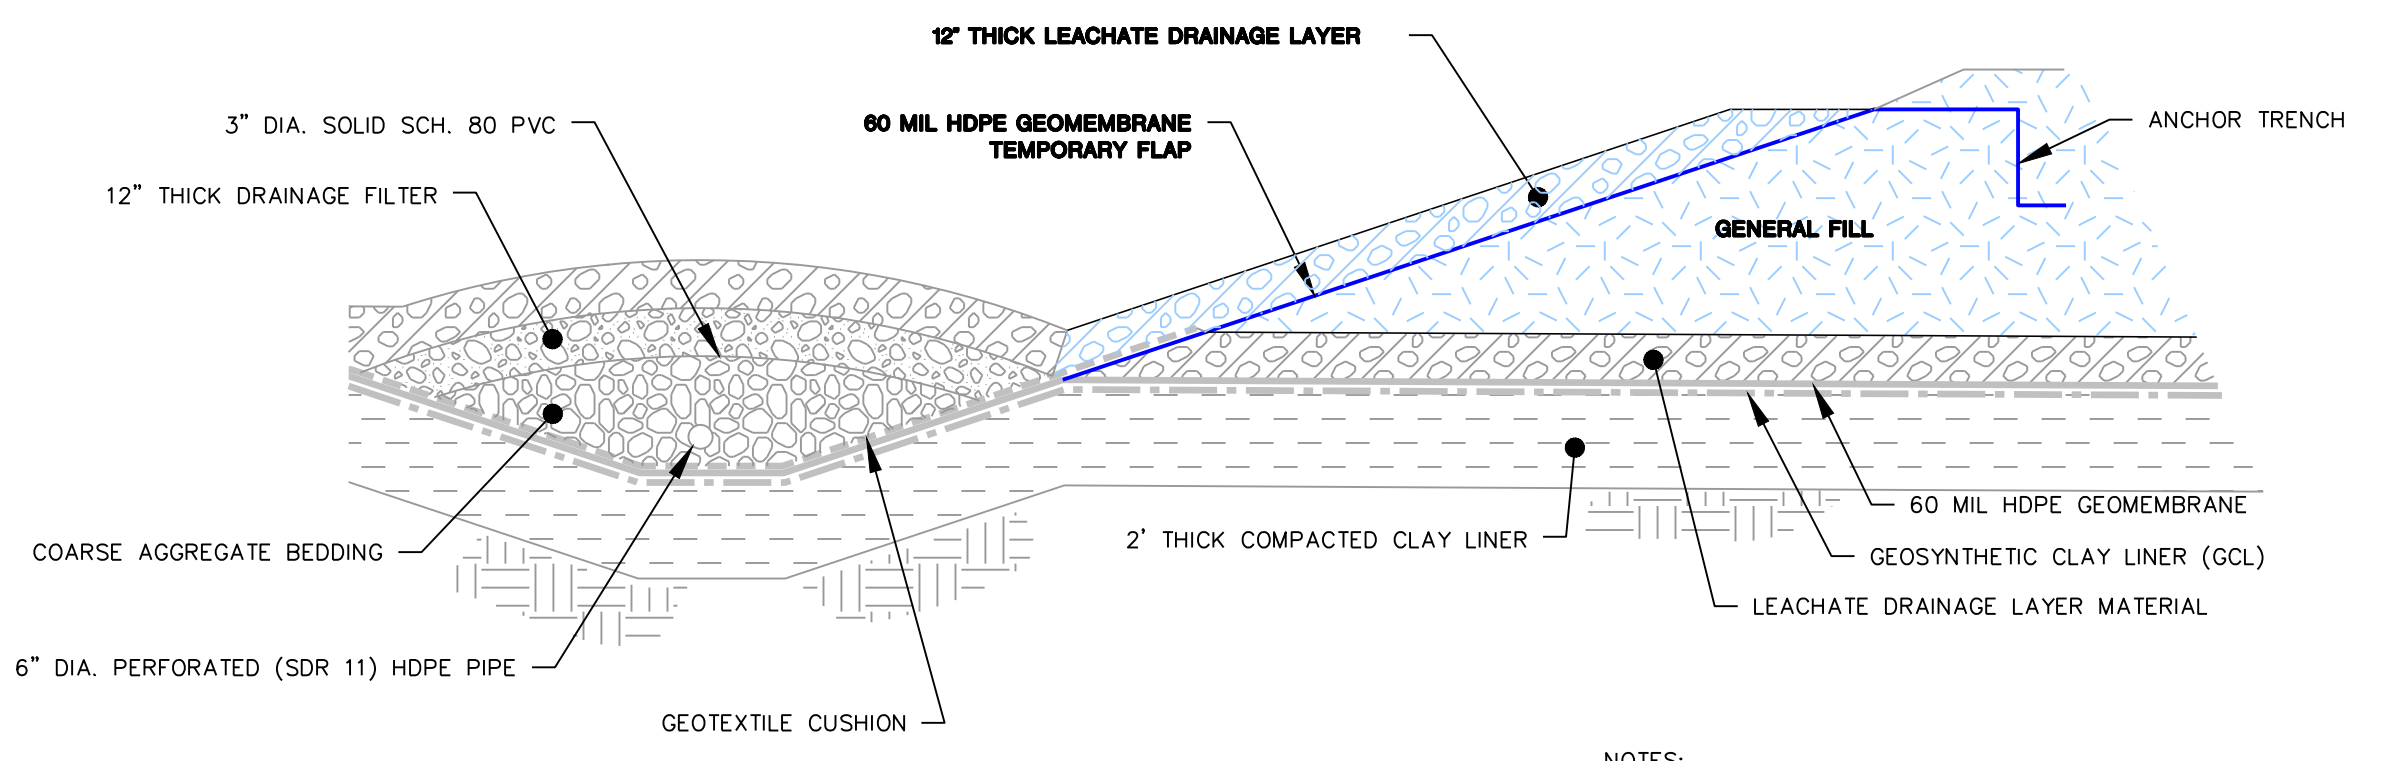
5
3 **TEMPORARY FLAP CONNECTIONS TO MODULE 10 AND 11**
 SCALE: 1" = 4'

NOTES:
 1. SIDE SLOPE DRAINAGE LAYER, GEOMEMBRANE AND GENERAL FILL MATERIALS WERE REMOVED AND REPLACED, AS NECESSARY, IN ORDER TO TIE-IN TO MODULE 10 & 11 CONSTRUCTED MATERIALS.
