**ALLIANT ENERGY
Wisconsin Power and Light Company
Edgewater Generating Station**

CCR SURFACE IMPOUNDMENT

STRUCTURAL STABILITY ASSESSMENT

Report Issued: September 21, 2016
Revision 0

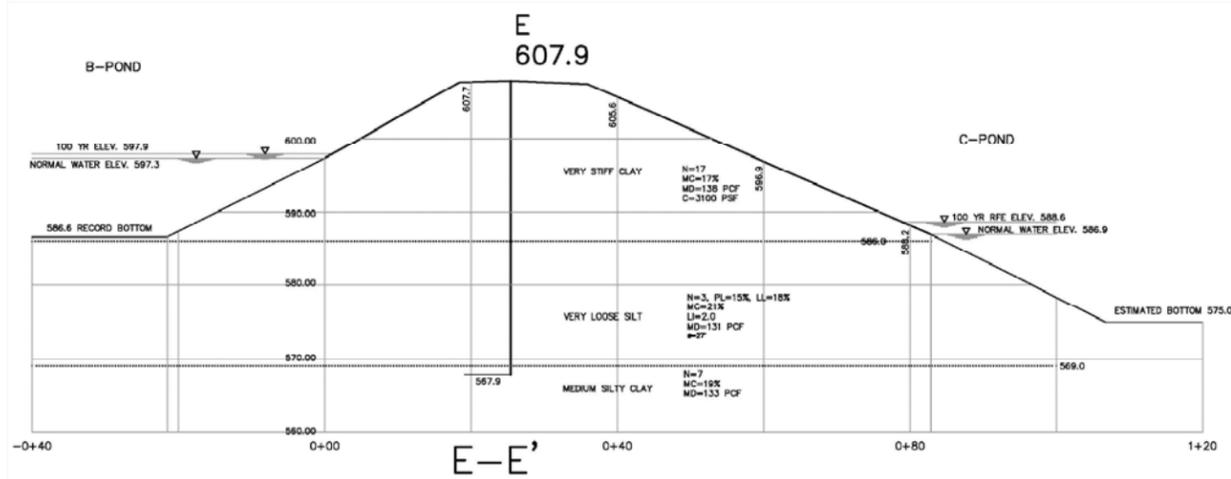
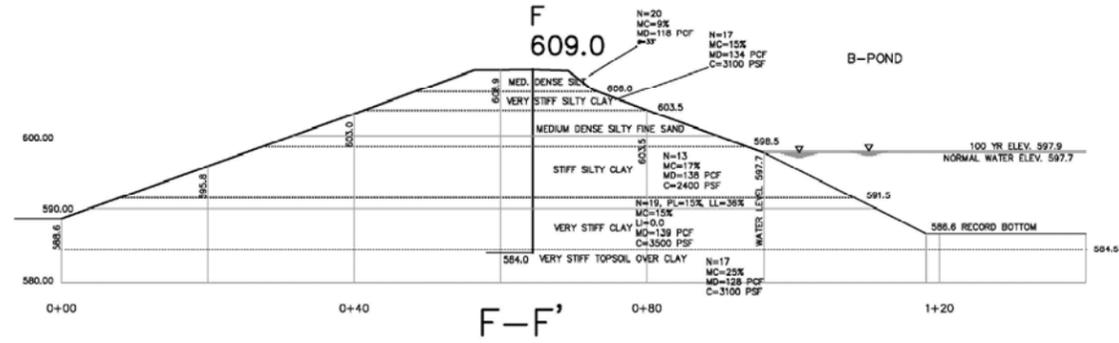
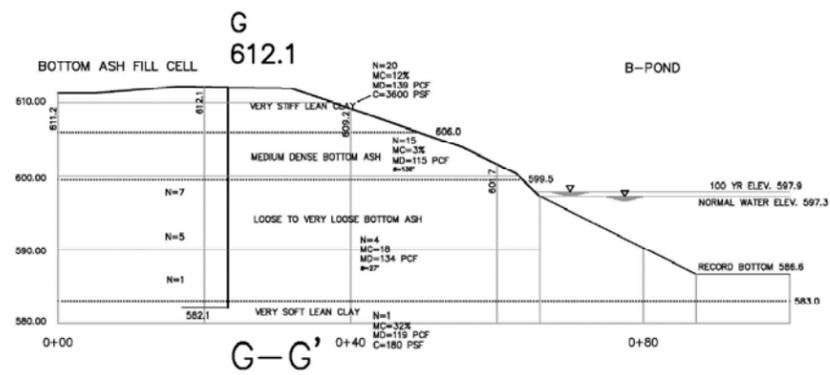
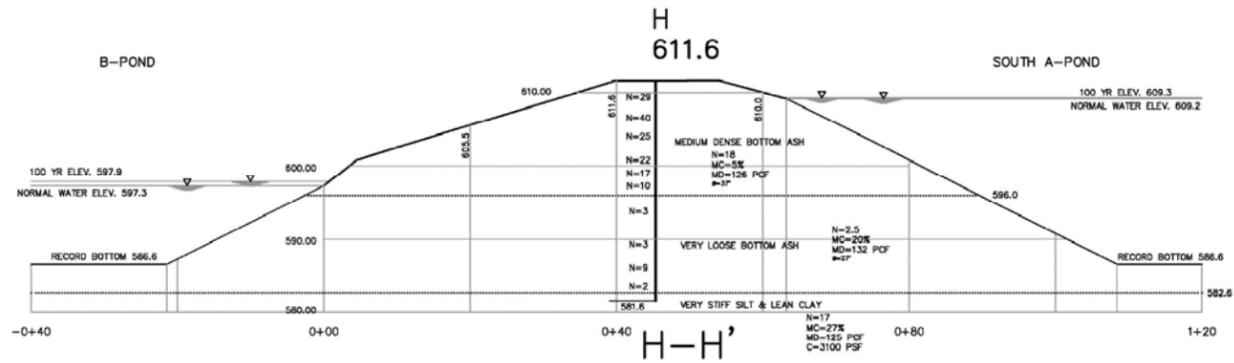
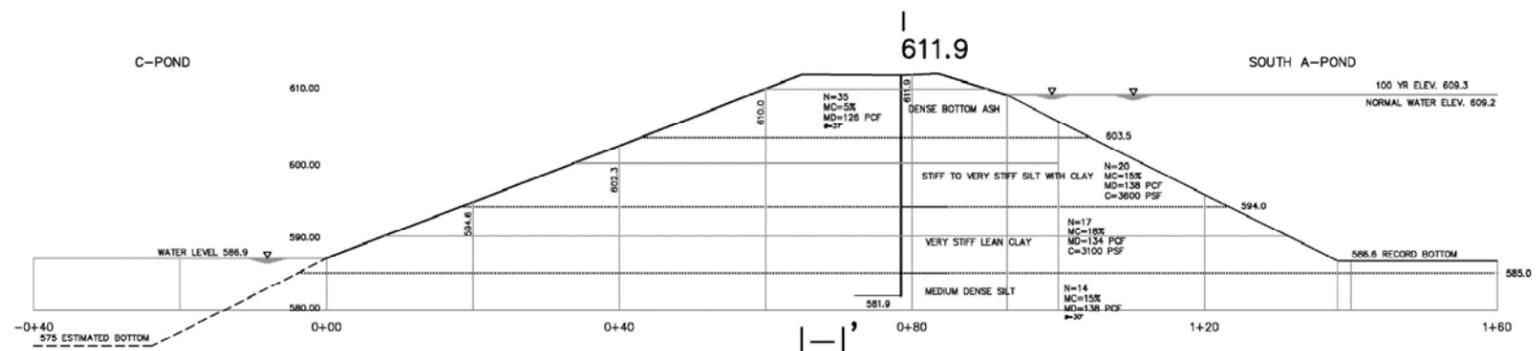
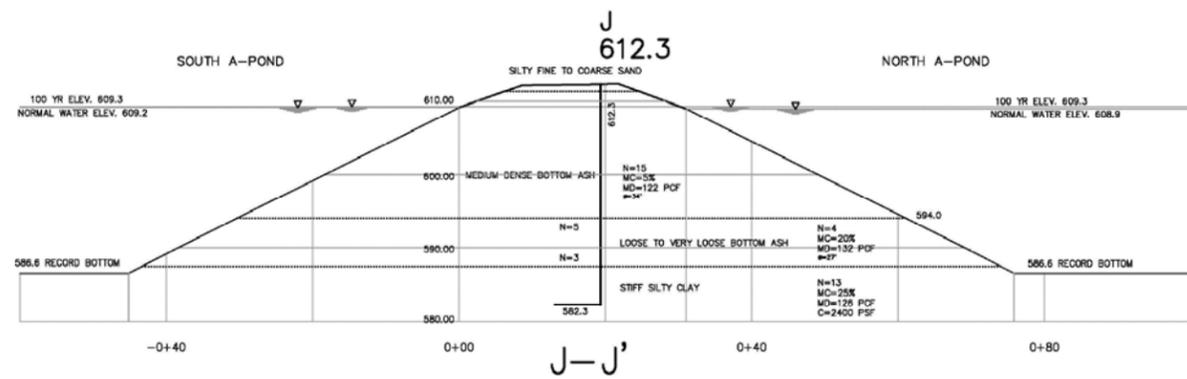
JOB 154.018.012.006
 SHT. FIGURE 3
 DWG. -----

The EDG South A-Pond is constructed between the EDG North A-Pond and the EDG B-Pond, Figure 2. The Pond has exterior embankments constructed of compacted clay on the east side of the Pond, Figures 3 and 5, is separated from EDG North A-Pond to the north by an interior embankment constructed of bottom ash, Figure 3, and is incised into

The embankment soil is stiff to very stiff low plasticity clay (CL) or (CL-ML) below elevation 603.5 and dense bottom ash to the crest at approximately elevation 612 feet. The foundation soil under the compacted clay embankment inferred from the nearest boring into the foundation soil (boring R and E, Appendix B, is loose silt (ML) which is underlain by medium stiff clay (CL). The crest of the EDG South A-Pond embankment is 4 foot higher than the embankment of the EDG B-Pond.

The EDG B-Pond is constructed in the southeast corner of the CCR management area located west of Lake Shore Drive, Figure 2. The impoundment has exterior embankments constructed of compacted clay on the east side of the impoundment, Figures 3 and 5, is separated from EDG South A-Pond to the north by an interior embankment constructed of bottom ash, Figure 3, and is incised into a CCR landfill area to the west.

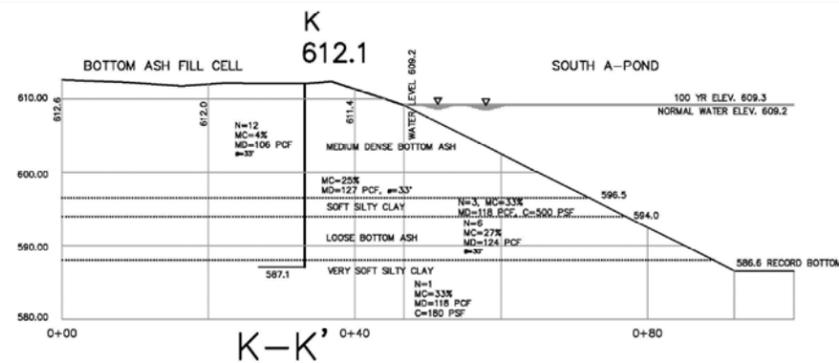
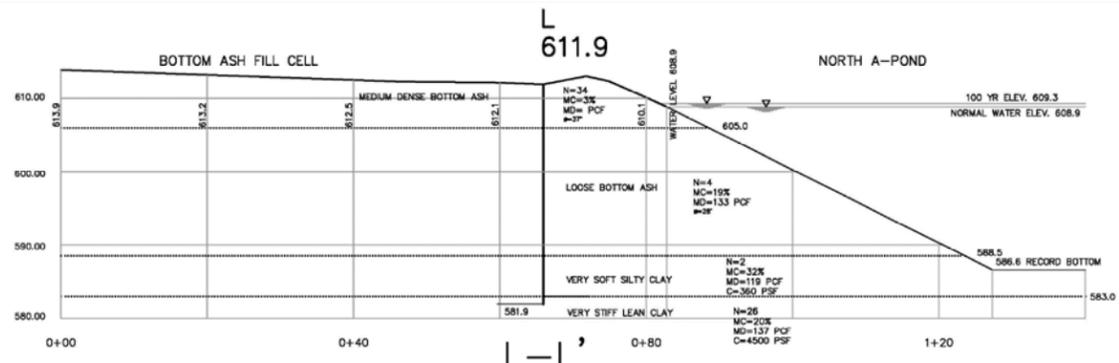
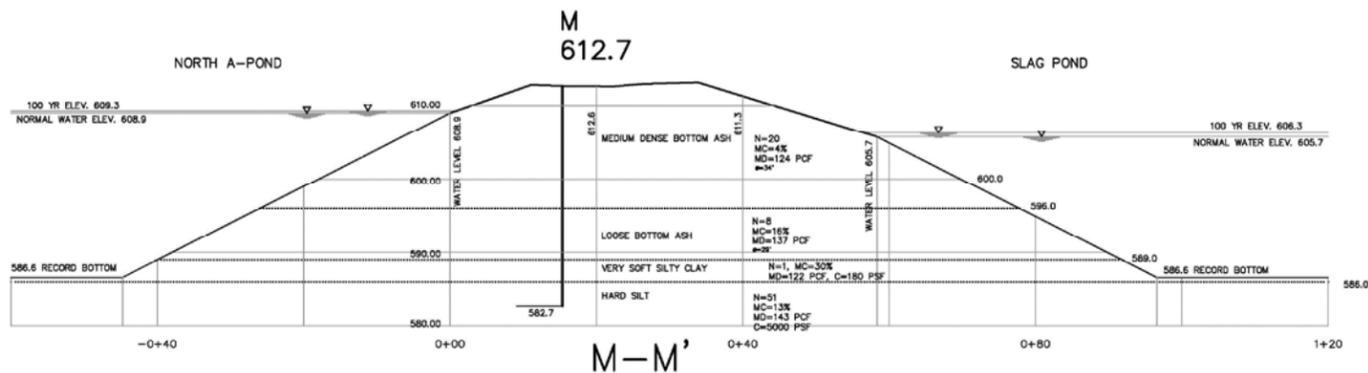
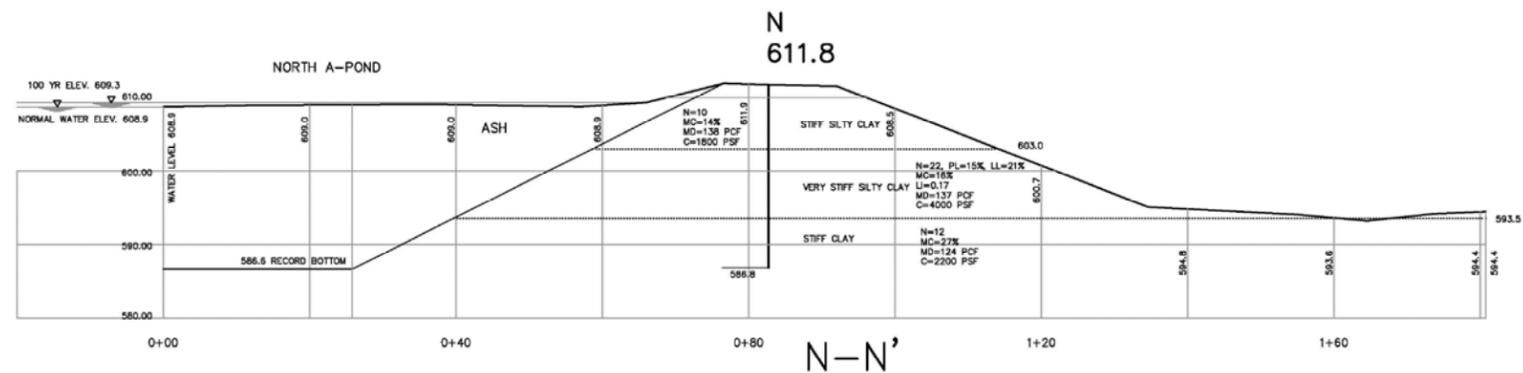
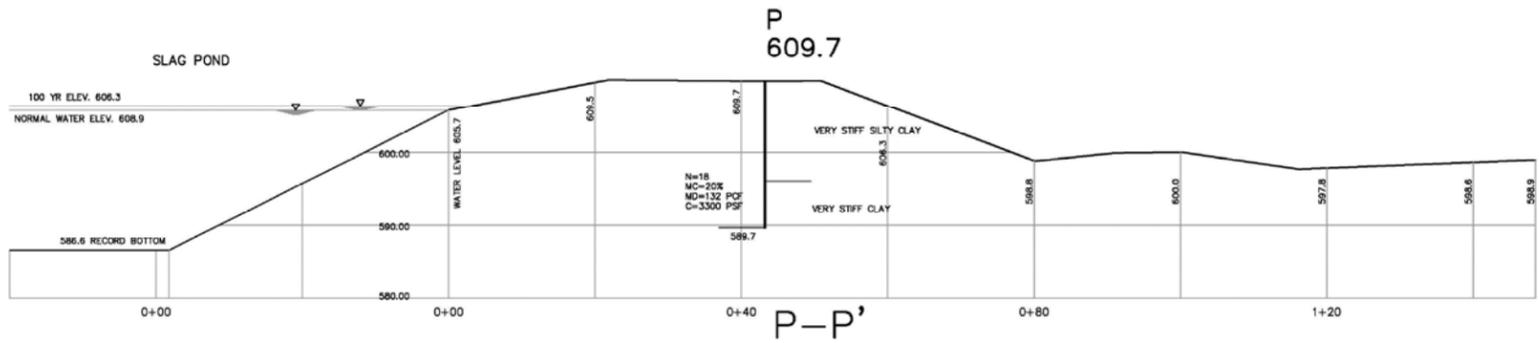
JOB 154.018.012.006
 SHT. FIGURE 4
 DWG. -----

The EDG Slag Pond is constructed in the northeast corner of the CCR management area located west of Lake Shore Drive, Figure 2. The impoundment has exterior embankments constructed of compacted clay on the north and east sides of the Impoundment, Figure 4, is separated from EDG North A-Pond to the south by an interior embankment constructed of bottom ash, Figure 4, and is incised into a CCR landfill area to the west.

The embankment soil is stiff to very stiff low plasticity clay (CL) or (CL-ML). The foundation soil under the compacted clay embankment inferred from the nearest boring into the foundation soil (boring R, Appendix B, is loose silt (ML) which is underlain by medium stiff clay (CL). The crest of the EDG Slag Pond embankment is 2 foot lower than the embankment separating the EDG Slag Pond from the North A-Pond.

The impoundment has a single exterior embankments constructed of compacted clay on the east side of the impoundment, Figure 4, and is separated from EDG South A-Pond and the EDG Slag Pond by an interior embankments constructed of bottom ash, Figure 4, and is incised into a CCR landfill area to the west.

The embankment soil is very stiff low plasticity clay (CL) or (CL-ML). The foundation soil under the compacted clay embankment inferred from the nearest boring into the foundation soil (boring R, Appendix B, is loose silt (ML) which is underlain by medium stiff clay (CL).
