Interstate Power and Light Company

Burlington Generating Station
CCR Surface Impoundment - Emergency Action Plan
154.018.025.001
Plan issued: April 6, 2017
Version 1.0 - Revision 1.0, April 6, 2022

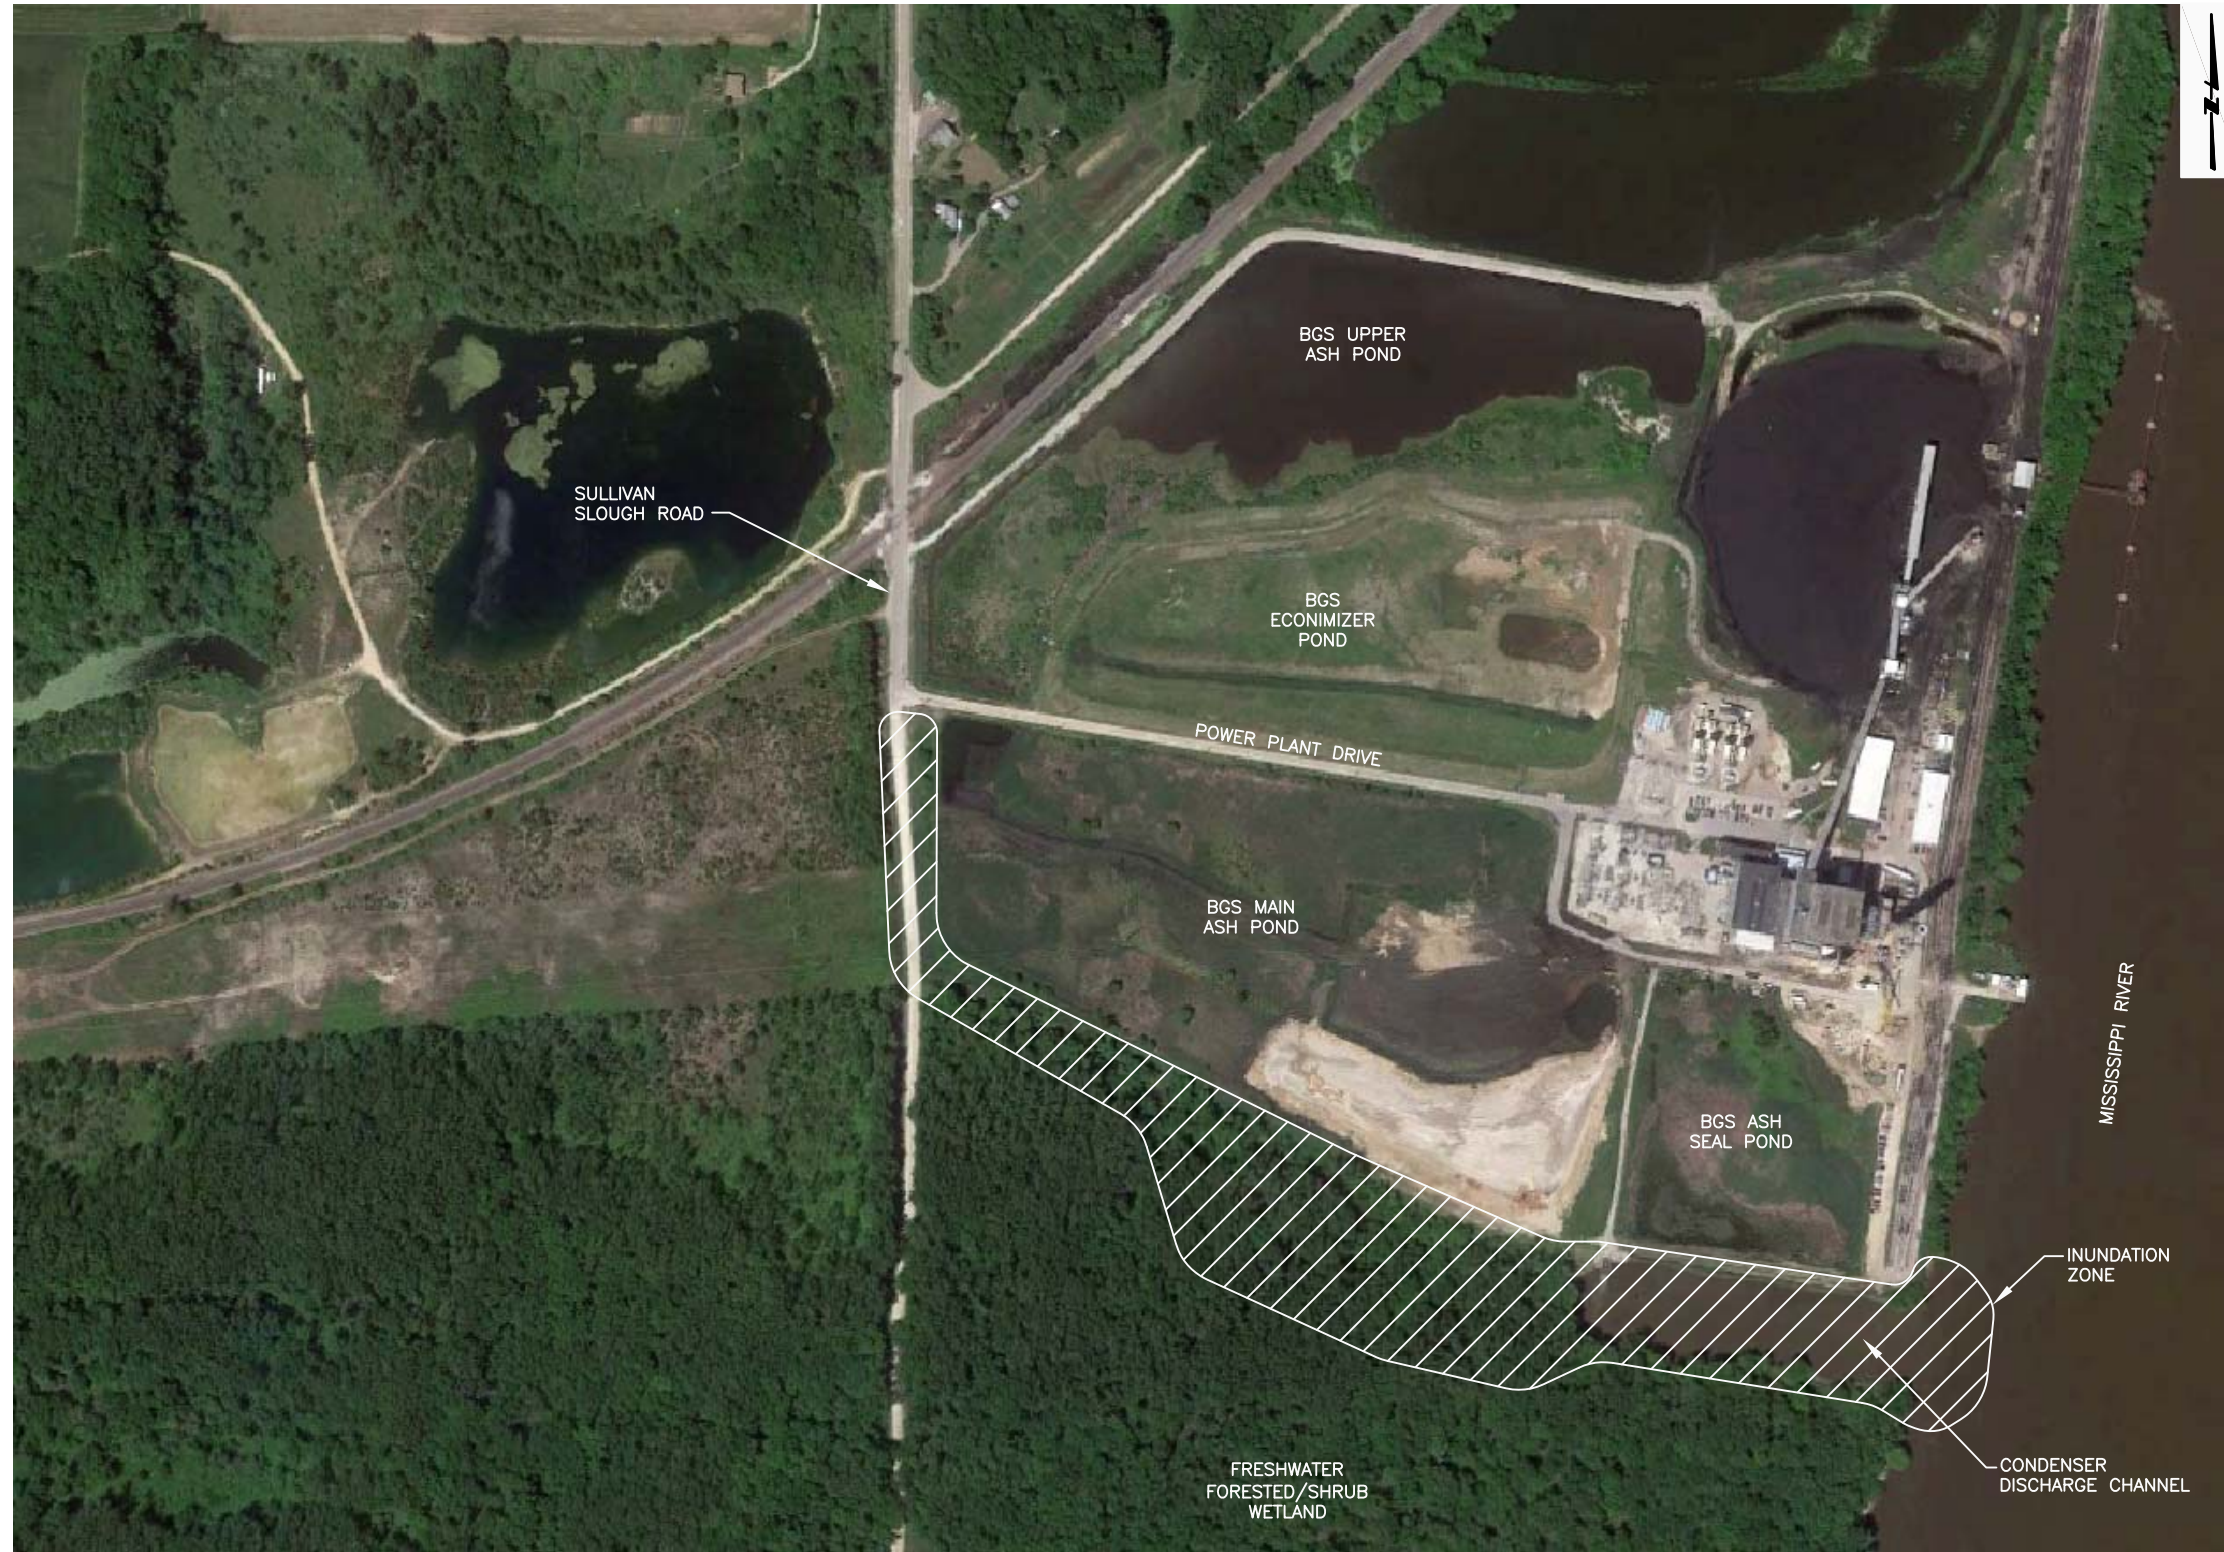
JOB 154.018.015.001
SHT. FIGURE 2
DWG. 154.018.015.001-D2

1. PER THE REQUIREMENTS OF THE CCR RULE (§257.73(A)(3)) AN INUNDATION MAP DELINEATES THE DOWNSTREAM AREAS WHICH WOULD BE AFFECTED IN THE EVENT OF A FAILURE OF A CCR SURFACE IMPOUNDMENT. THE INUNDATION MAP IDENTIFIES CRITICAL INFRASTRUCTURE AND POPULATION-AT-RISK SITES THAT MAY REQUIRE PROTECTIVE MEASURES, WARNING, AND EVACUATION PLANNING.

DRAWING DESCRIPTION
CCR SURFACE IMPOUNDMENT - EMERGENCY ACTION PLAN
INUNDATION MAP

This EAP identifies areas potentially impacted as a result of a failure of a CCR surface impoundment that has been classified as having a significant or high hazard potential. These areas are delineated in an inundation map (Figure 2), which identifies the probable maximum downstream limits that are likely to be impacted by the failure of the CCR surface impoundment. The inundation map shall be used to assist the facility and local emergency responders in the event of a safety emergency event with a potential or imminent failure.
