ALLIANT ENERGY
Interstate Power and Light Company
Lansing Generating Station

CCR SURFACE IMPOUNDMENT

STRUCTURAL STABILITY ASSESSMENT

Report Issued: September 2, 2016
Revision 0

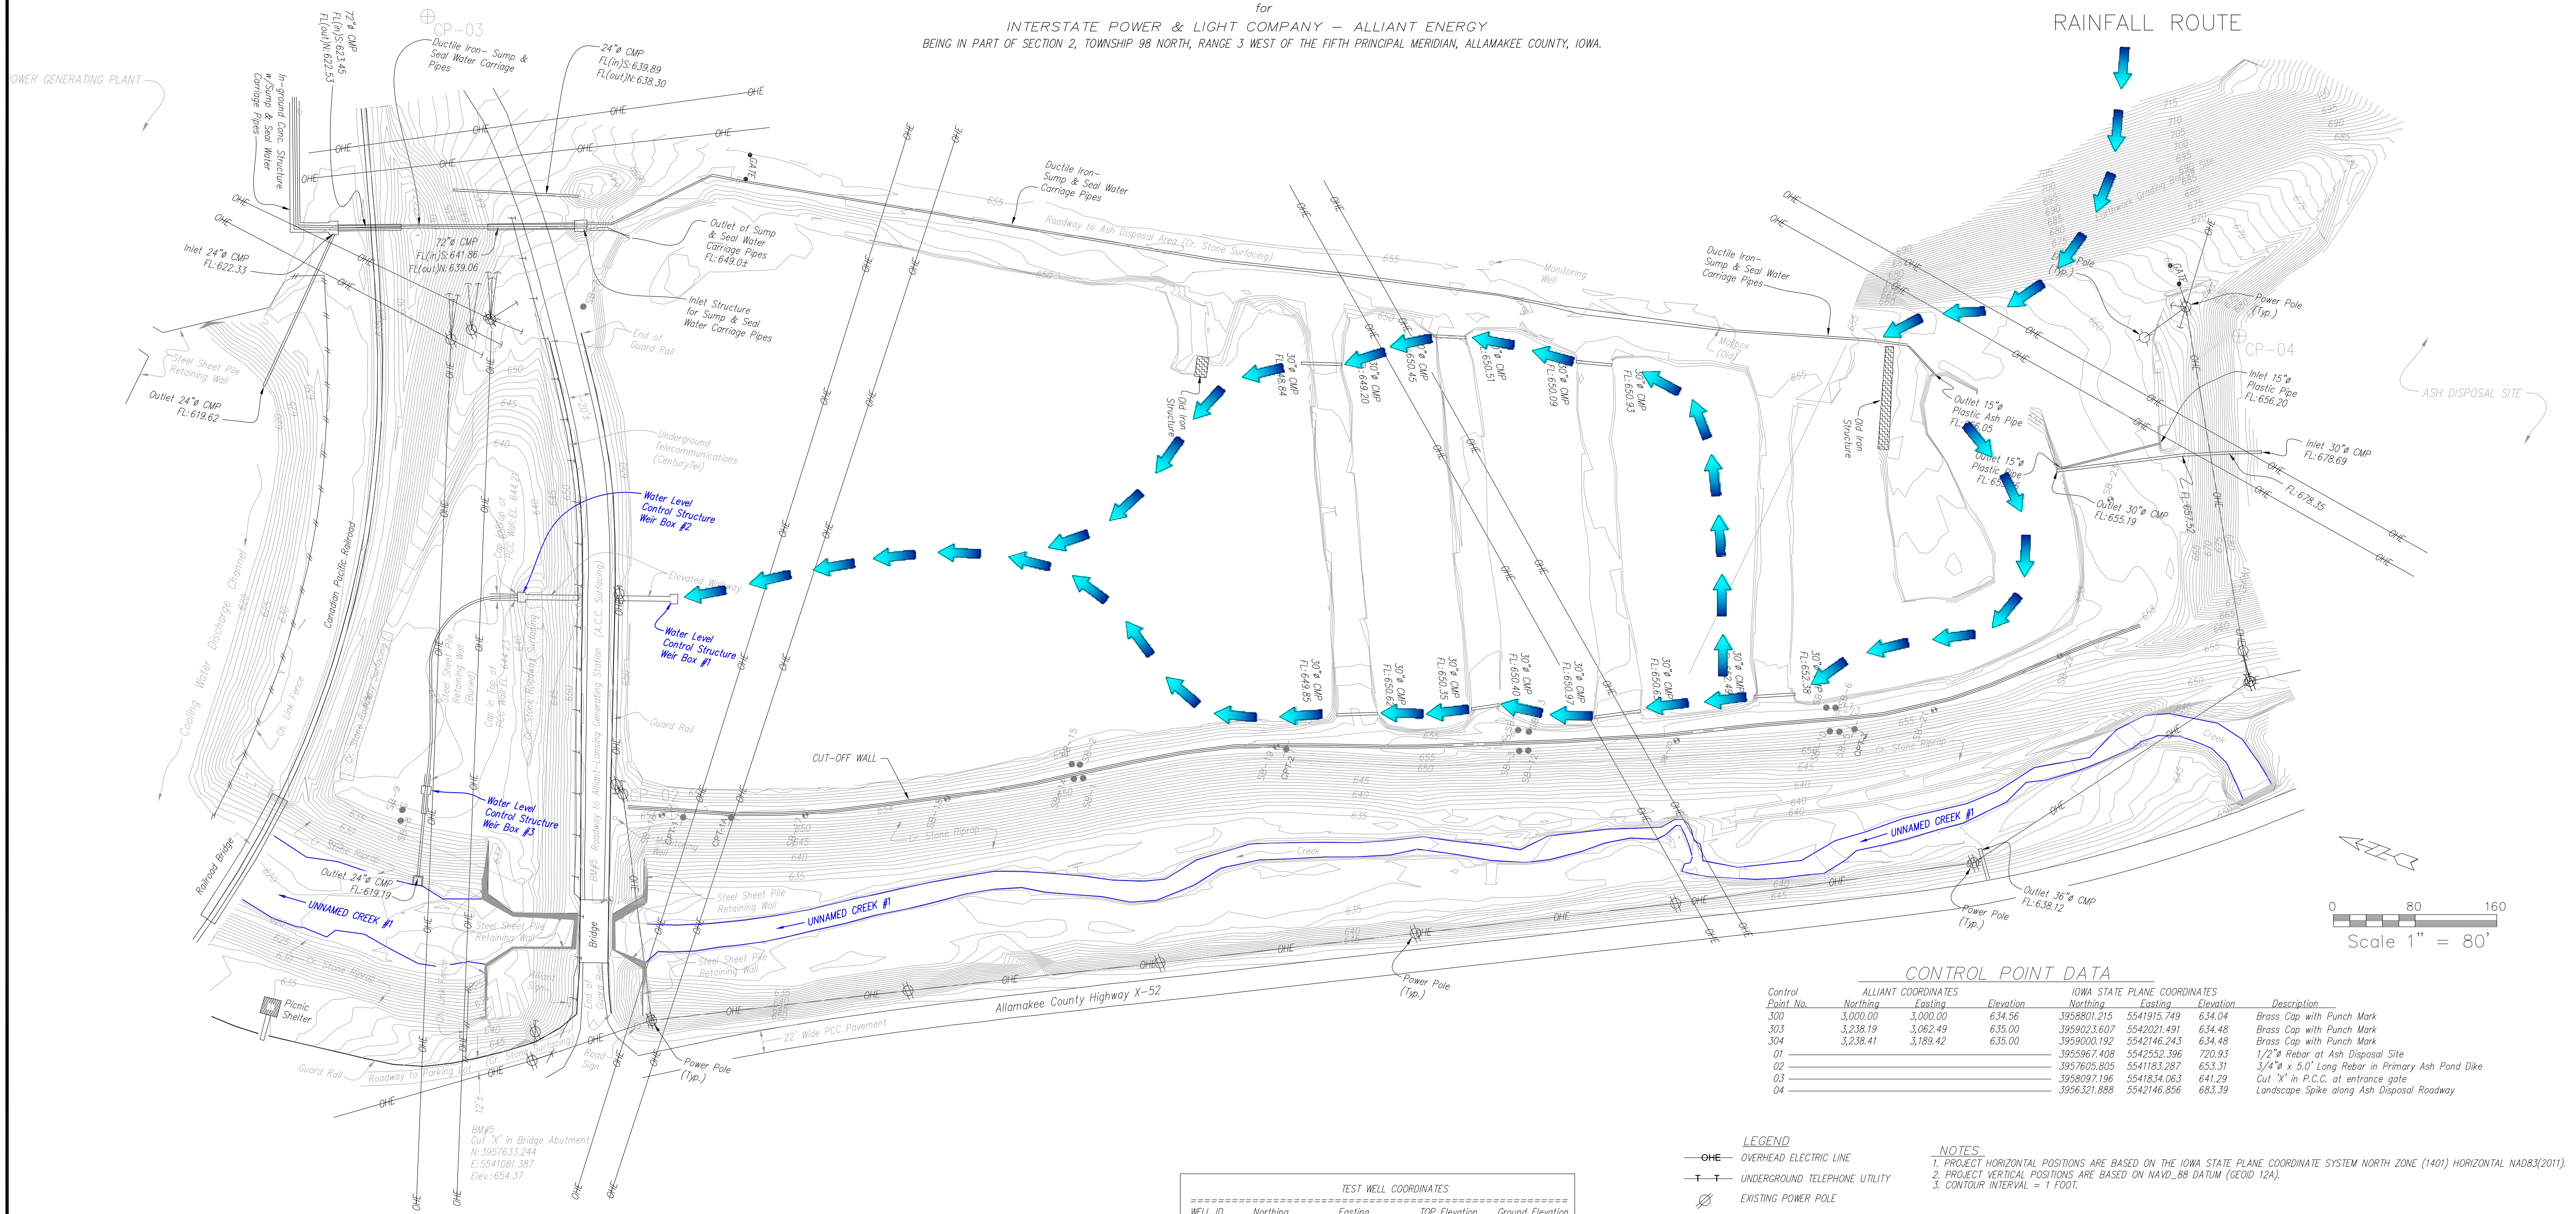
JOB 154.018.012.002
SHT. FIGURE 2
DWG. 154.018.012.002-D2

In the summer of 2015, the west embankment of the LAN Upper Ash Pond was improved by the installation of a cement-bentonite cutoff wall along the center line of the embankment. The cutoff wall reduced seepage loss through the embankment and eliminated the saturation of the embankment toe and flow of surface water from the toe to the Unnamed Creek #1, Figure 2.
