ALLIANT ENERGY
Wisconsin Power and Light Company
Columbia Energy Center

CCR SURFACE IMPOUNDMENT

STRUCTURAL STABILITY ASSESSMENT

Report Issued: October 16, 2020
Revision 1

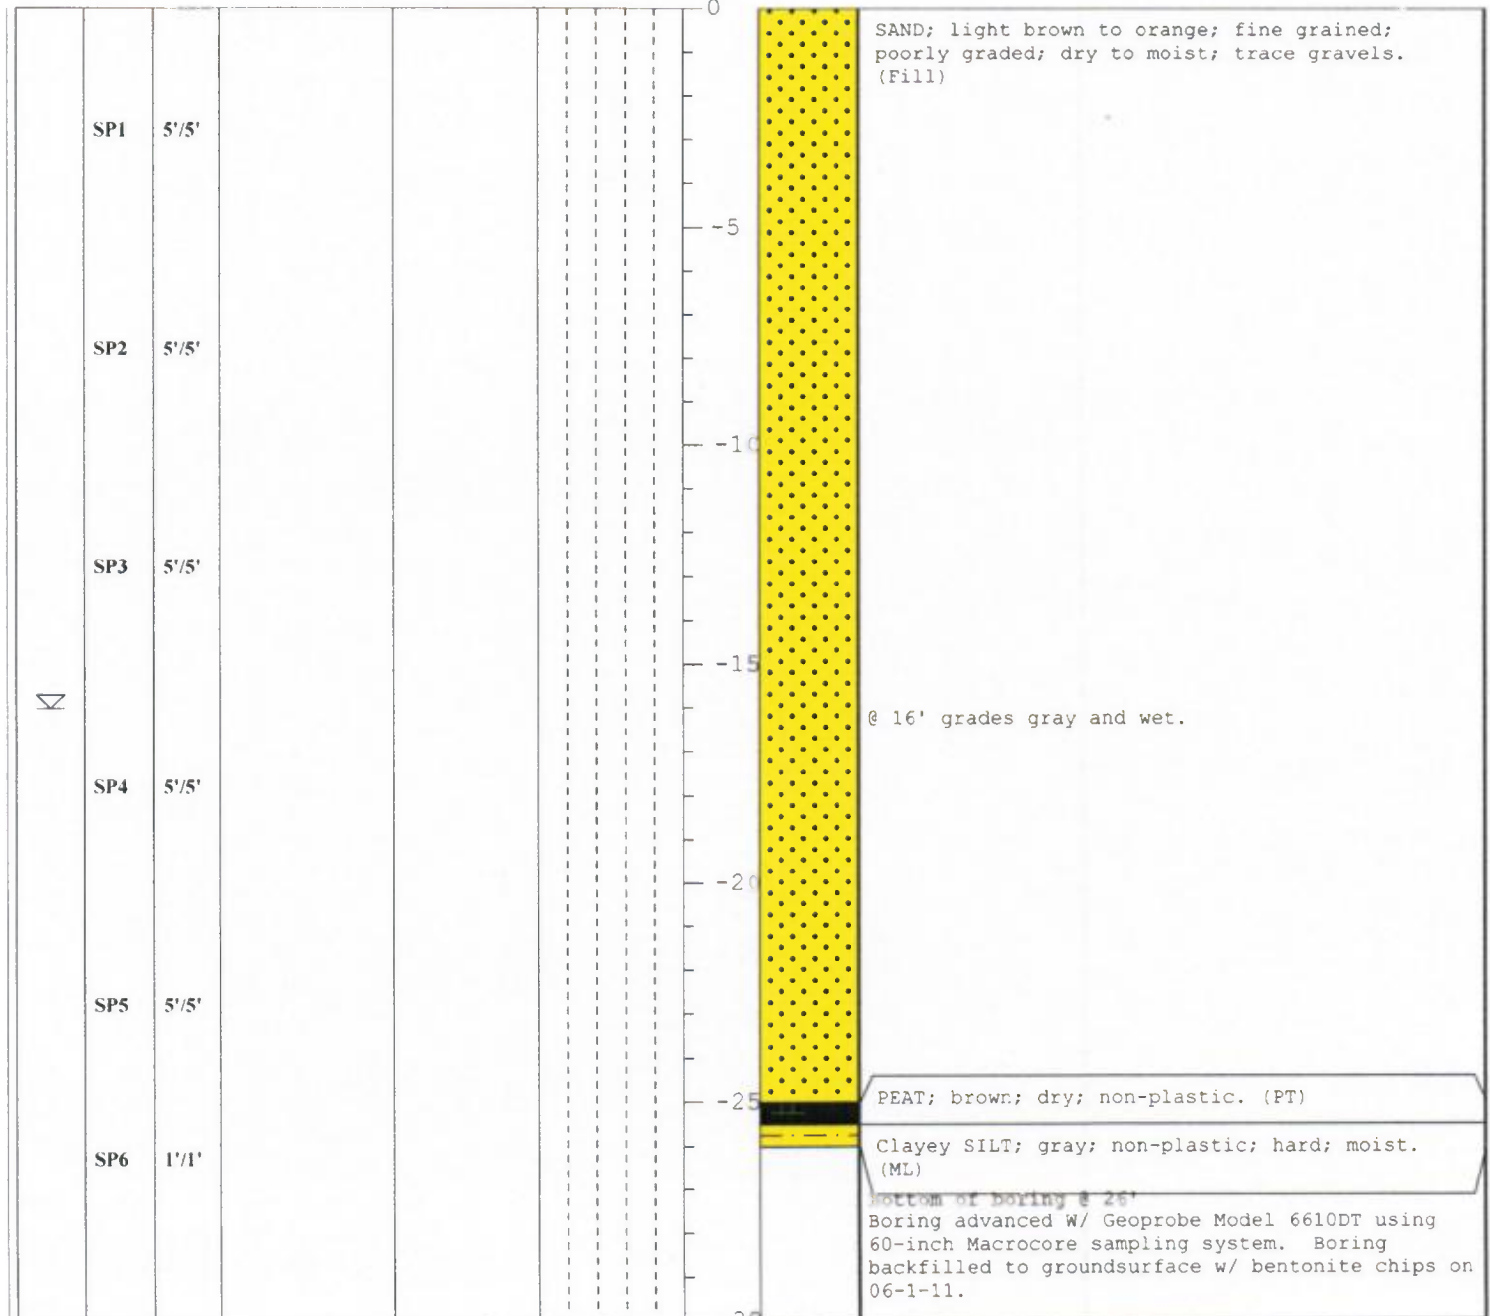
50

USED 54'-0" OF CASING

In 2011 and 2015, subsurface soil investigations were undertaken to collect soil samples and determine the in-situ density of the embankments and install monitoring wells. The soil borings were advanced using a Geoprobe and hollow stem augers and sampling was completed with a standard split spoon (ASTM D1556), Figure 2. The density information, Appendix B, indicates the current conditions of the embankments.
