## ALLIANT ENERGY Wisconsin Power and Light Company Columbia Energy Center

# **CCR SURFACE IMPOUNDMENT**

## STRUCTURAL STABILITY ASSESSMENT

Report Issued: September 19, 2016 Revision 0

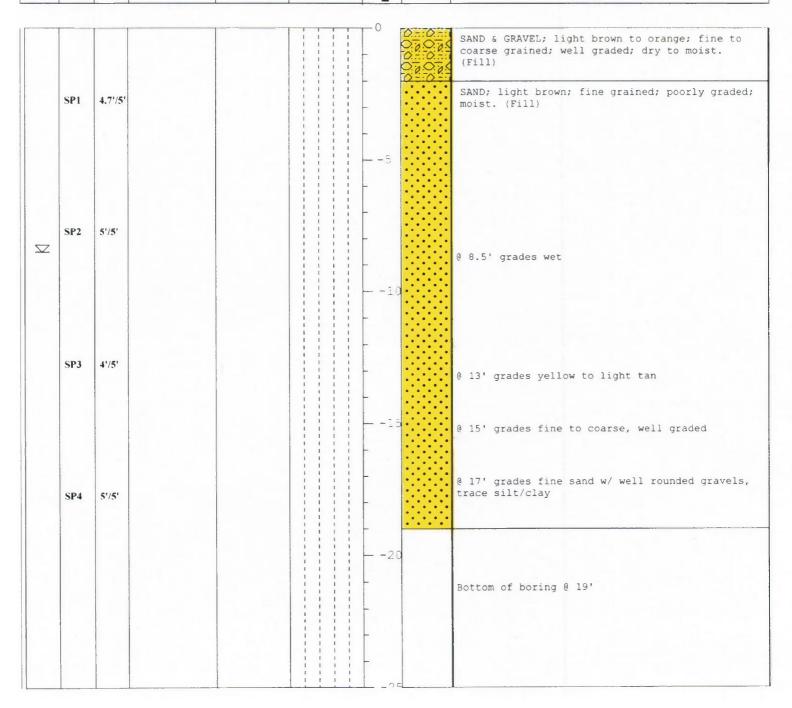
# **BORING LOG**

E DRILLING PLE NO.	PLE RECOVERY	PLE INFROMATION	KET PENETROMETER NS/FT2)	NSISTENCY VS. DEPTH	I IN FEET	ILE	LOGGED BY: EDITED BY: CHECKED BY: DATE BEGAN: DATE FINISHED GROUND SURFA	John Noyes John Noyes Chris Sullivan 06-01-11 0: 06-01-11 ACE ELEVATION:	-
WHII SAMI	SAM	SAM	POC (TO	io o	EPTI	PROF		DESCRIPTION

In 2011 and 2015, subsurface soil investigations were undertaken to collect soil samples and determine the in-situ density of the embankments and install monitoring wells. The soil borings were advanced using a Geoprobe and hollow stem augers and sampling was completed with a standard split spoon (ASTM D1556), Figure 2. The density information, Appendix B, indicates the current conditions of the embankments.

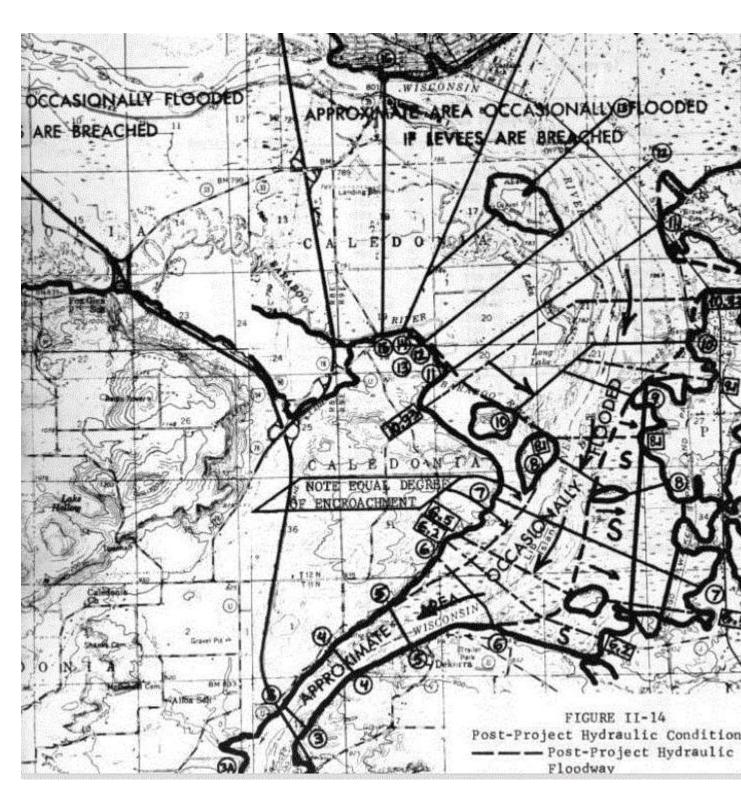
HEC Analysis 1974 Draft Environmental Impact Report/Impact of Construction of Columbia Energy Center Prepared by USACE River Cross-Section 8 and 10 at North End of COL

11-20 TABLE II-11 - WISCONSIN RIVER LEVELS\*
REGIONAL FLOOD (100 Year)

The toe of the embankment is in the floodplain of the Wisconsin River. When the plant was constructed in 1974, the USACE reported that the 100 year flood elevation would be 794 feet on the north embankment of the COL Primary Ash Pond due to construction in the floodplain, Appendix C. The drawdown caused by the flood receding would result in drainage from the toe of the embankment. The embankment is constructed of fine sand (expected permeability of  $10^{-2}$  to  $10^{-3}$  cm/sec) and is not susceptible to rapid drawdown hydraulic pressure. River flooding will not lead to toe stability issues.

The toe of the embankment is in the floodplain of the Wisconsin River. When the plant was constructed in 1974, the USACE calculated the 100 year flood elevation would be 794 feet on the north embankment of COL due to construction in the floodplain, Appendix C. The drawdown caused by the flood receding would result in drainage from the toe of the embankment. The embankment is constructed of fine sand (expected permeability of  $10^{-2}$  to  $10^{-3}$  cm/sec) and is not susceptible to rapid drawdown hydraulic pressure<sup>1</sup>. River flooding will not lead to toe stability issues.
