Initial Annual Inspection  
Inactive CCR Surface  
Impoundment - Main Ash Pond

**M.L. Kapp Generating Station  
Clinton, Iowa**

**Initial Annual Inspection  
Inactive CCR Surface Impoundment – Main Ash Pond  
M.L. Kapp Generating Station  
Clinton, Iowa**

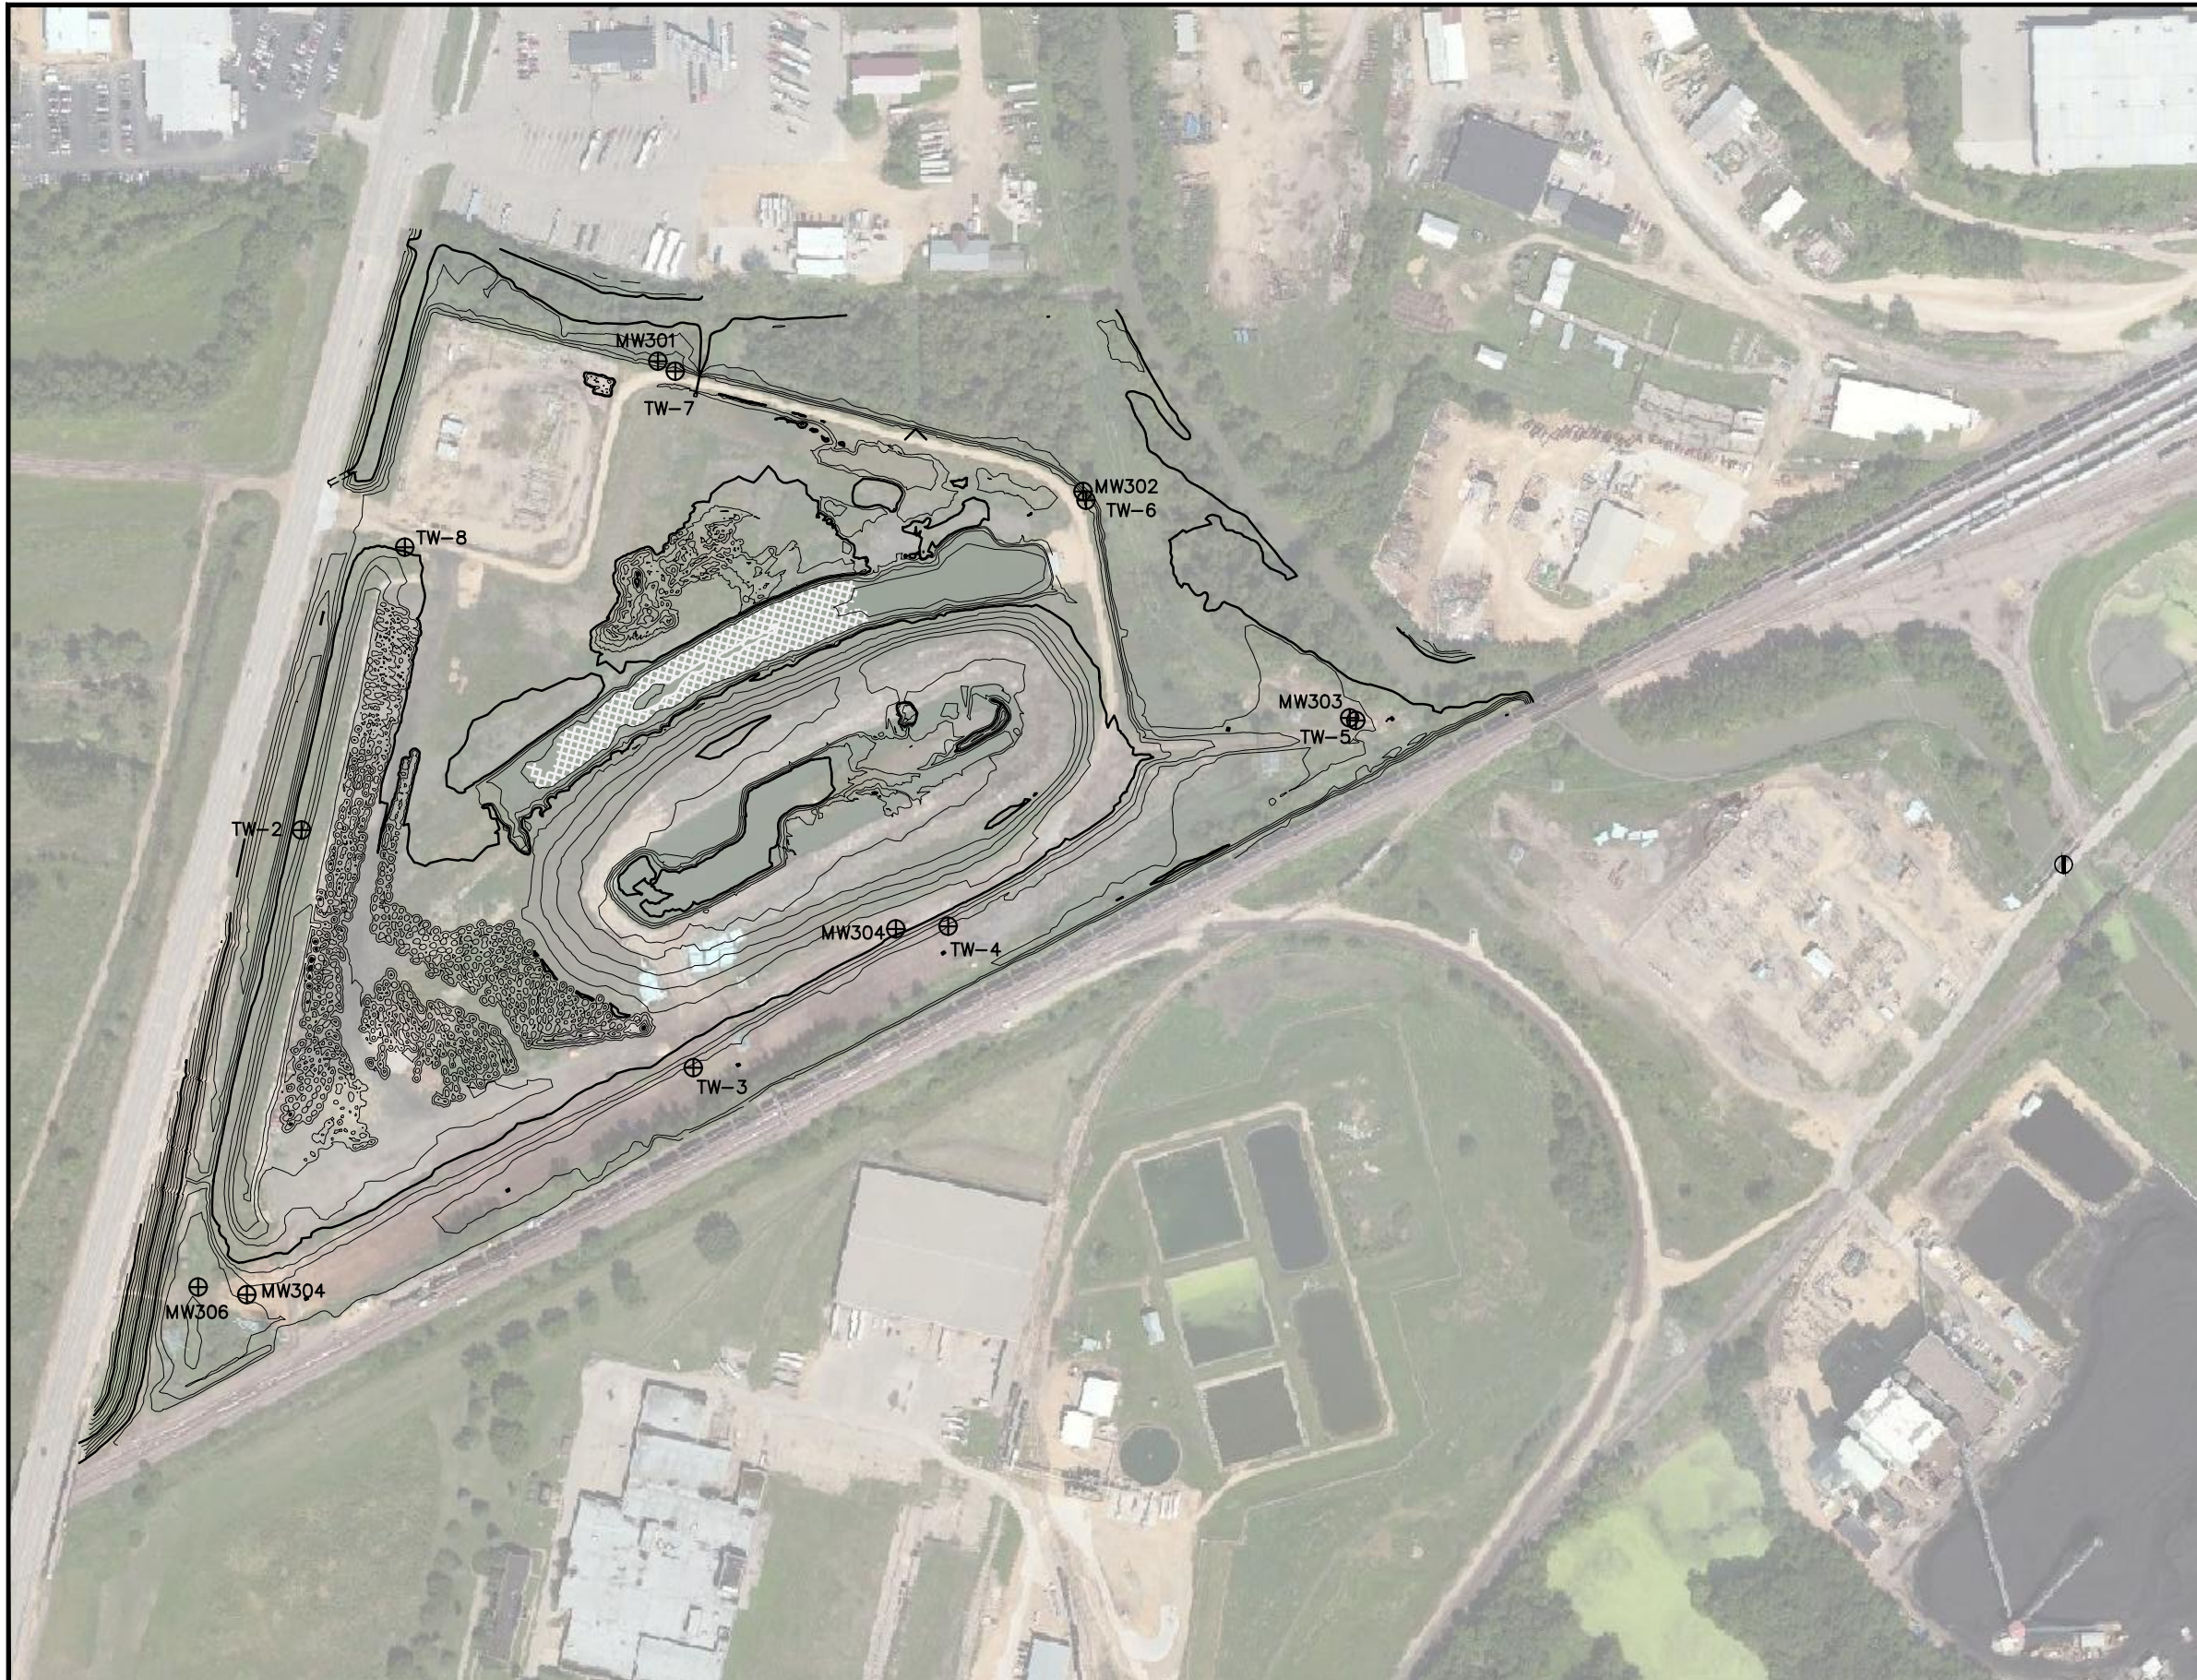
### Temporary Well Information

- TW-5 ⊕ PROPOSED TEMPORARY WELL LOCATIONS
- MW303 ⊕ PROPOSED PERMANENT WELL LOCATIONS
- ⓪ SURFACE WATER ELEVATION MONITORING LOCATION
