Interstate Power and Light Company

Lansing Generating Station CCR Surface Impoundment Annual Inspection Report 154.018.020.002 Report issued: December 9, 2019

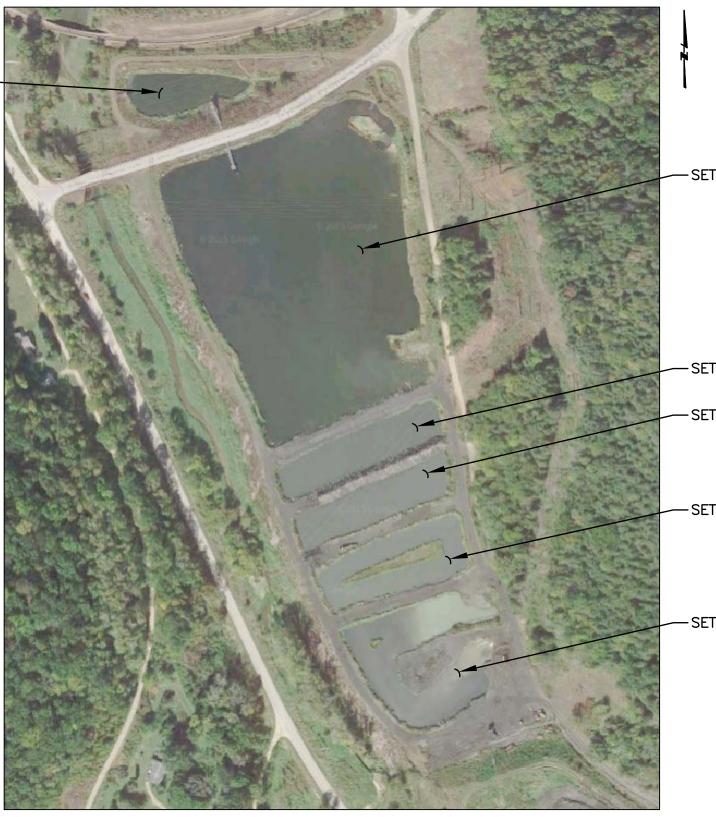
Figure 1: LAN Upper Ash Pond Settling Areas

The Interstate Power and Light Company (IPL), Lansing Generating Station (LAN) in Lansing, Iowa has one existing CCR surface impoundment that meets the requirements of Section 1.1, identified as the LAN Upper Ash Pond. The LAN Upper Ash Pond consists of five interconnected settling areas separated by intermediate dikes. Settling Area #1 is located furthest south, while Settling Area #5 is located furthest north. Figure 1 identifies the location of each of the five interconnected settling areas of the LAN Upper Ash Pond.

LAN UPPER ASH POND AERIAL PHOTOGRAPH NOT TO SCALE

-SETTLING AREA #5

-SETTLING AREA #4

-SETTLING AREA #3

-SETTLING AREA #2

-SETTLING AREA #1
