**Interstate Power and Light Company**

Lansing Generating Station  
CCR Surface Impoundment Annual Inspection Report  
154.018.024.002  
Report issued: December 10, 2021

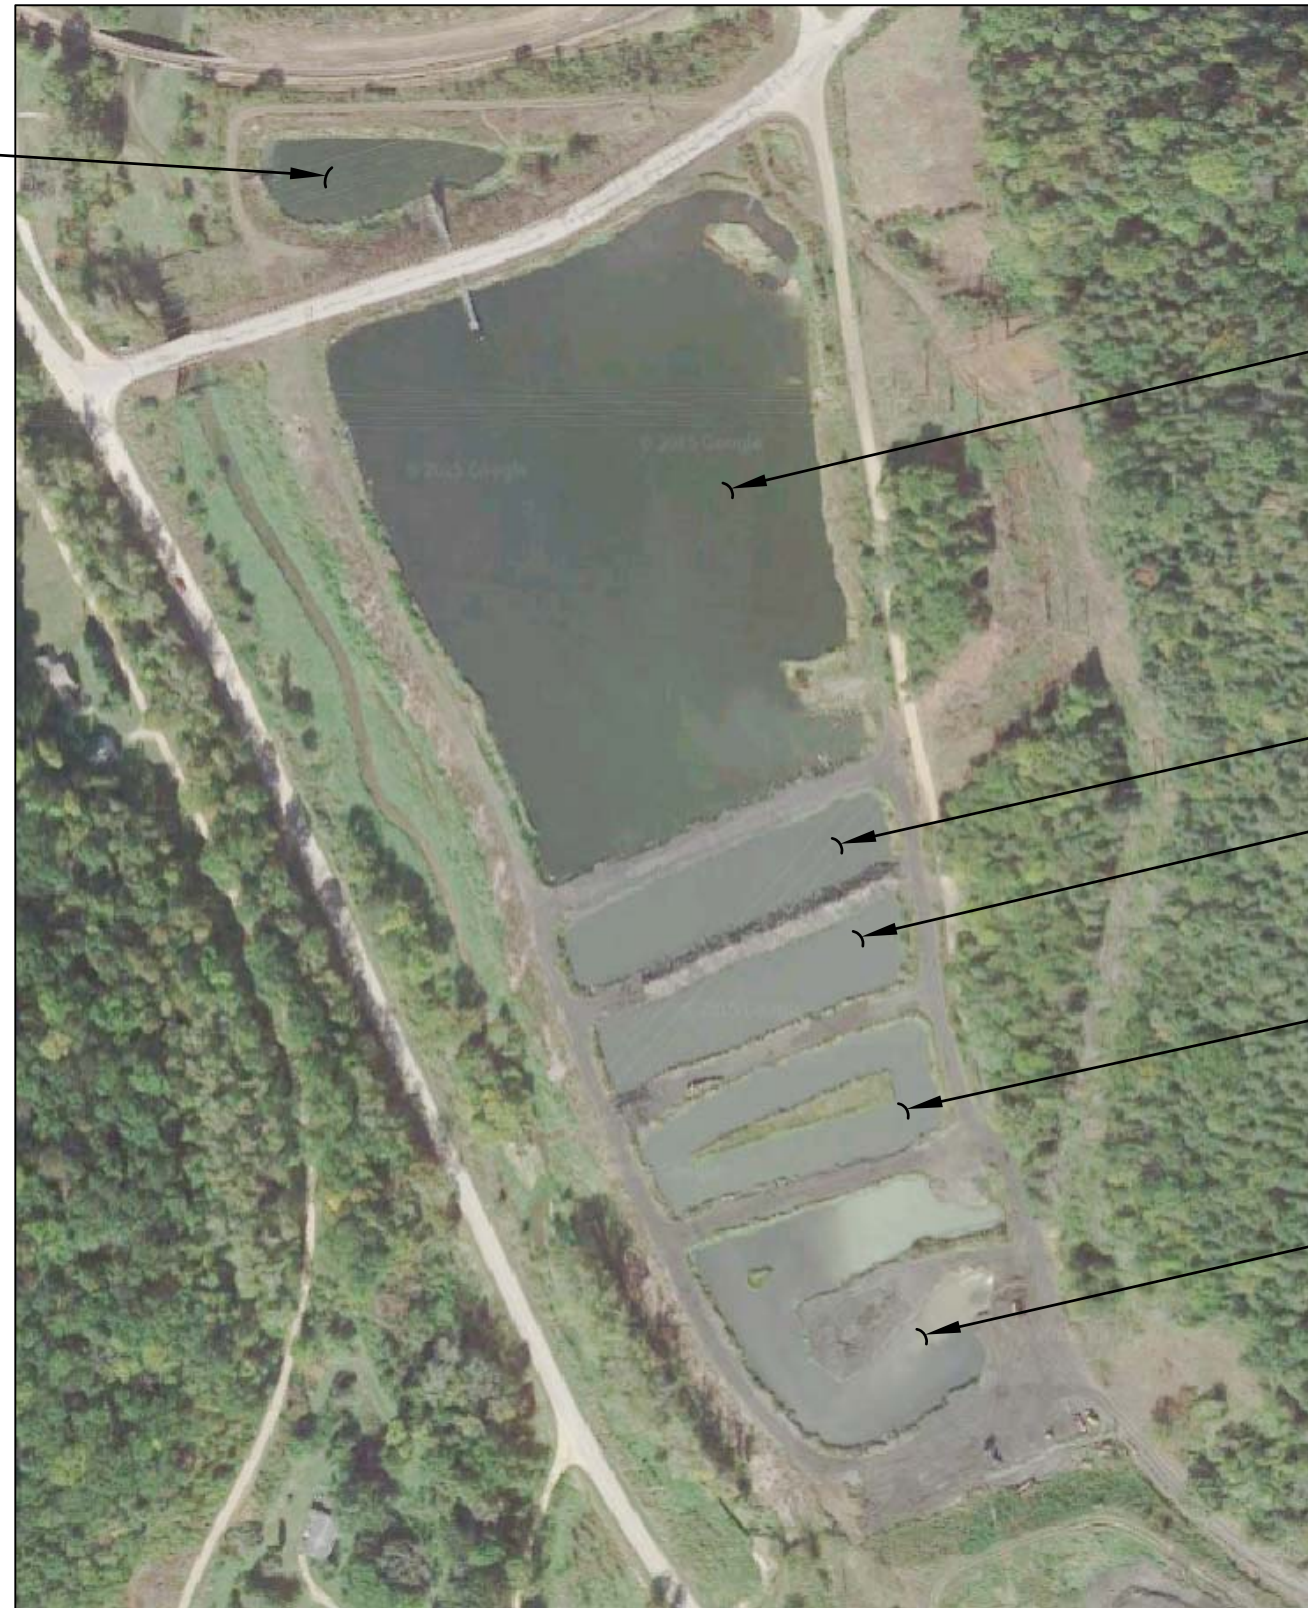
*Figure 1: LAN Upper Ash Pond Settling Areas*

LOWER POND  
CLOSED SEPTEMBER 2015

SETTLING AREA #5

SETTLING AREA #4

SETTLING AREA #3

SETTLING AREA #2

SETTLING AREA #1

LAN UPPER ASH POND  
AERIAL PHOTOGRAPH  
NOT TO SCALE

The Interstate Power and Light Company (IPL), Lansing Generating Station (LAN) in Lansing, Iowa has one existing CCR surface impoundment that meets the requirements of Section 1.1, identified as the LAN Upper Ash Pond. The LAN Upper Ash Pond consists of five interconnected settling areas separated by intermediate dikes. Settling Area #1 is located furthest south, while Settling Area #5 is located furthest north. Figure 1 identifies the location of each of the five interconnected settling areas of the LAN Upper Ash Pond.
